RTW 2021

Airbus

A220

Liebherr Saline

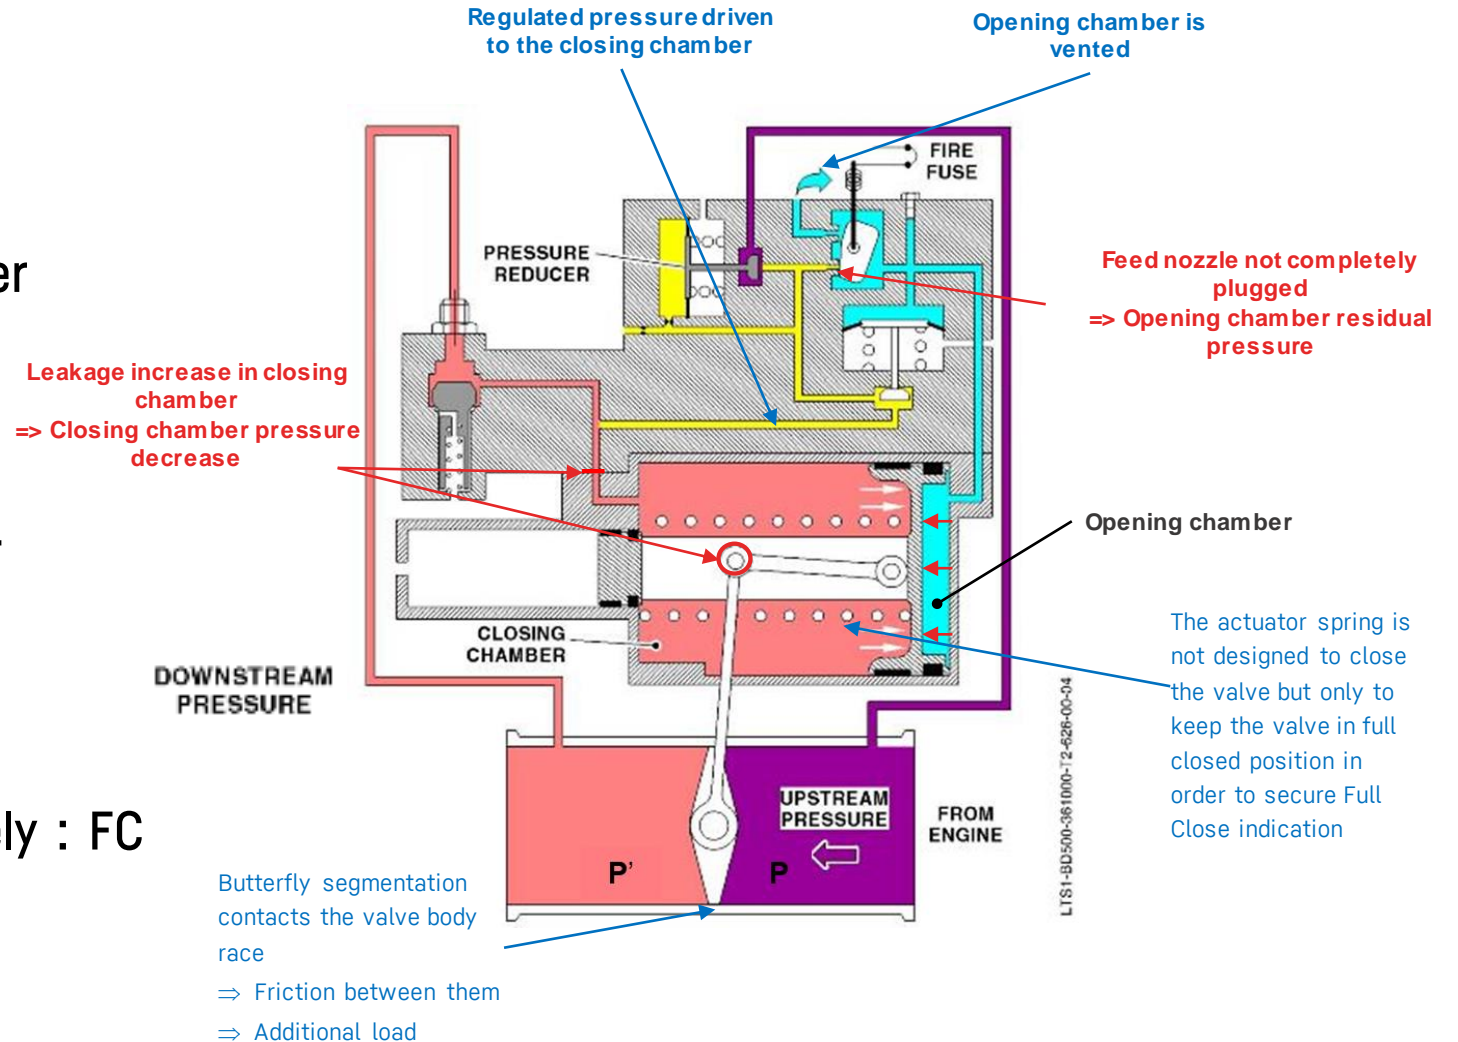
PRSOV FAILED OPEN

Vibration environment as main root cause for premature torque motor and seals wear

- Severe vibration environment leads to
 - Torque motor bearing damage :
 - Cage degradation : Particles due to cage wear prevent ball bearings motion.
 - Vibrations levels high enough to counter torque motor bearing pre-load (reversible phenomenon which is acceptable during a limited time of exposure).
 - Impact : Residual pressure in opening chamber
 - pressure regulation drift and/or failed open events

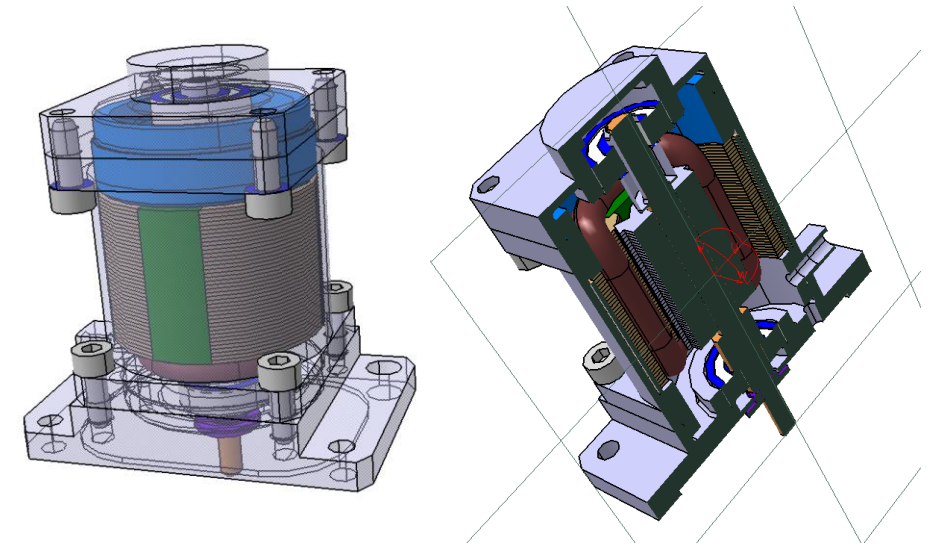
PRSOV FAILED OPEN

Vibration environment as main root cause for premature torque motor and seals wear

- Seals wear : excessive external leakage
 - Wear is observed on graphite seals located along butterfly axis leading to leakage from closing chamber and from valve body.
- Impact : Pressure decrease inside closing chamber
 - pressure regulation drift and/or failed open events

- Mitigation actions
 - Systematic replacement of torque motor and seals at each valve's return (since 2018)
 - Health monitoring : PRSOV failed open algorithm (since January 2021)
 - PRSOV Amendment A :
 - Since July 2020, VSB 70115-36-01 is recommended and is implemented on attrition systematically

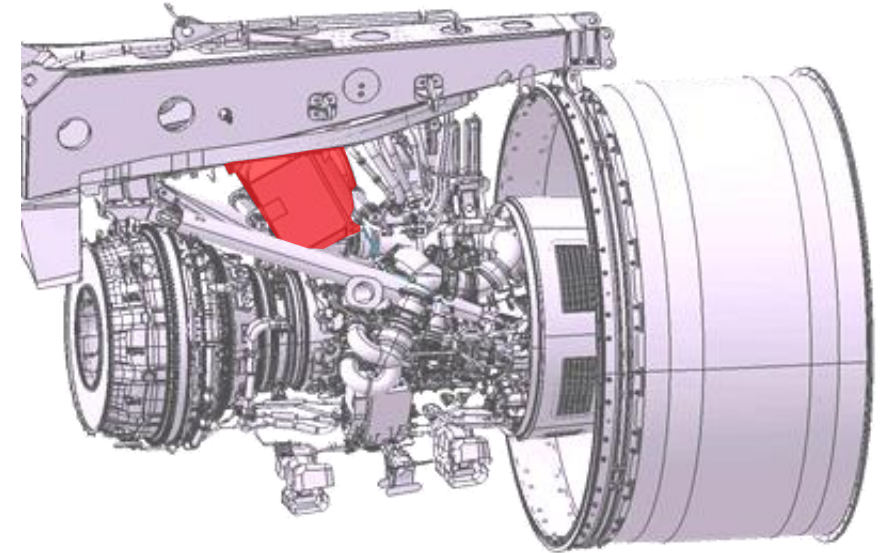
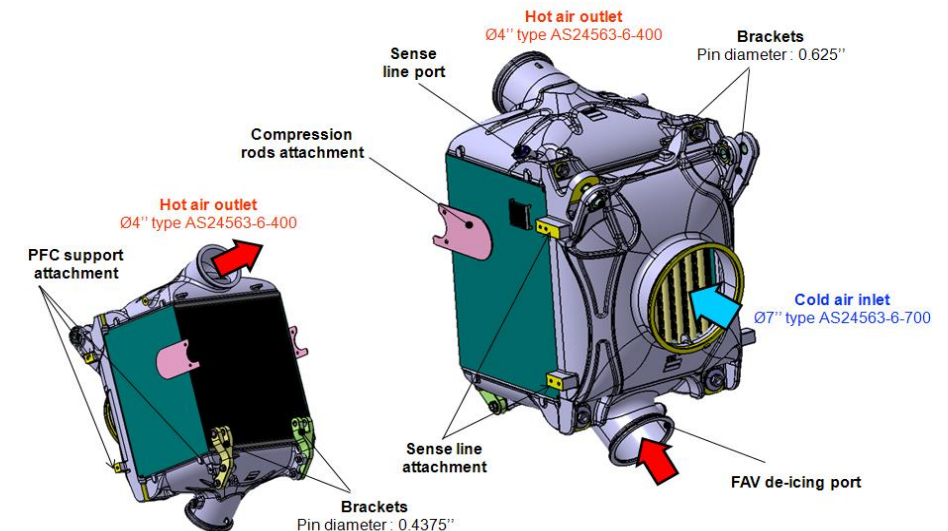
Precooler P/N 70263A leakage

Shop findings:

- Main leakage is located under the bumpers (ID plate side), on the cold outlet side.
- The two first parting sheets are cracked on several centimeters and in one case the first hot closure bar was starting to detach and slide outside.
- No brazing defect (manufacturing parameter) was observed on the different removals analyzed by our material laboratory.

Leakage test performed at Liebherr shop during incoming inspection

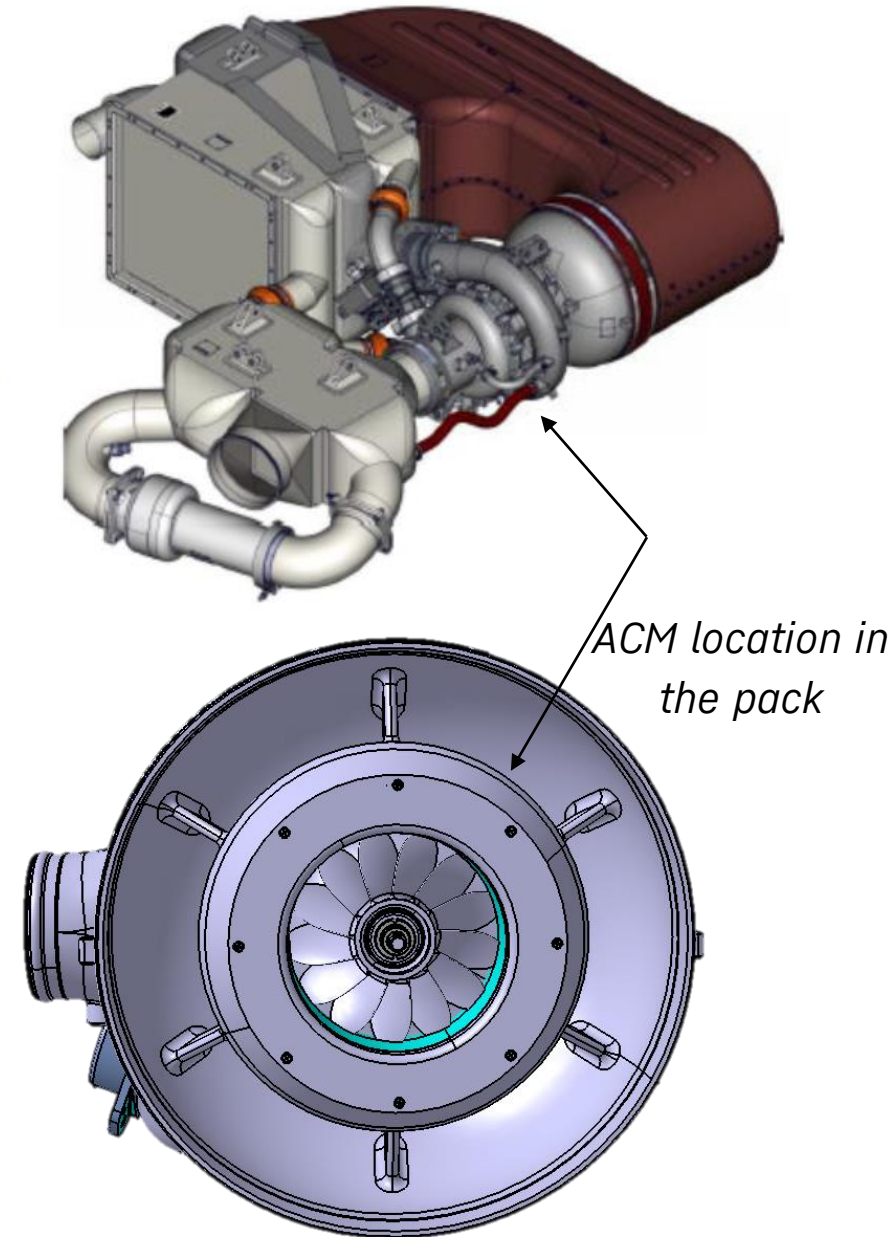
ACM 70067A – Fan wheel failure

Shop finding :

All the failed ACM were found with one or several blades broken.

All observed failures have a typical fatigue fracture cross section with a crack initiation from blade surface

Root cause:

After extensive investigations, the combination of the following causes originates the failure :

- The residual stresses after machining
- The frequency mistuning phenomenon of blades
- The bending stresses induced by the variable aerodynamic flow

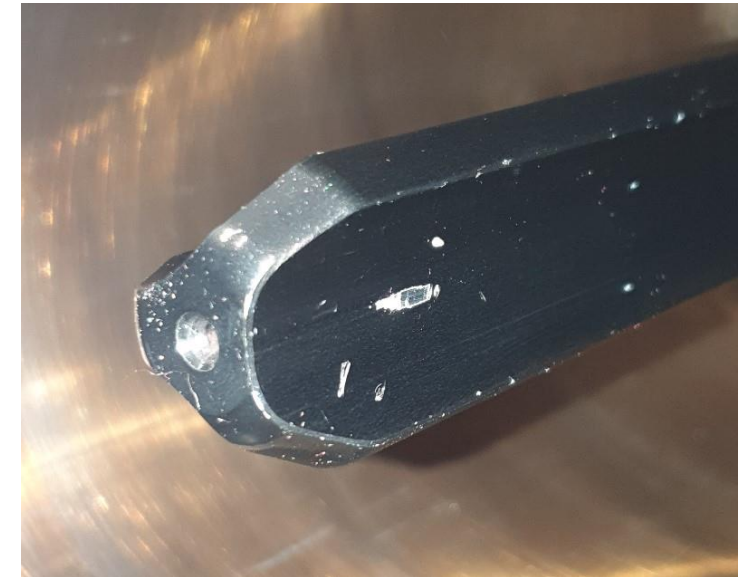
Metering Pin damaged

Lost screws create damage on inner surfaces and parts

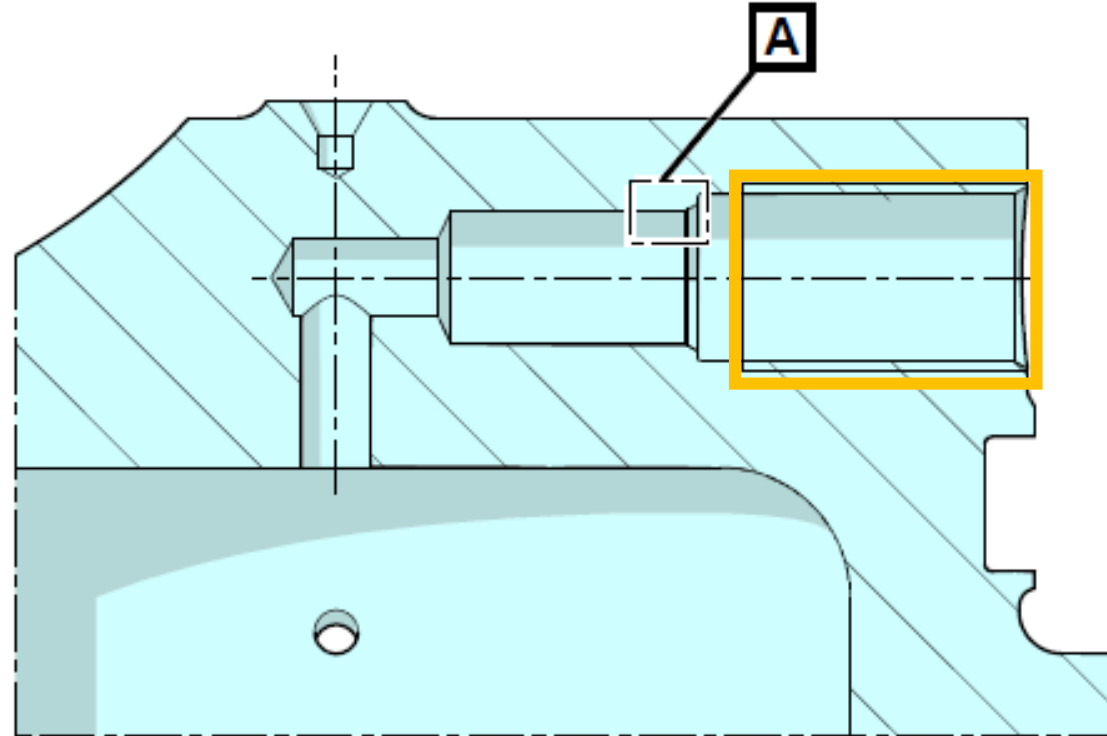
A-A

Inspection Zone 2 - Potential damage at the Inner Diameter of the Bore

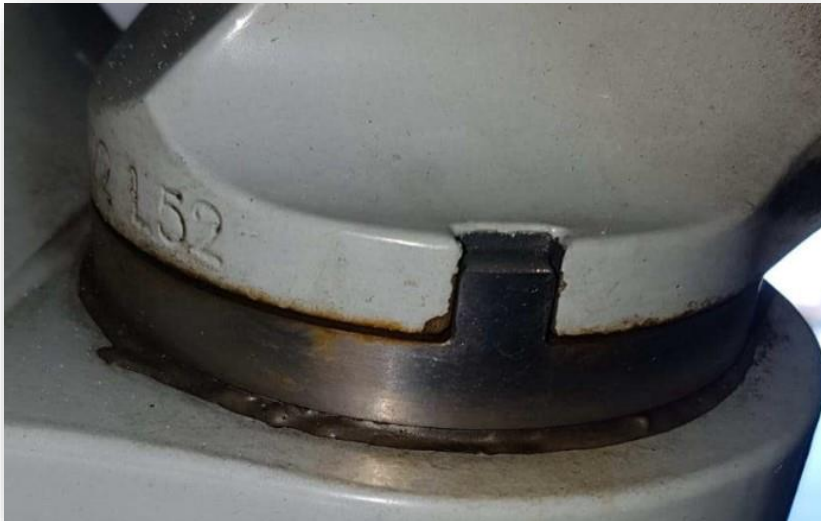
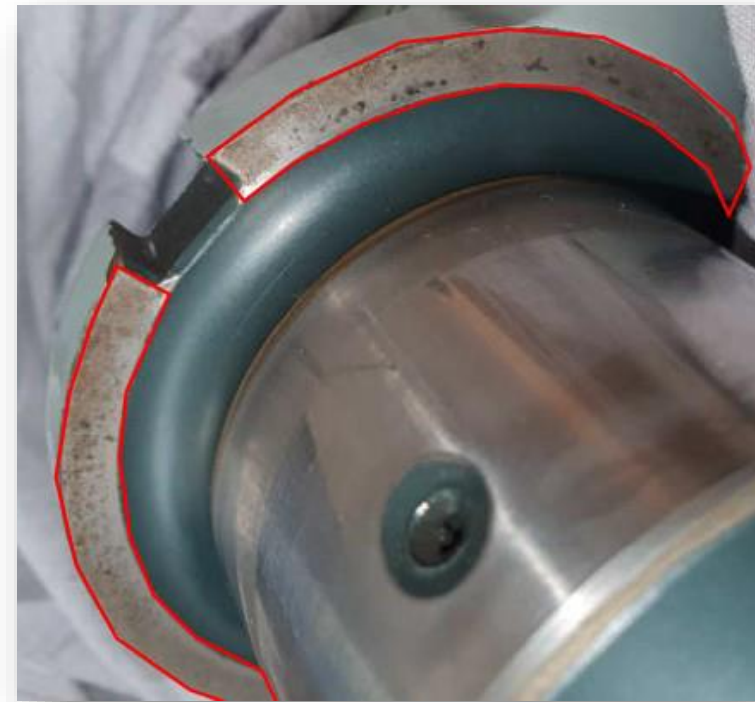
Corrosion on Lower Spindle was detected.
