RTW 2021

Airbus

SA Family

Liebherr Saline

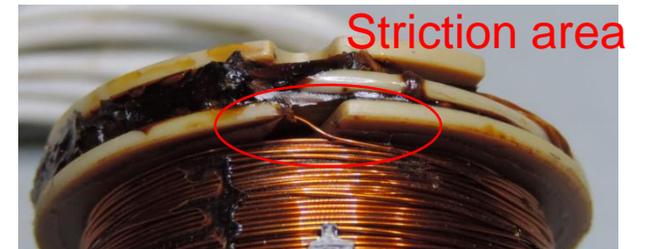
- ✓ *Solenoid winding weakness*

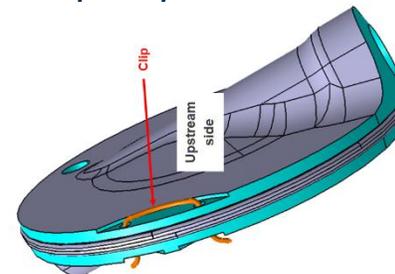
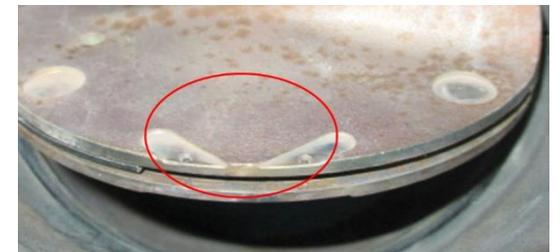
- ✓ *Butterfly clip rupture*

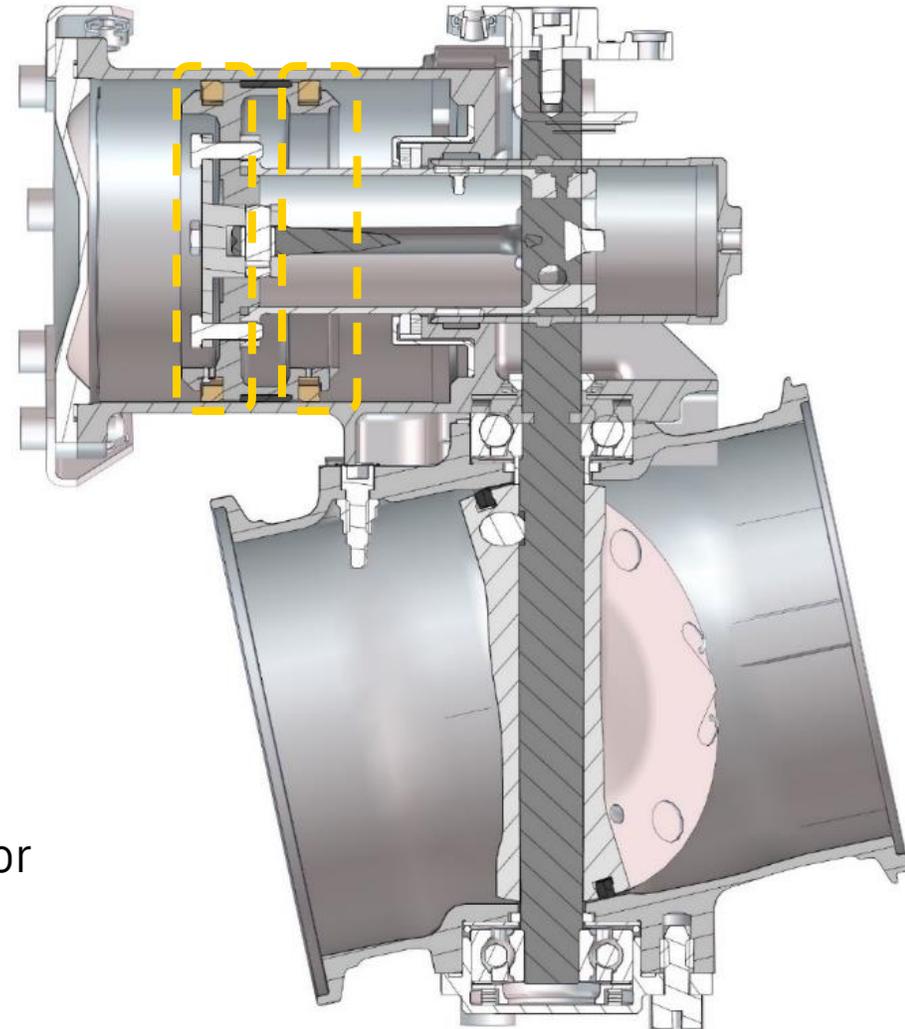
HPV Faults – Actuator piston seals

Actuator piston seals graphite exudation

Seals get stuck on the piston

Pressure transfer between both Actuator chambers

This finding contributes to both HPV failed open and failed closed occurrences

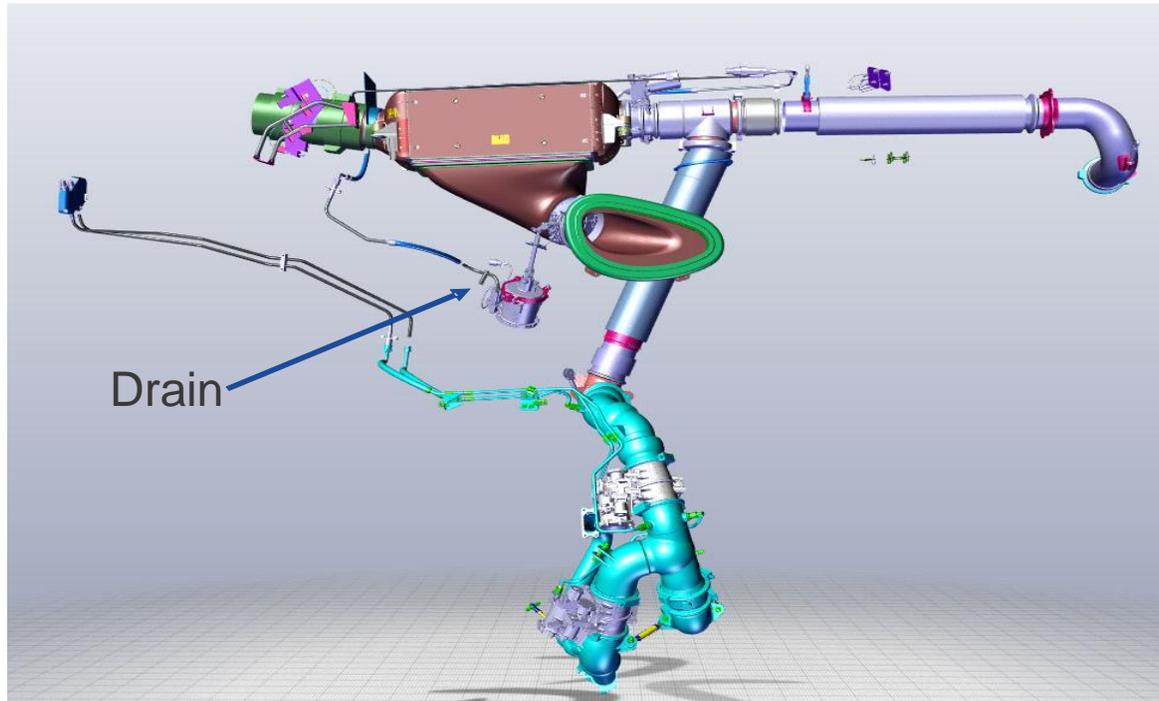
Water ingestion thru sense line at FAV muscle pressure port creating corrosion and contamination damages within FAV actuator subassemblies.

Ex on CFM installation, note that PW installation is very similar for FAV sense line integration.

Water retention increased during A/C parking or storage period

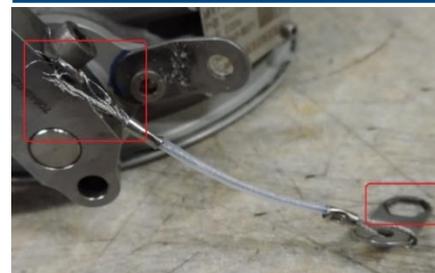
For CFM & PW engine installation, a combination of aeroacoustics resonances in the fan inlet scoop & Installation variability lead to excessive vibrations and break the inlet scoop brackets. Load are then transmitted to FAV sub assemblies.

Retaining cable damaged

During aircraft inspection, if any of these damages are observed, the complete FAV Body + ROD needs to be replaced.

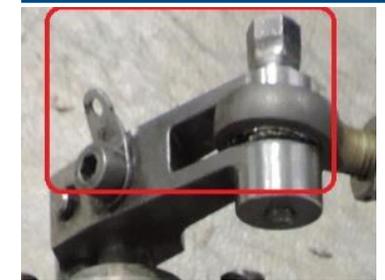
Retaining cable missing

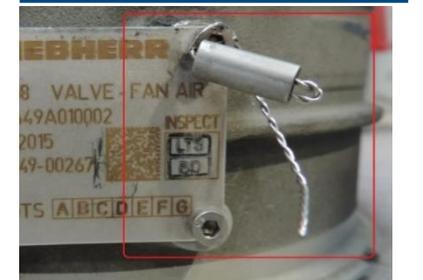
Lock wire or seal damaged

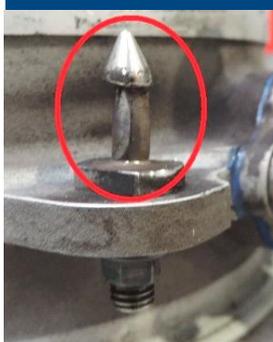
Pins damaged

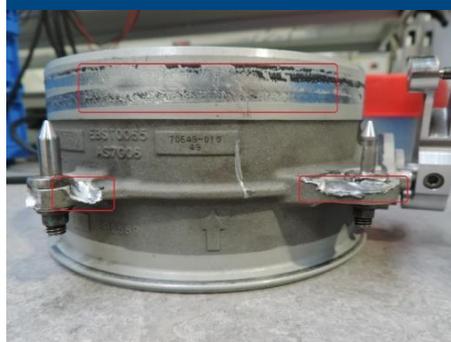
Valve body damaged

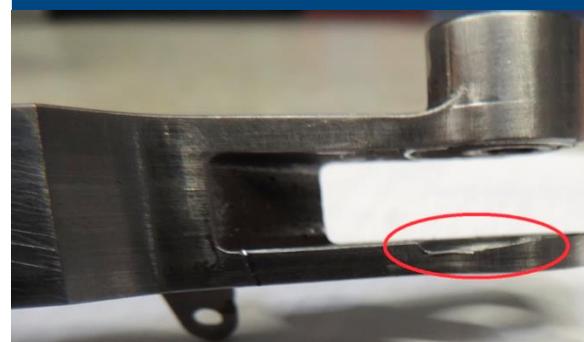
Lever assy damaged

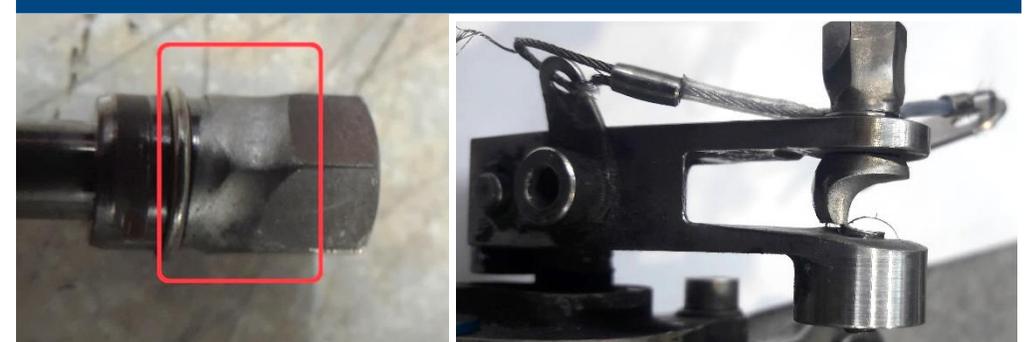
Special screw damaged

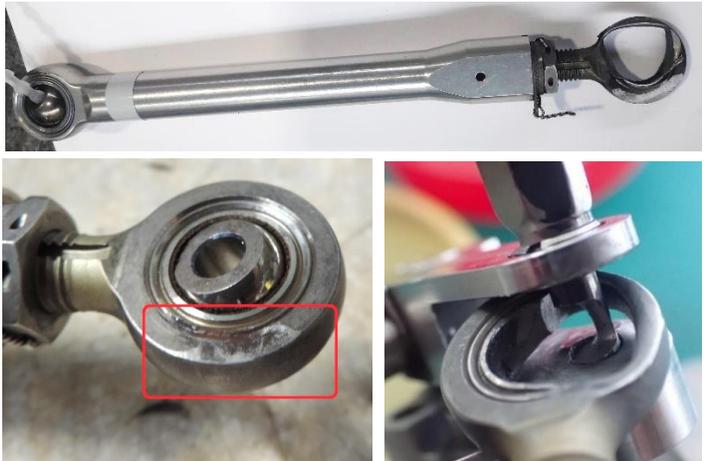
Rod assy damaged

Important reminder: AMM does not provide instructions to replace only the FAV rod on the wing. Airbus and Liebherr absolutely do not recommend replacing only the rod because other parts integrity cannot be ensured.

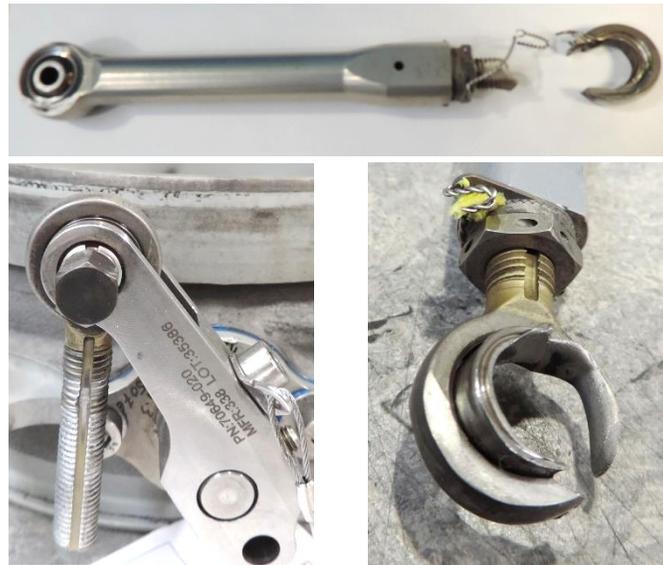
Rod assy broken

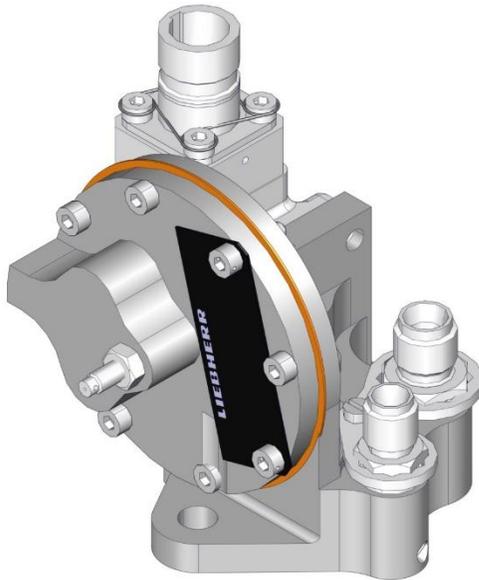
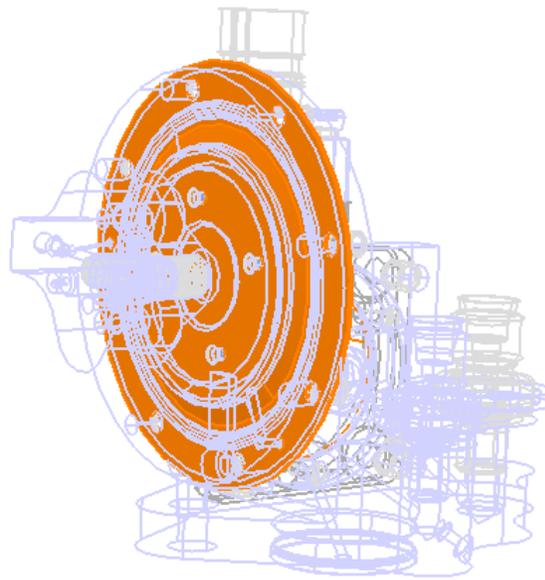
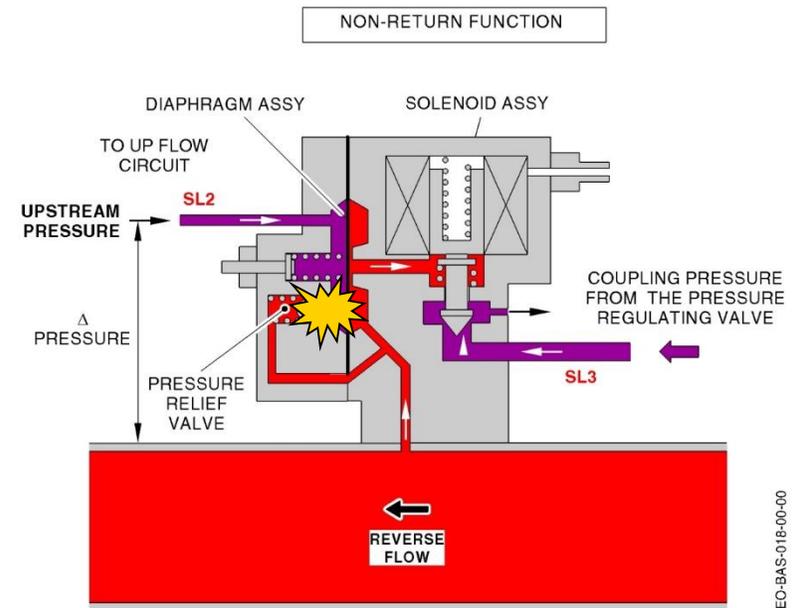
After engine stall events, a lot of TLT (341F010000) were investigated and found with pollution in the Non-return function and the solenoid.

After analysis, some RTV was found as part of the pollution and RTV is used in the manufacturing of TLT diaphragm

With temperature the RTV can migrate and partially obstruct the non-return function hole.

The modification will consist in removing RTV during diaphragm manufacturing only.

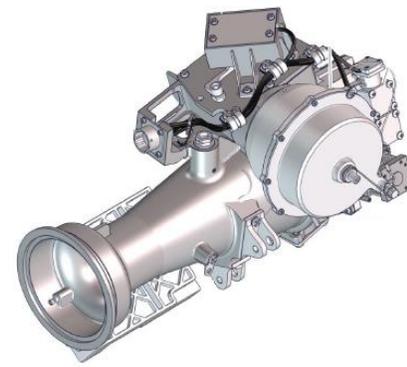
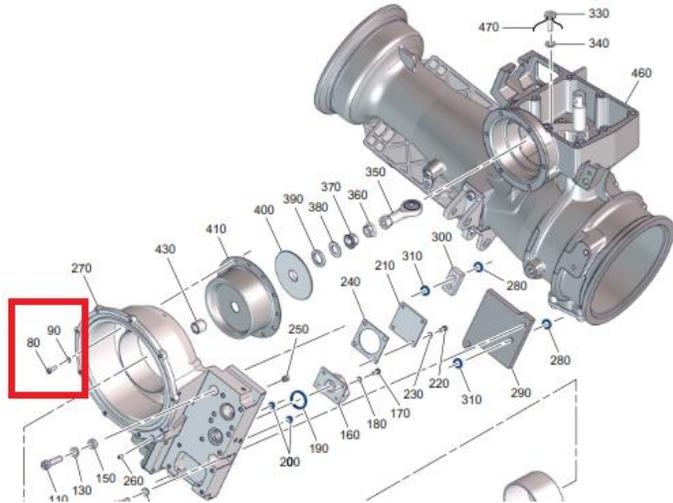
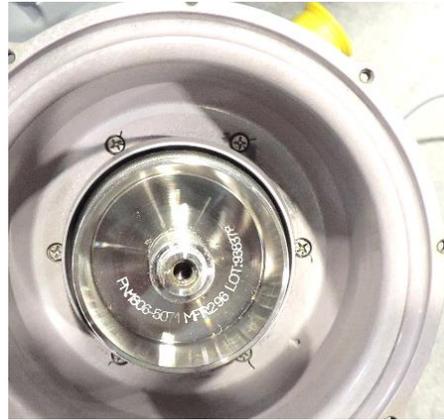
Majority of removed units have loose screws inside the actuator body :

Manufacturing process & repair shop in Jan 2021 : addition of a second torqueing task of the actuator screws to secure the tightening on a longer period than with a single torqueing.

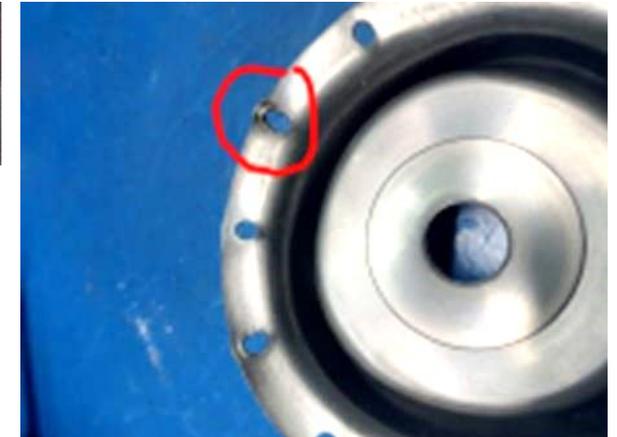
Actuator screws found loose

Component consequence : lower actuator diaphragm wear found on some units

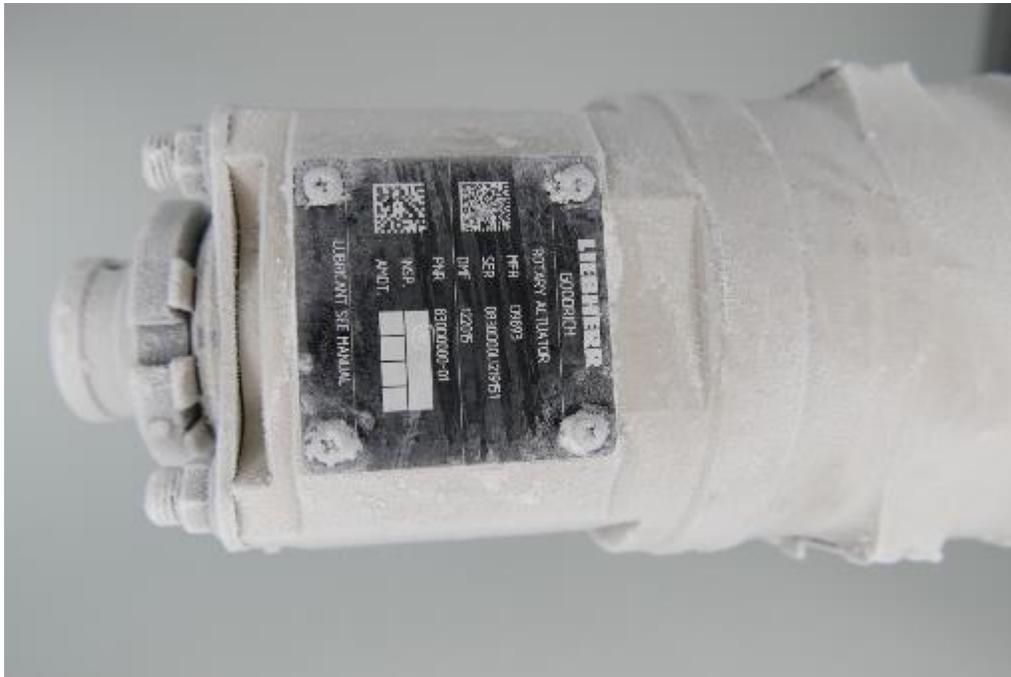
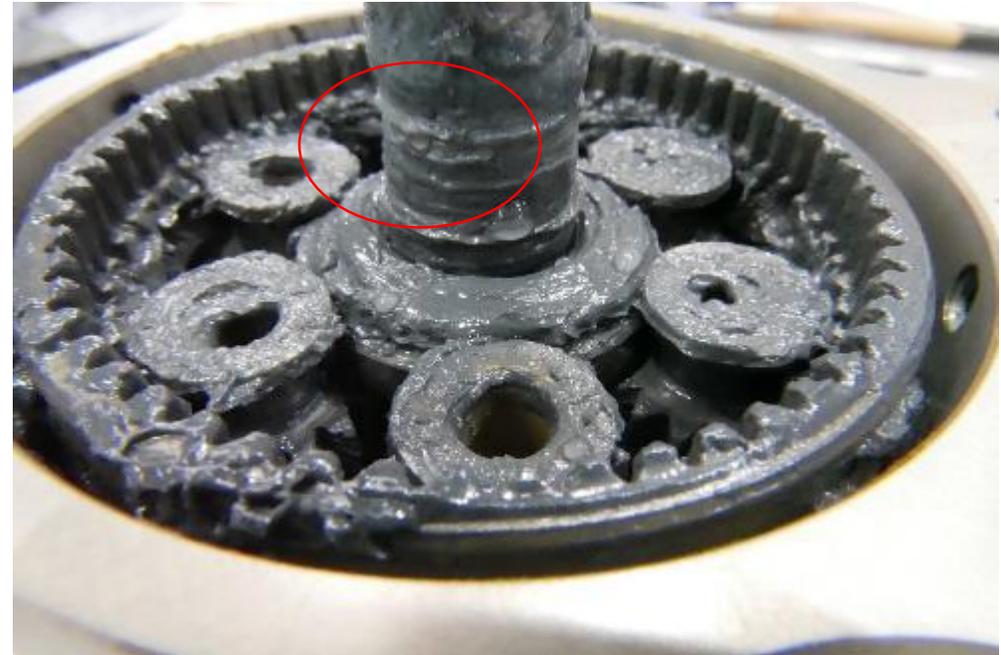
- 43% of returned GRAs jammed @ -40°C test *
- Moisture found on 45% GRAs during disassembly.*

- Root cause on GRA level: Frozen water
- Root Cause contributor on A/C level: Increased wing bending (sharklets)

- Change the grease from AeroShell 33 back to Nyco GN22
- Sealing the gap between the Housing and the Cover.

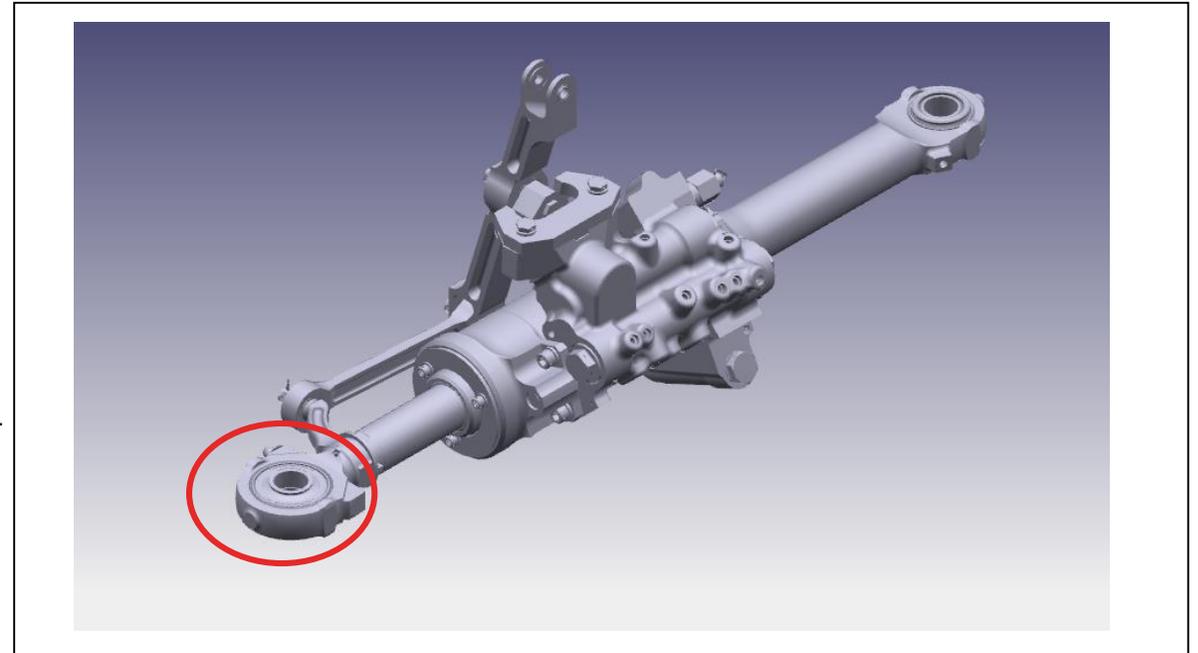
Excessive play in contributes to aircraft vibration.

Change of liner eye-end bearing on-wing via in-situ tool.

Introduction of new roller bearing.
