RTW 2022

Airbus

Liebherr-Aerospace Toulouse

Airbus SAceo

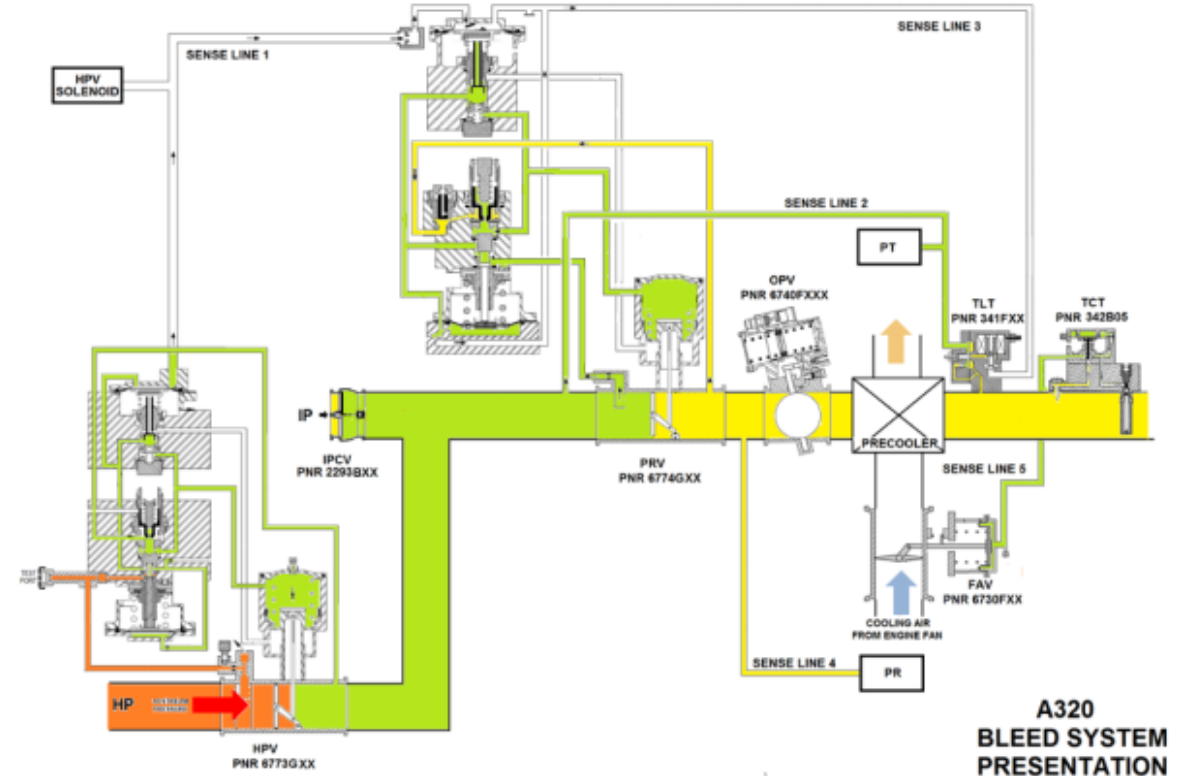
Complete failure of TLT reverse flow function just after the engine start sequence with APU Bleed (10s) may lead to engine stall.

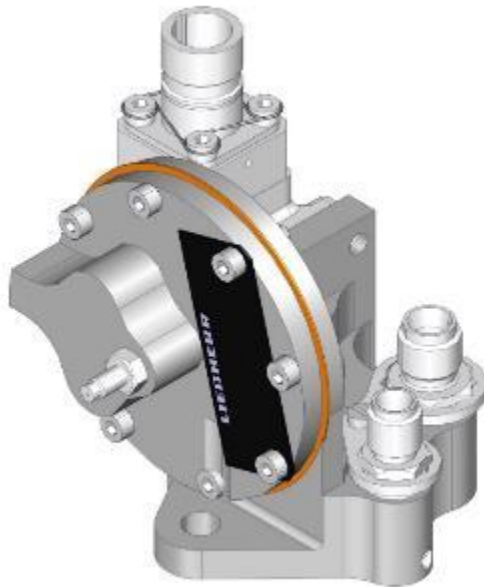
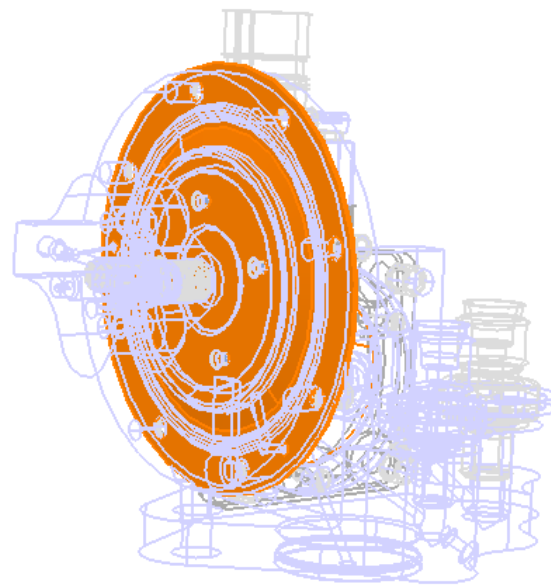
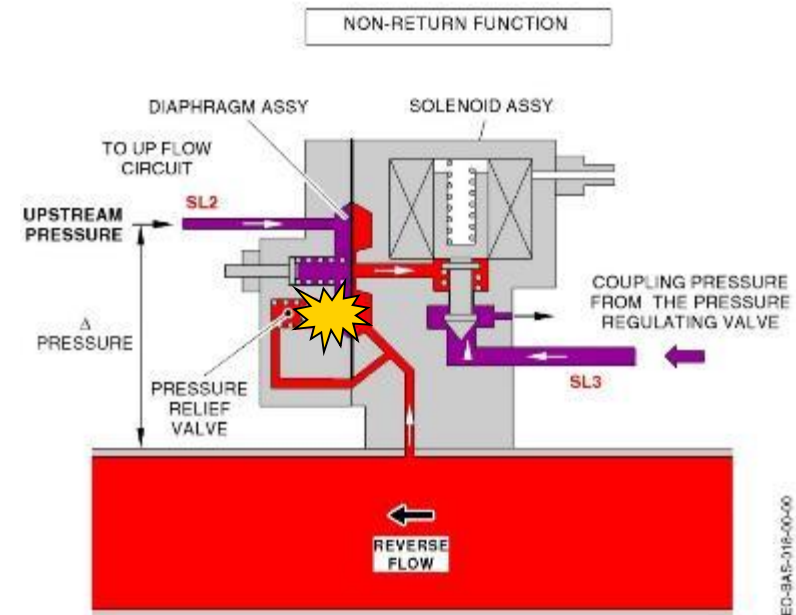
After engine stall events, some TLT (341F010000) were investigated and found with pollution in the Non-return function and the solenoid.

After analysis, some RTV was found as part of the pollution and RTV is used in the manufacturing of TLT diaphragm

The modification will consist in removing RTV during diaphragm manufacturing only.

VSB 341F-36-01 to be applied on attrition basis. At opportunity of a Major repair, systematic embodiment at no additional costs.

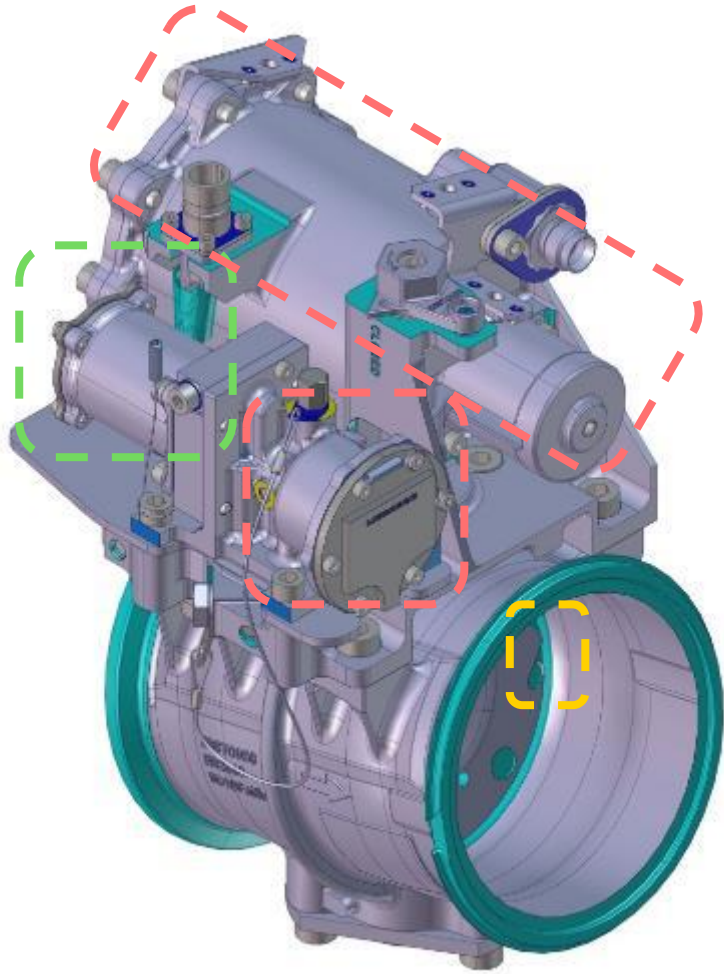
- ✓ *Aluminium phosphate exudation from JPXX32 graphite on actuator seals and regulation clapper*

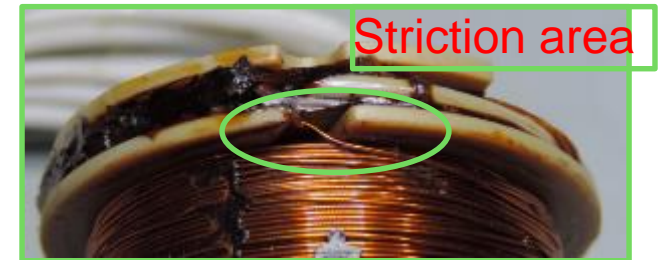
- ✓ *Solenoid winding weakness*

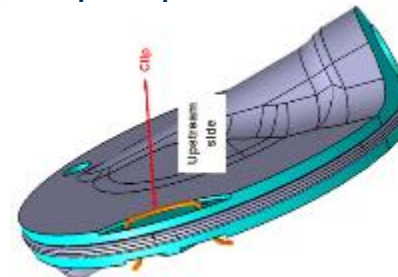
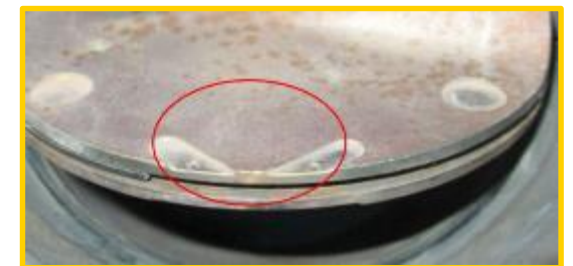
- ✓ *Butterfly clip rupture*

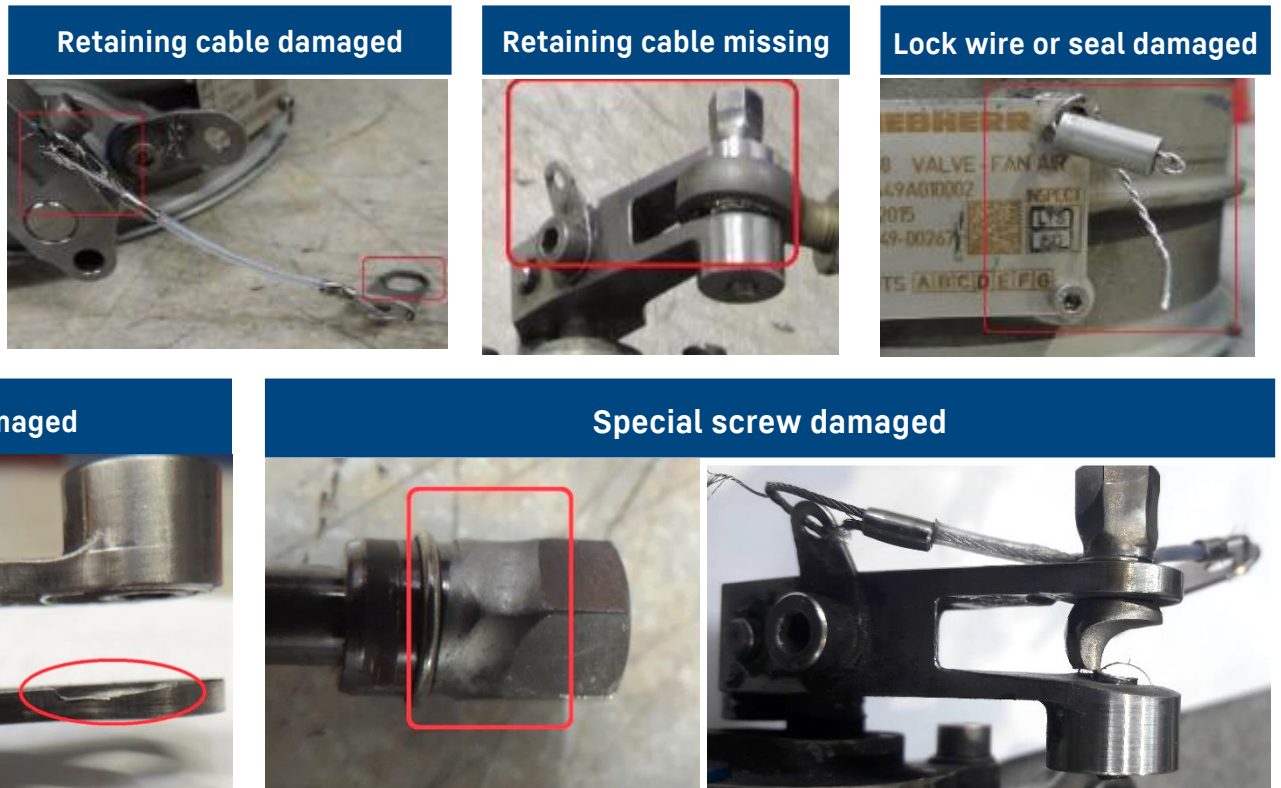
From 2018, reports of FAV (body & rod) damage on AC with reinforced brackets i.e:

- Airbus POST SB 54-1045 or POST MOD 164147 for PW engines
 - Airbus POST SB 54-1044 or POST MOD 163328 for CFM engines
- Typical finding described here:

Pins damaged

Valve body damaged

Lever assy damaged

Special screw damaged

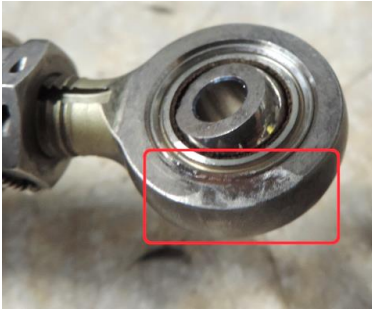
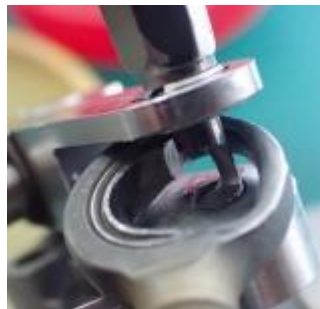
Rod assy damaged

During aircraft inspection, if any of these damages are observed, the complete FAV Body + ROD needs to be replaced

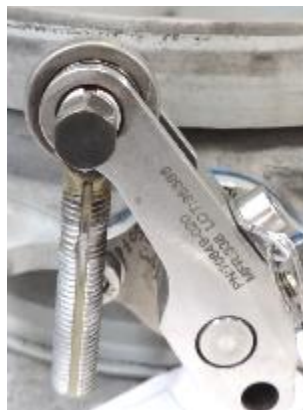
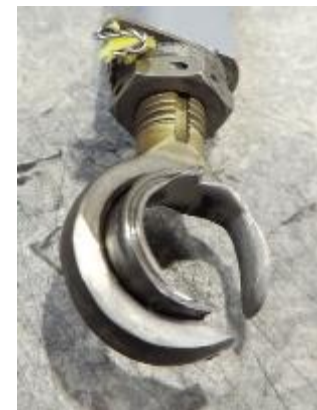
Rod assy broken

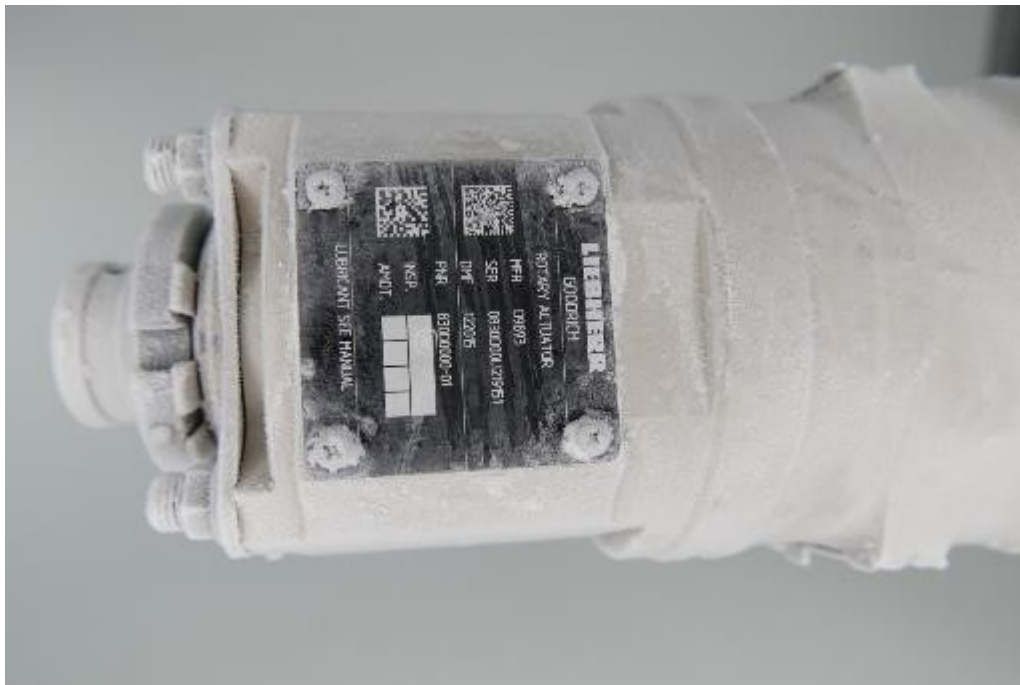
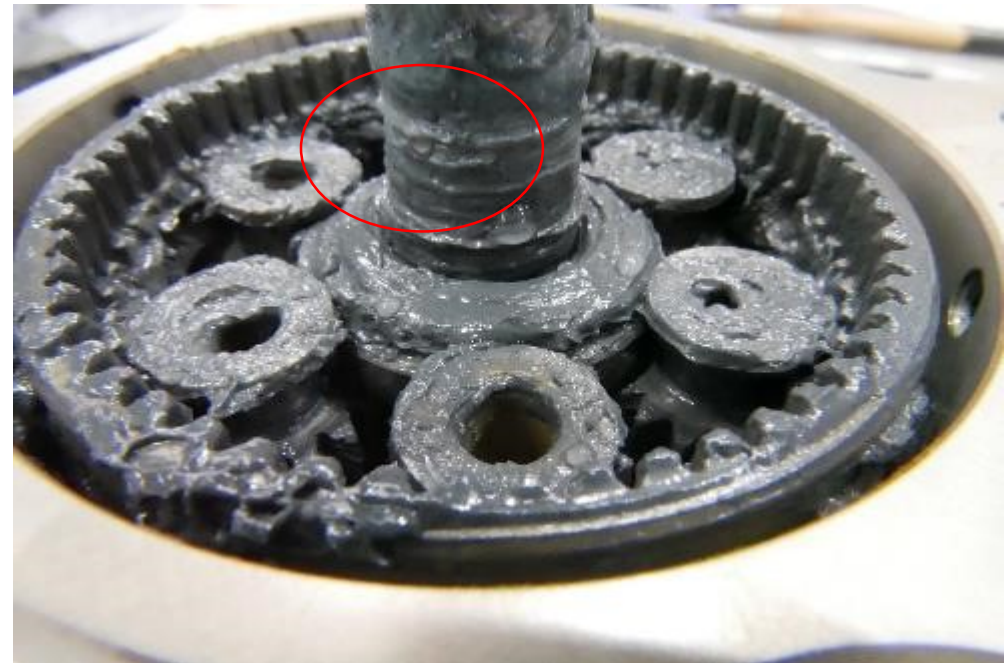
- 43% of returned GRAs jammed @ -40°C test *
- Moisture found on 45% GRAs during disassembly.*

- Recommendation: ship affected units in sealed plastic bags to avoid water evaporation
- Reminder: Report every slat jam event to Airbus

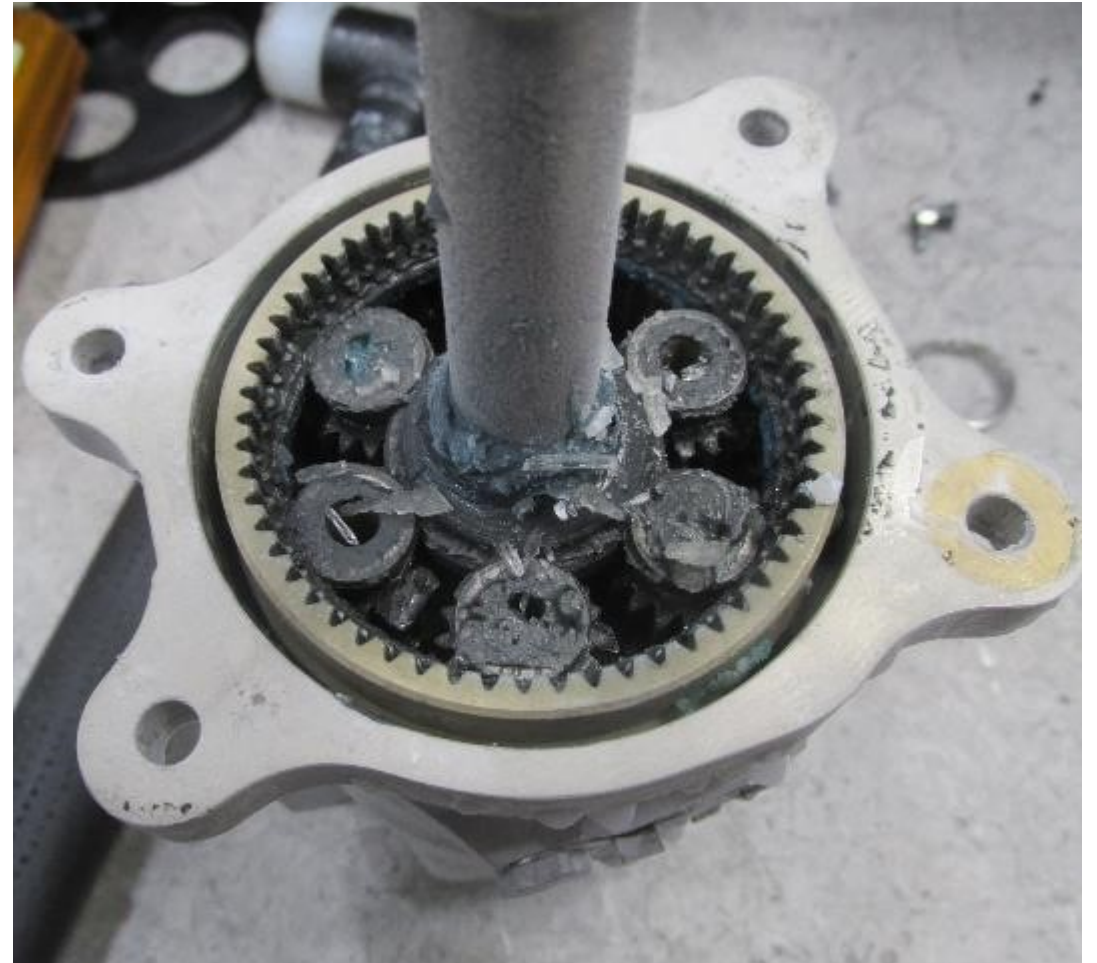
- Root cause on GRA level: Frozen water
- Root Cause contributor on A/C level: Increased wing bending (sharklets) - Refer to Airbus TFU 27.80.00023 for more information
