# ATA 21 – Air Conditioning System SA

A320 CEO/NEO

# LIEBHERR

October – November 2023

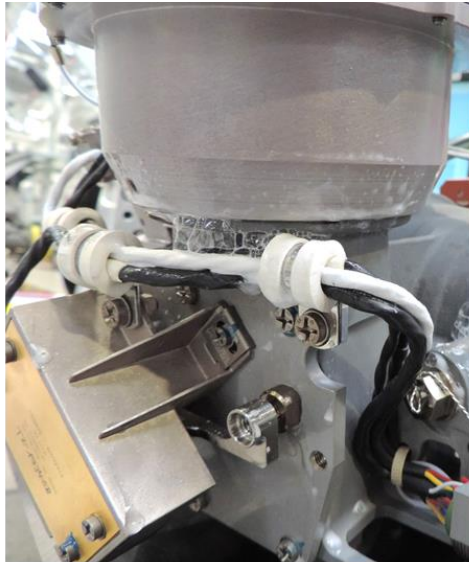
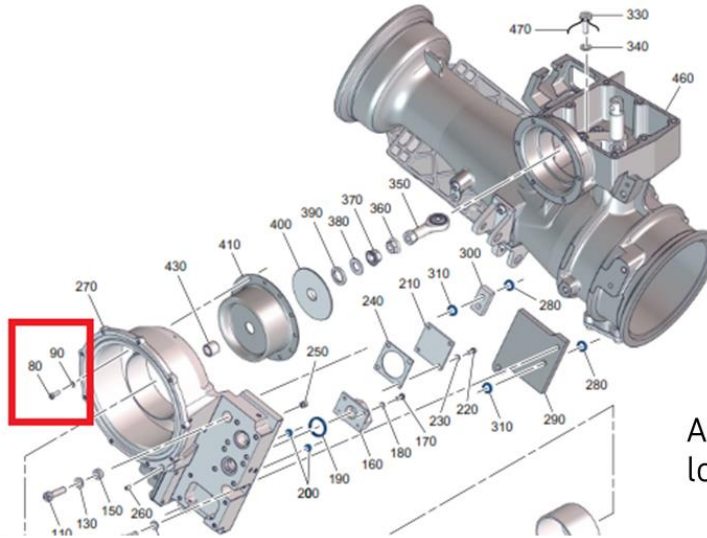
Root cause: Air leakage between actuator and valve body

FCV PNR 1806D0000-02 use unique casting for actuator and valve body, introducing an hyperstatic assembly, more sensitive to several factors (screws size and number, screw-locks sizes, soft contact surfaces, differential thermal dilatation, vibration...).

Actuator screws found loose

Mitigation action in manufacturing process & repair shop : addition of a second torqueing task of the actuator screws to secure the tightening on a longer period than with a single torqueing.

Root cause & corrective action plan launched in March 2021. Solution is to redesign the actuator body in order to avoid a hyper static assembly.

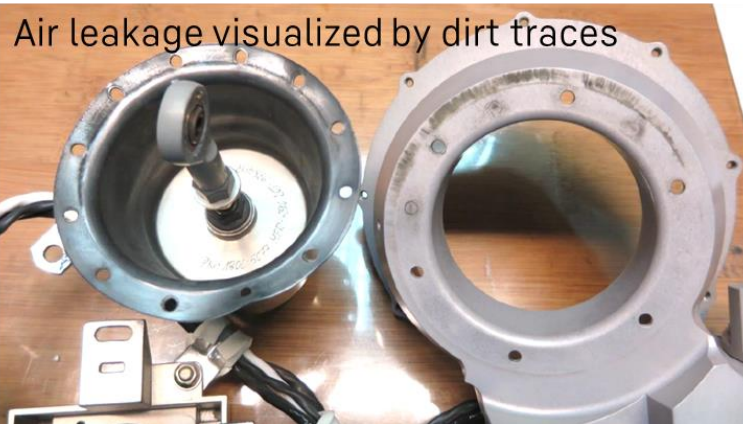
Air leakage visualized by dirt traces

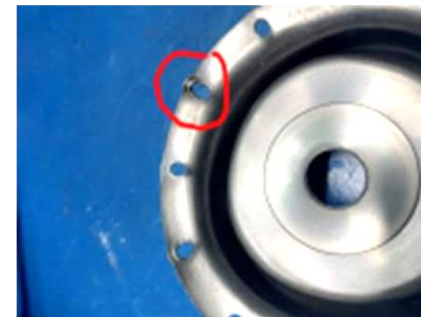
Component consequence: lower actuator diaphragm wear found on some units

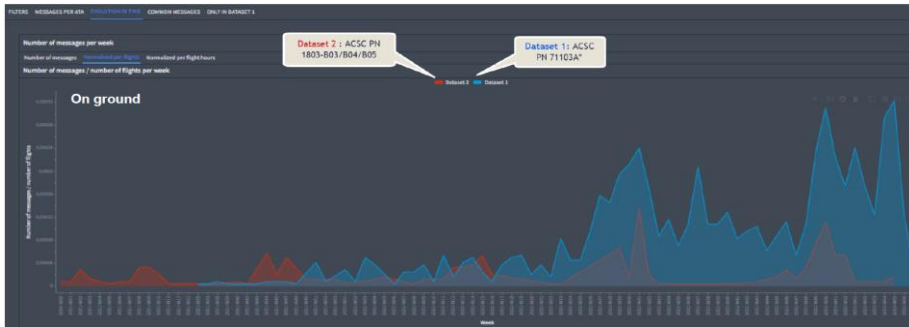
On some aircraft fitted with **ACSC PN 71103A010101**, an increase of message « COND TRIM AIR SYS FAULT » occurrences has been observed on Ground only.

One of the main contributor identified is the ACSC emergency mode on Ground, where TAV is no more supplied but the monitoring by ACSC software is still active.

The mismatch between the TAV command and the TAV position feedback leads to a failure message which is latched until system test or power reset.

- An analysis was launched for a new ACSC software in order to inhibit the emergency mode on ground
- An investigation (Airbus MISP) has been open to identify other potential contributors and followed through the Airbus TFU 21.60.00029
