# Airbus A320NEO

ATA36 System

**LIEBHERR**

Regional Technical Workshop  
2023

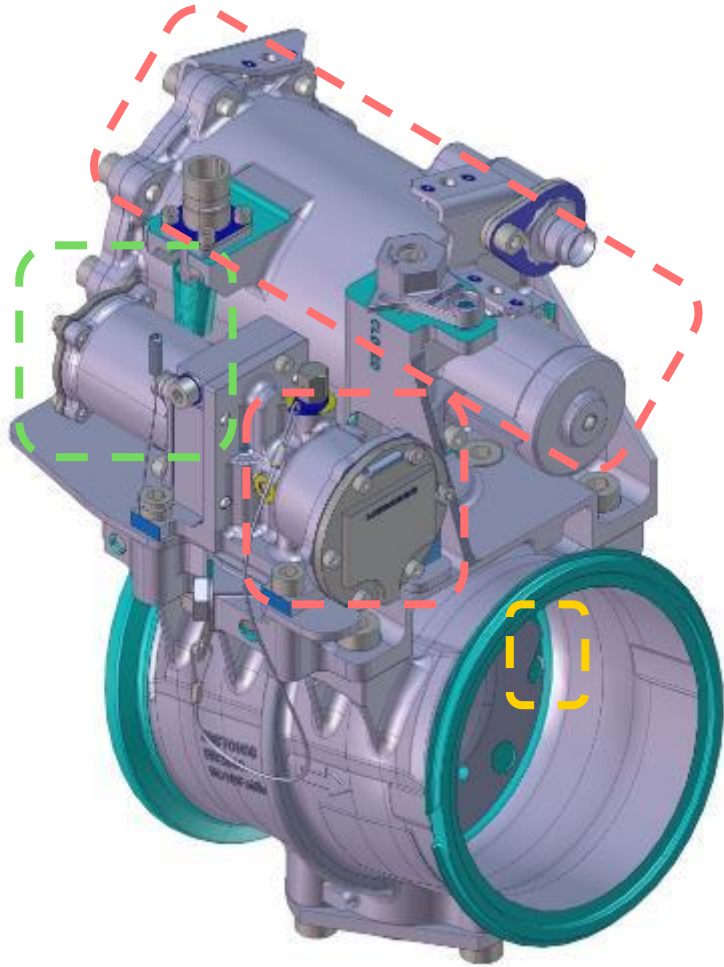
✓ *Aluminium phosphate exudation from JPXX32 graphite on actuator seals and regulation clapper (already fixed by SB 70645-36-01, Amdt A)*

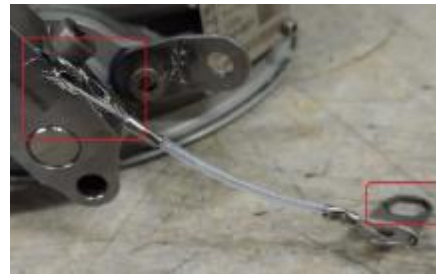
Acoustic resonances from the fan inlet scoop are transmitted to the FAV, generating induced damages on FAV (body & rod) for both P&W and Leap engine installations.

Retaining cable damaged

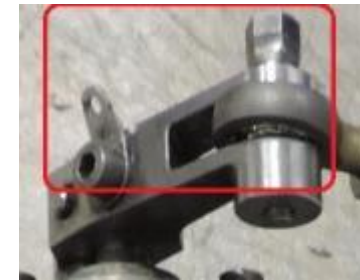
Retaining cable missing

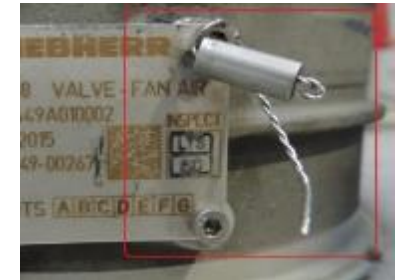
Lock wire or seal damaged

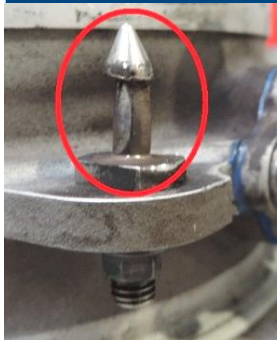
Pins damaged

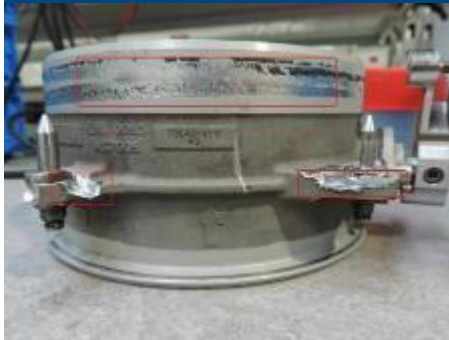
Valve body damaged

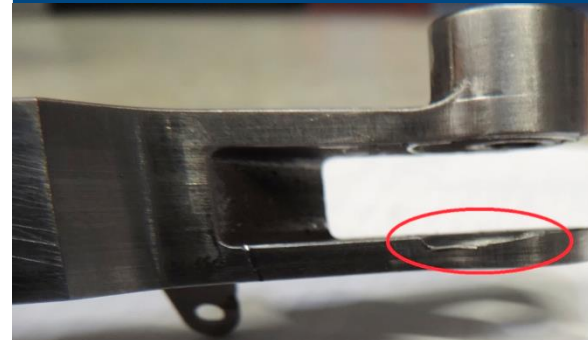
Lever assy damaged

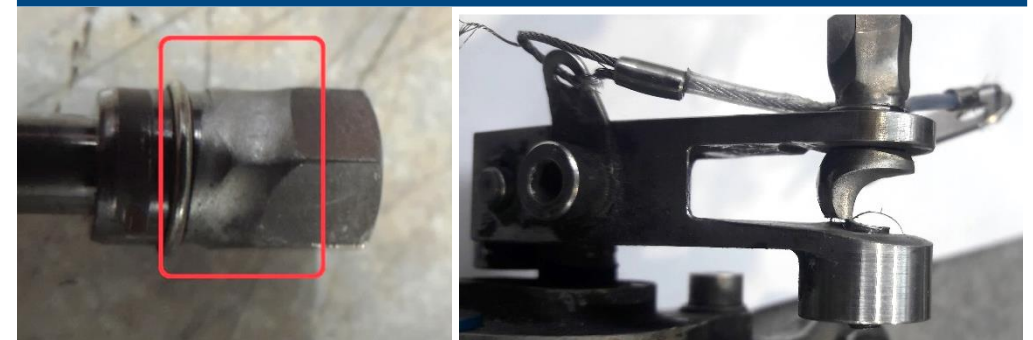
Special screw damaged

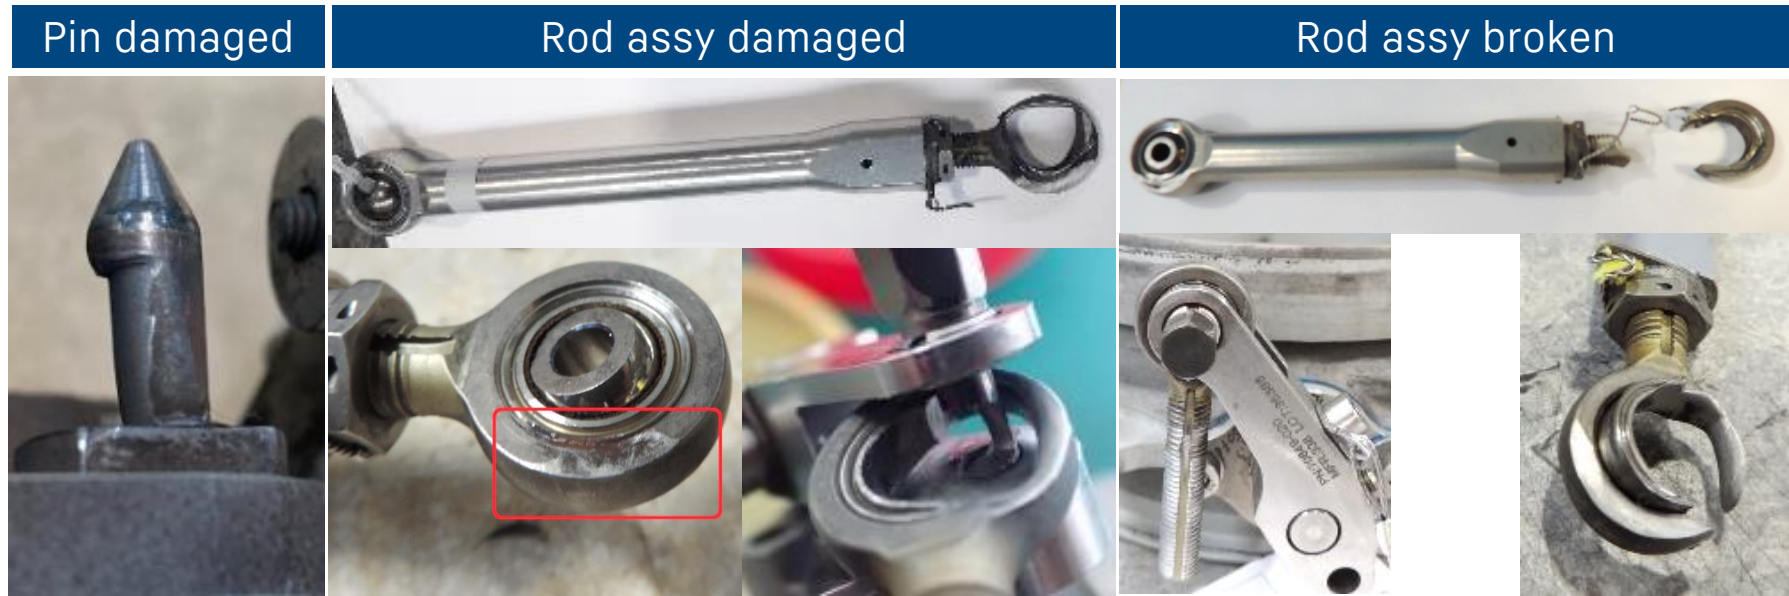
FAV FIN 7120HM1/7120HM2  
PN 70649A010001 (PW)  
PN 70649A010002 (CFM)

Damages on A/C are observed even with reinforced brackets i.e:

Typical finding post mod described here:

On aircraft with reinforced brackets, main damages concentrate at pin and cinematic level
