**RTW 2023**  
**Airbus**  
**A330CEO**  
**ATA 36**

Liebherr-Aerospace Toulouse SAS

# Engine Bleed Not Closed – Airbus / Liebherr ISE Status

# HPV NOT OPEN

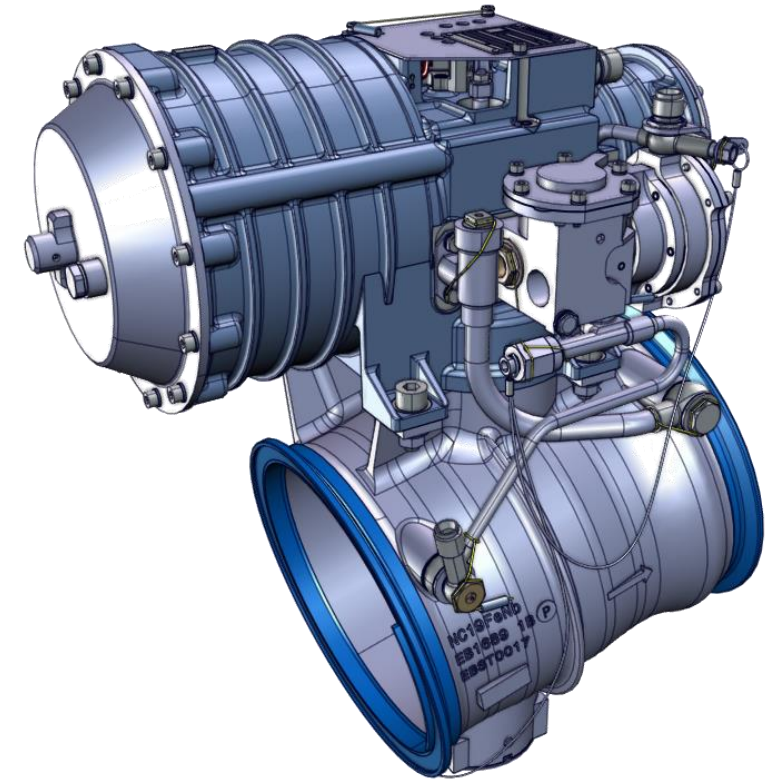
**PRV 6764B040000 Amdt A &  
6764B060000**

“AIR ENG BLEED NOT CLSD” ECAM warning reported on A330 Fleet

- PRV failed to close.

With current PRV design, Air pressure is needed to ensure that the valve closure in all condition.

- During engine shutdown, not enough pressure to close the valve when APU bleed pressure is not available.

- AIB documentation modification (TSM & FCOM),
- Predictive maintenance algorithm,
- Preventive maintenance workscope (ISE).

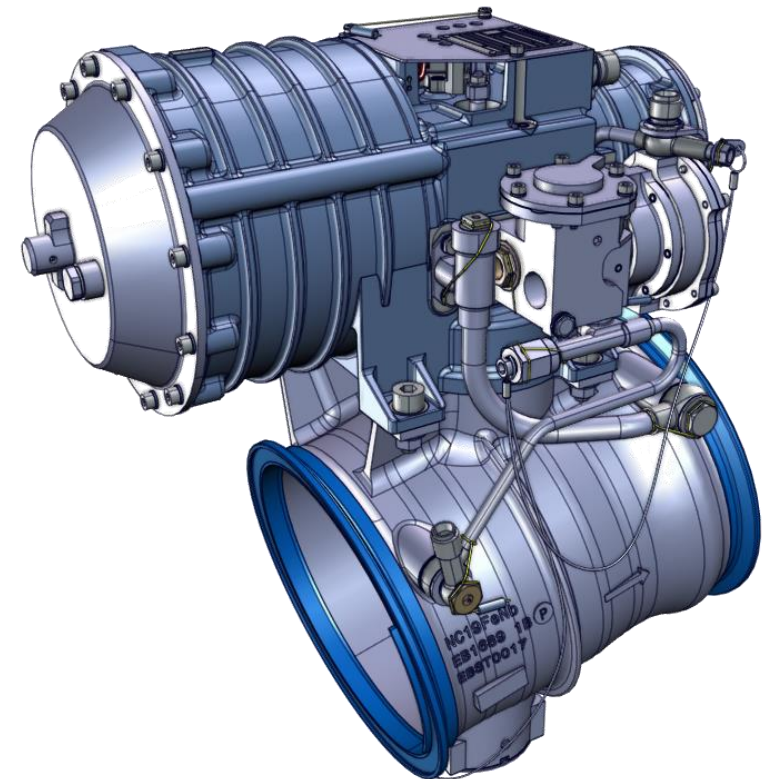
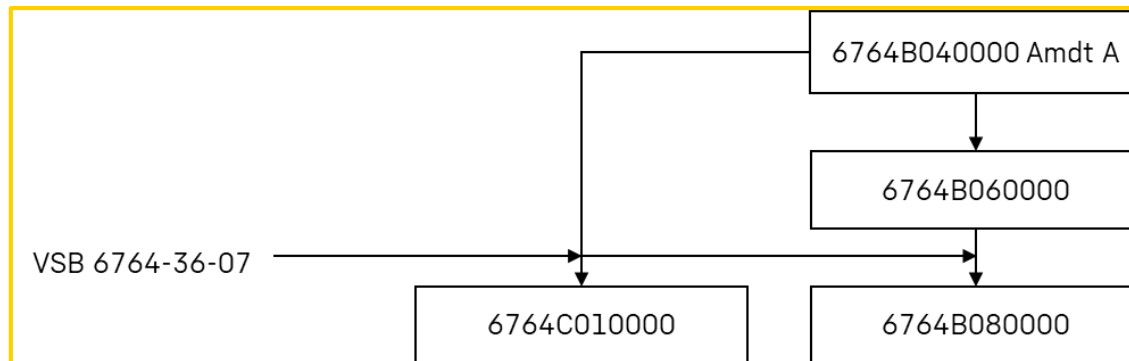
**PRV 6764B080000 &  
6764C010000**

Airbus request for PRV modification to make the PRV able to re-open at high upstream pressure (for **Take-Off, Bleed OFF & APU Bleed ON** operations for specific airlines).

Design modification of Regulation sub-assy clapper and clapper seat.

Allow re-opening of the PRV in case of upstream pressure up to 27.5 barg.

VSB 6764-36-07 available since March 2023

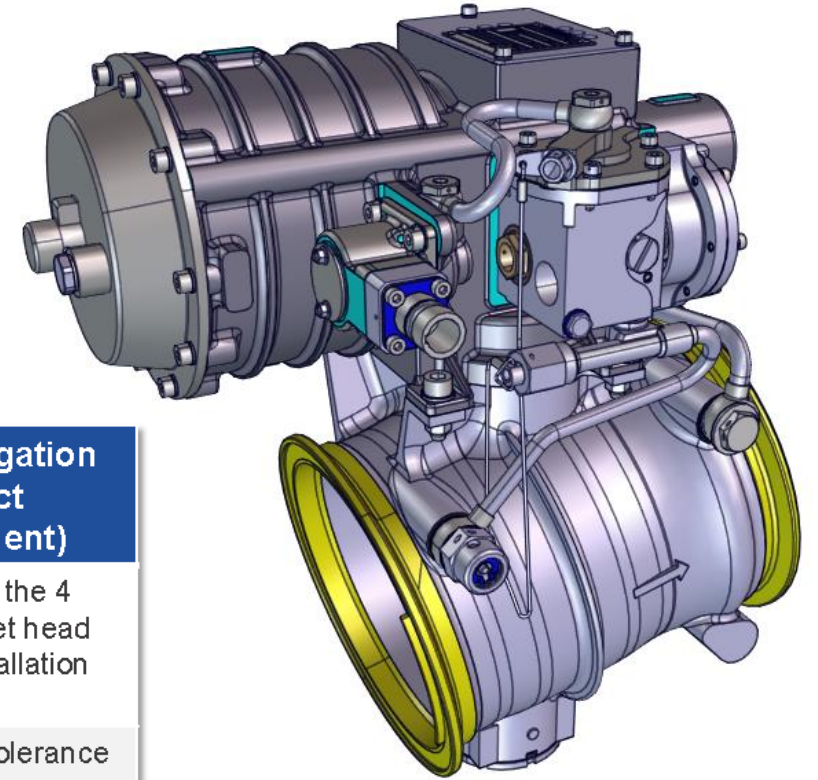
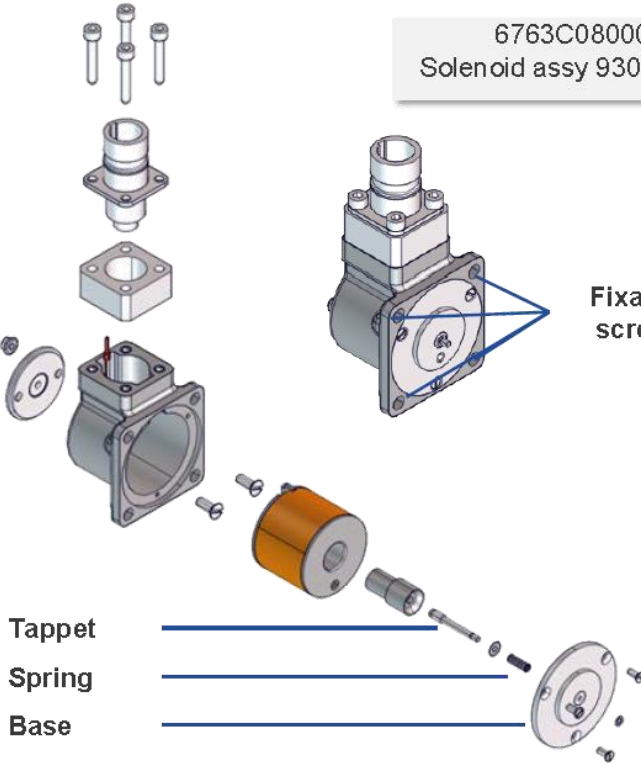
**PRV 6763C080000**

HPV Not Opening in flight, mainly at Top of Descent (transient phase from Cruise to Descent), the HPV is requested to open based on BMC de-energization command toward the HPV Solenoid thus allowing the HPV to open.

The Solenoid assy was identified as a contributor to the HPV opening occurrences.

6763C080000  
Solenoid assy 93003-0300

Fixation screws

Tappet  
Spring  
Base

Recommendation to perform Solenoid cleaning task ref TASK-36-11-26RM-100-802-A01 during disassembly of the equipment even if the HPV CMM test results are compliant.

Cleaning procedure SIL 6763-36-04 released in Sept 2018

VSB 6763-36-08 available

Solenoid assy	Maintenance Mitigation	Design Mitigation (Product Improvement)
Fixation screws	After solenoid cleaning and re-assembly on the HPV, ensure screws are correctly torqued	Replacement of the 4 screws by socket head screws and installation with lock-wire
Tappet 93003-42	Cleaning or replacement pending visual inspection	Manufacturing tolerance improvement
Spring S100-687	Replacement	Design unchanged
