# A350 NLG

Steering & Operating Noise

Liebherr-Aerospace

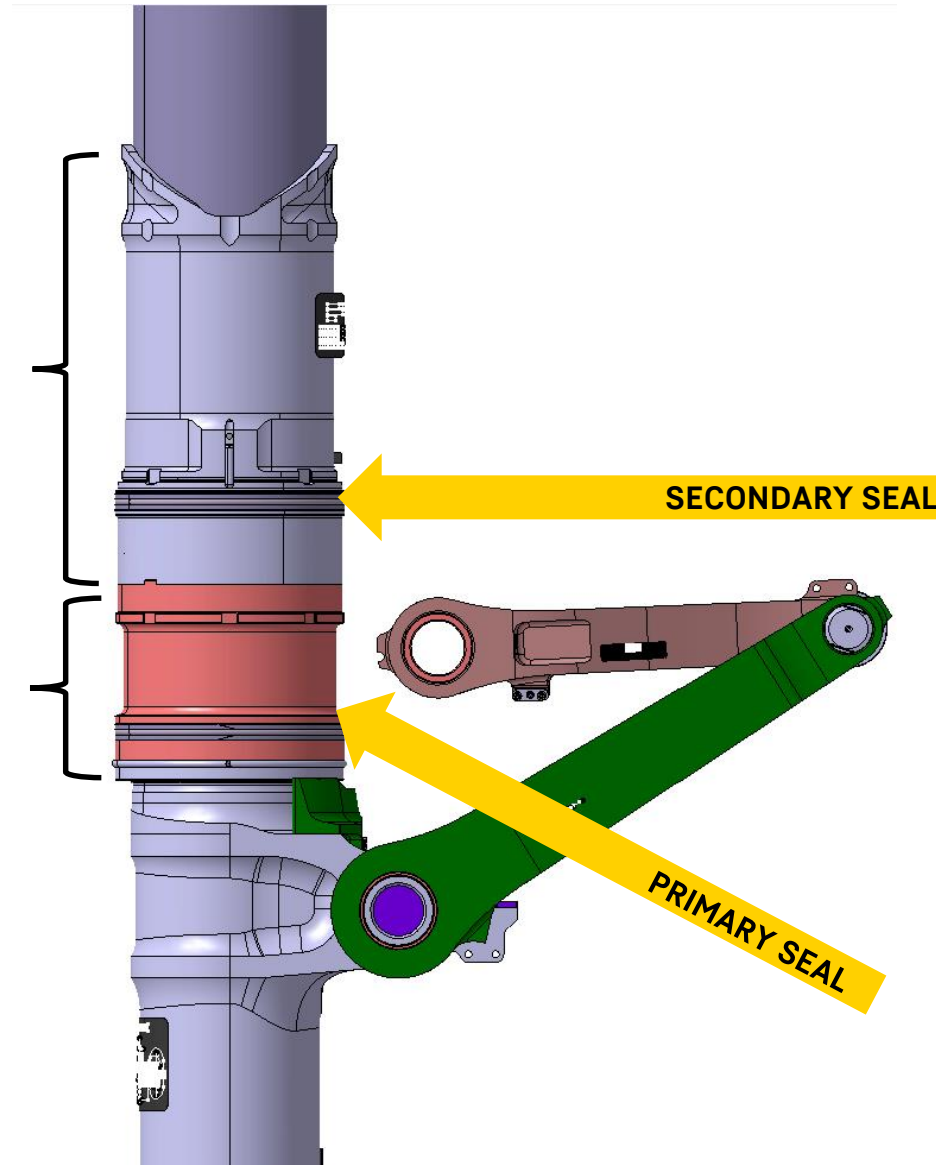
**Upper Carrier  
(Contains Secondary  
Sealing System)**

**Lower Carrier  
(Contains Primary  
Sealing System)**

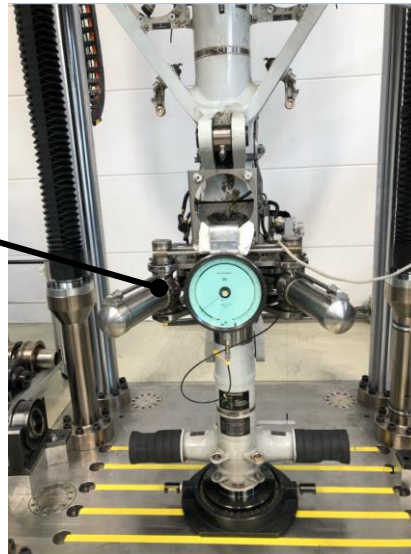
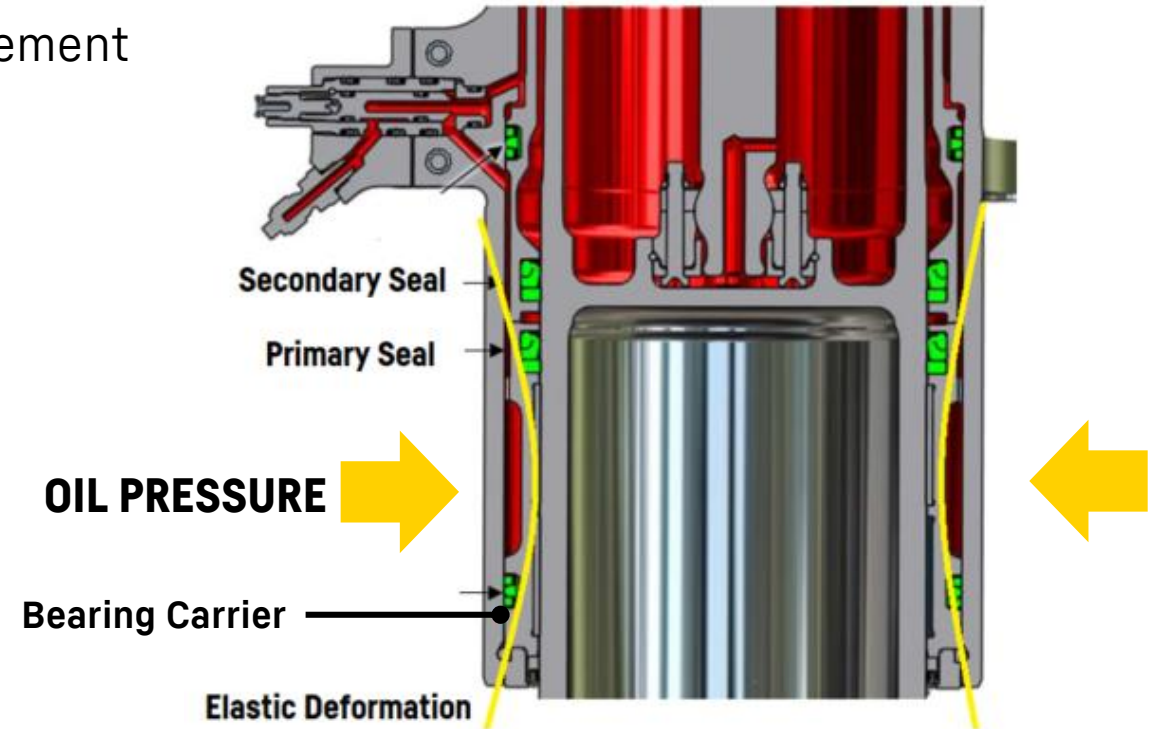
**OIL PRESSURE MEASUREMENT**

- No noise / no elastic deformation on bearing carrier (A/C unloaded)
- Elastic deformation on bearing carrier with high oil pressure (A/C loaded)
- Noise confirmed for the investigated NLGs @ LLI Test Rig
- Noise confirmed for turning and/or damping movement

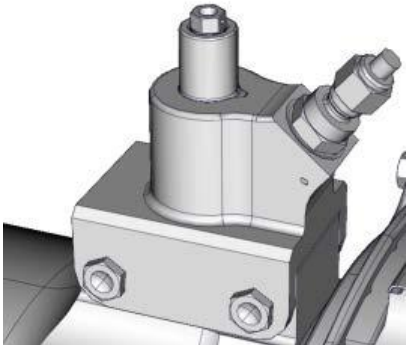
COV is NOT Activated = red mark is not visible

- Activation of secondary seal in weight off wheels conditions (on jacks) per MP Task **A350-A-32-21-73-02001-132A-A** , this restores nominal behavior.
- Ref. Airbus Technical Follow Up TFU No.: 32.21.00090

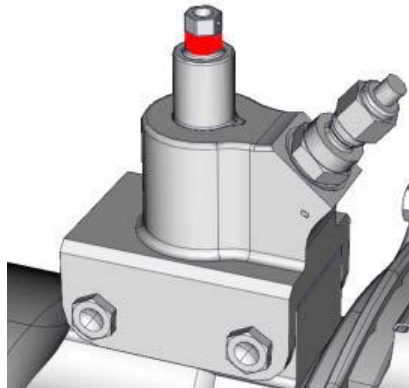
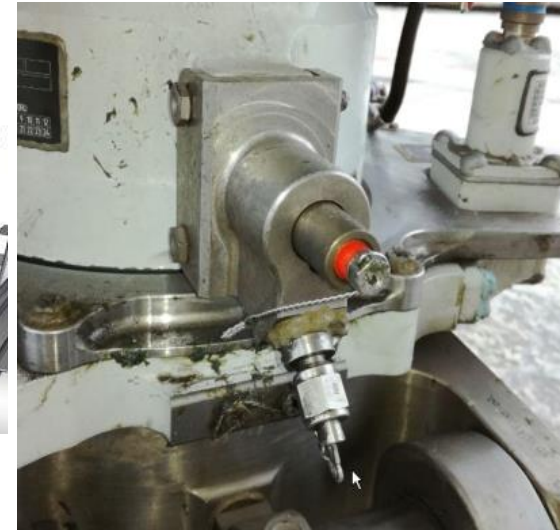
COV is Activated = red mark visible

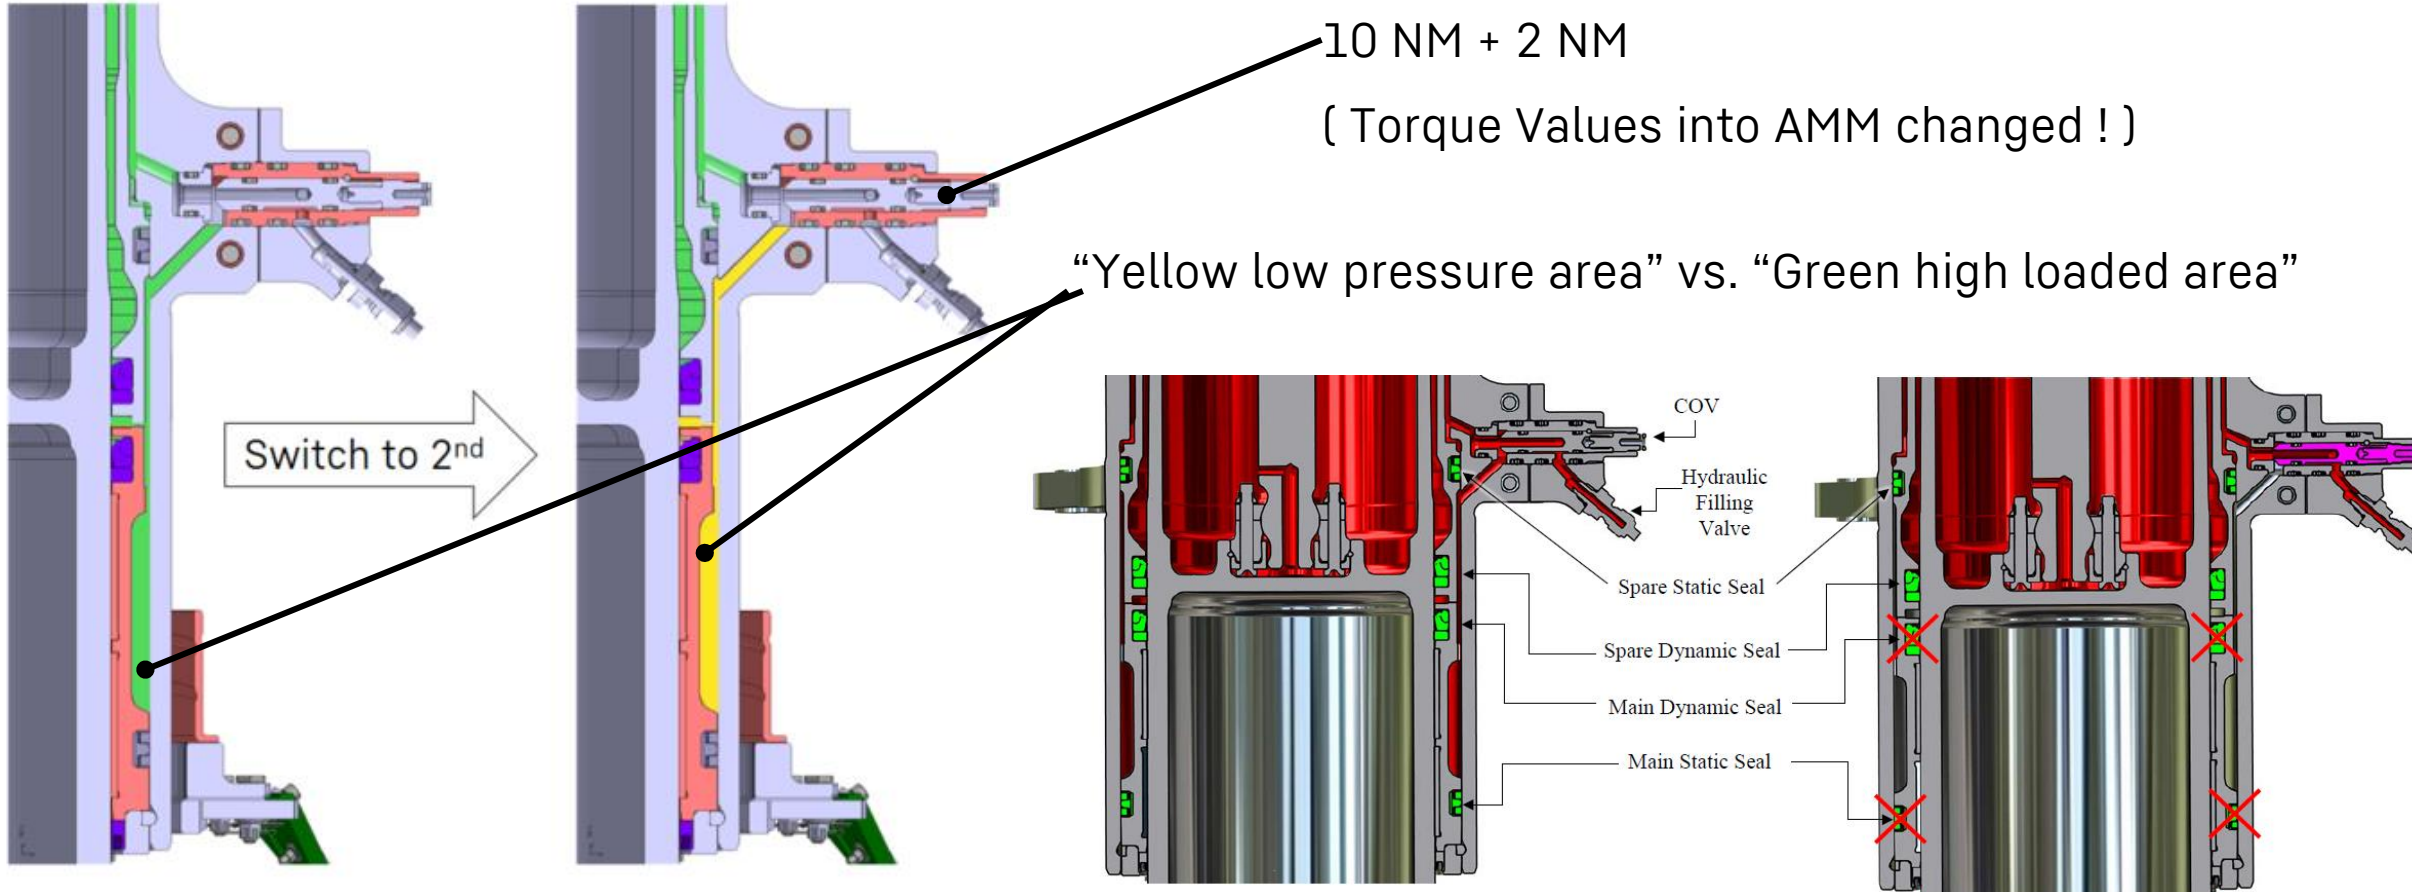
– **Switch to 2<sup>nd</sup> seal eliminates pressure effects**

“Yellow low pressure area” vs. “Green high loaded area”

10 NM + 2 NM

( Torque Values into AMM changed ! )

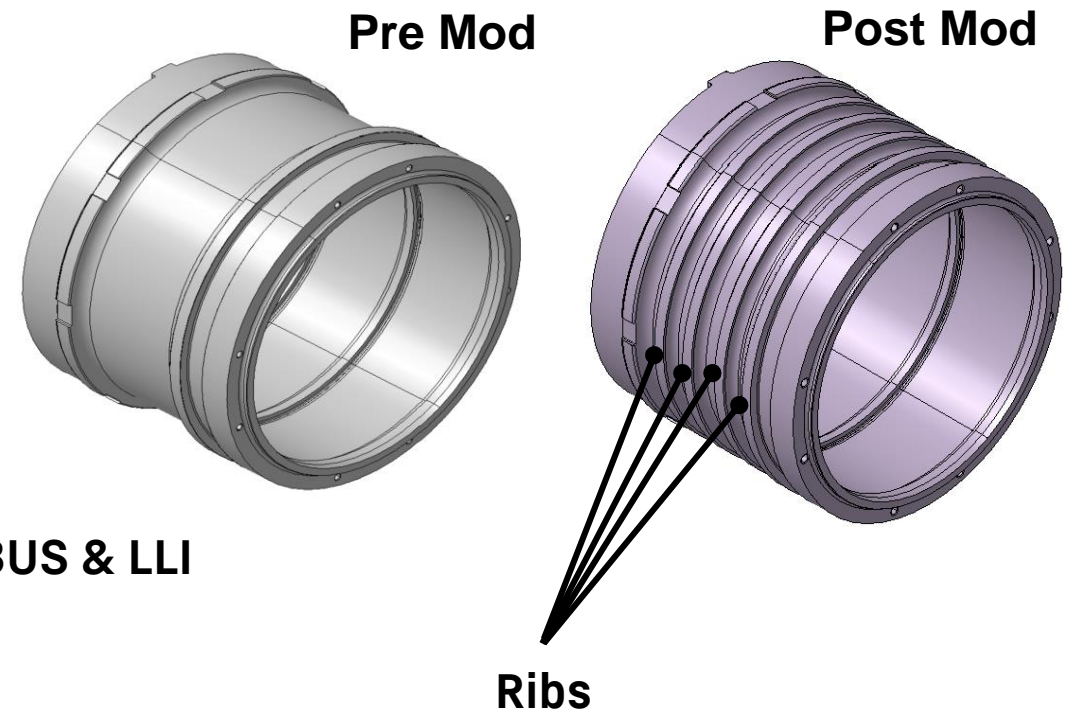
Modification of bearing carrier to minimize the load effect at “high compressions” SATs

- Change of bearing clearance (higher gap)
- Stiffening of bearing carrier (additional ribs)
- Material change for common gear carrier
