Airbus SAceo

ATA 36

Liebherr-Aerospace

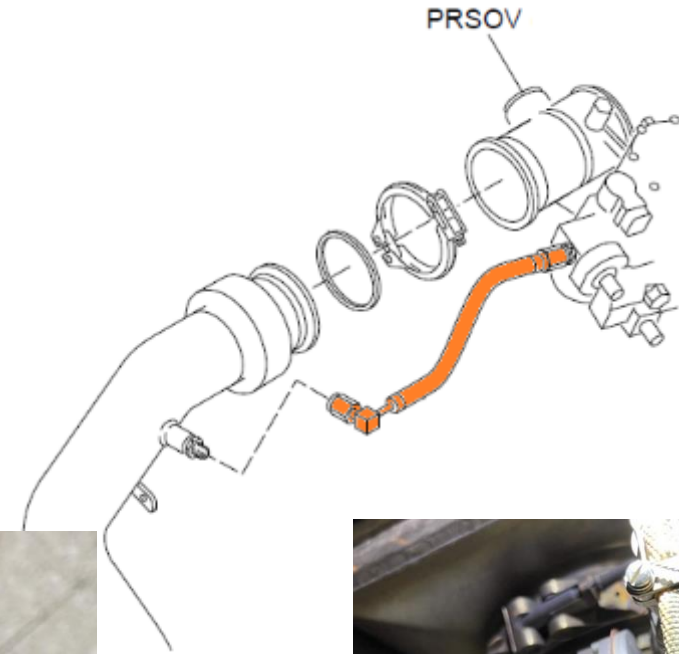
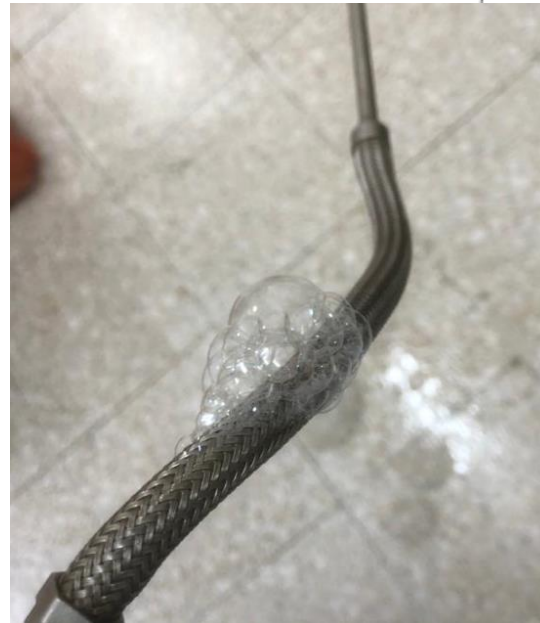
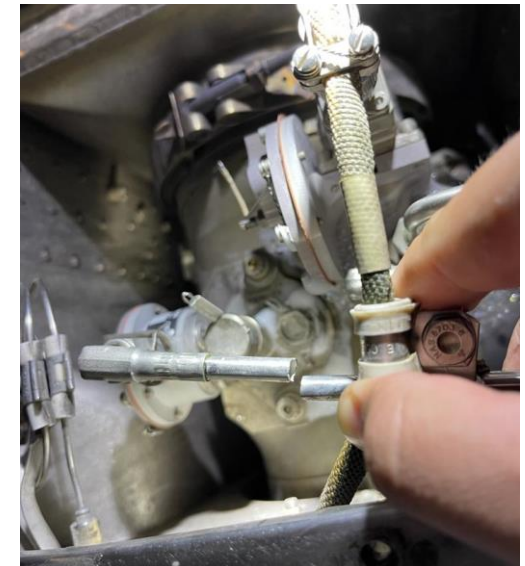
Sense Lines check:

Sense lines connection to the Bleed Valves (HPV; PRV; FAV) and associated Thermostats (TLT; TCT) must be in good condition. It is important to look for following parameters during scheduled checks and troubleshooting:

- Disconnection
- Leak
- Pinch
- Union conditions

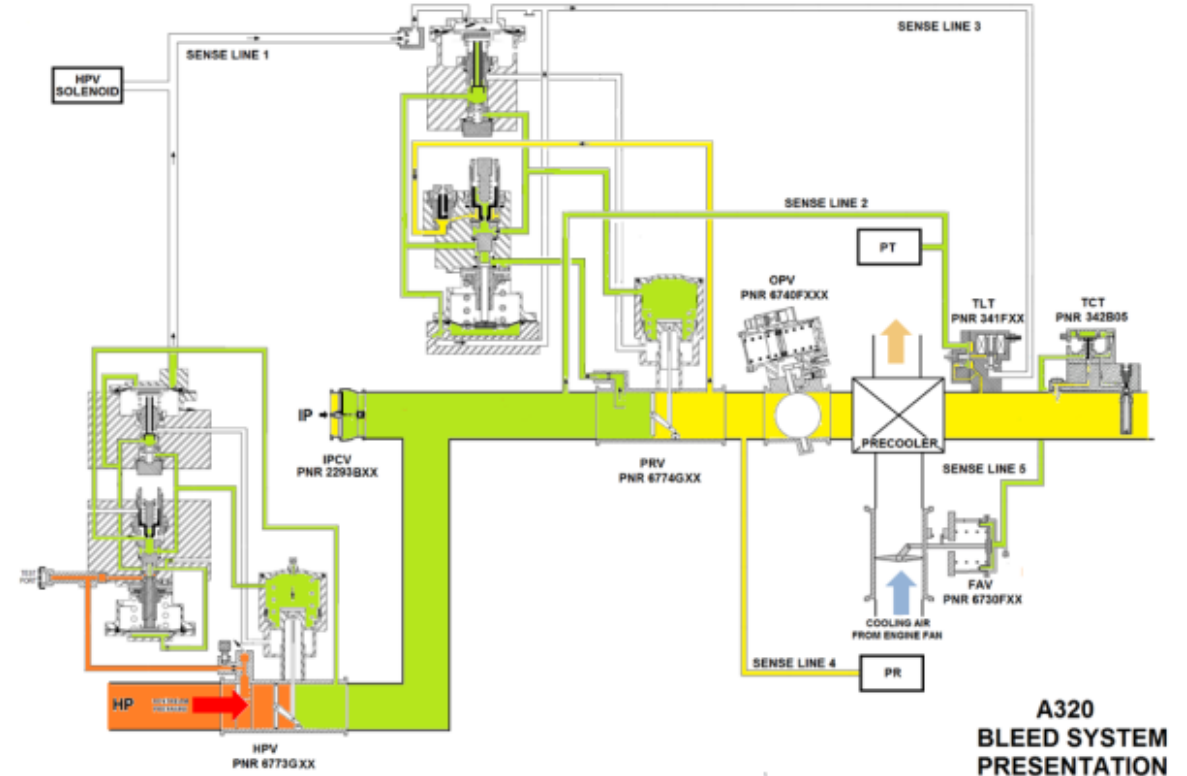
Complete failure of TLT reverse flow function just after the engine start sequence with APU Bleed (10s) may lead to engine stall.

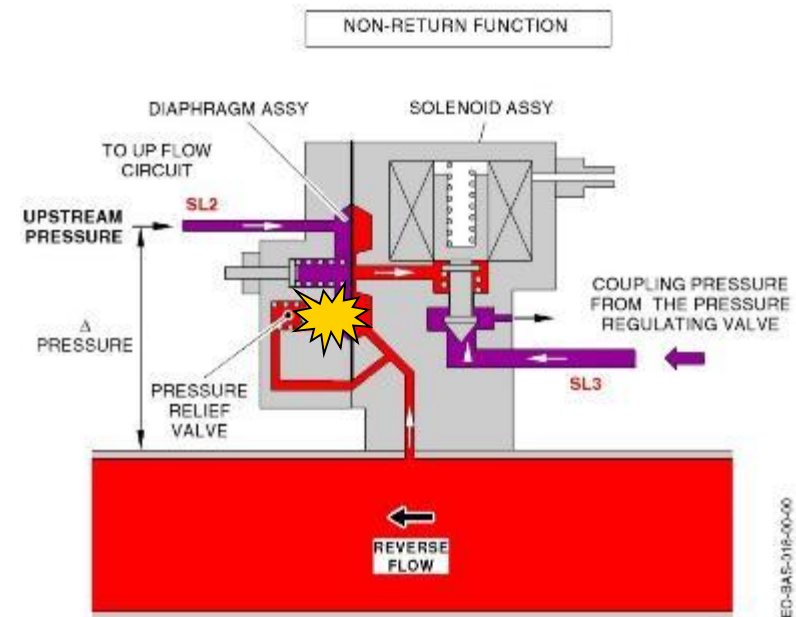
Engine Reverse Flow - TLT 341F010000 manufacturing evolution

After engine stall events, some TLT (341F010000) were investigated and found with pollution in the Non-return function and the solenoid.

After analysis, some RTV was found as part of the pollution and RTV is used in the manufacturing of TLT diaphragm

The modification will consist in removing RTV during diaphragm manufacturing only.

VSB 341F-36-01 to be applied on attrition basis. At opportunity of a Major repair, systematic embodiment at no additional costs.
