Job Report

BOS 80/2500 D EX

Slewing Bearing Exchange Project

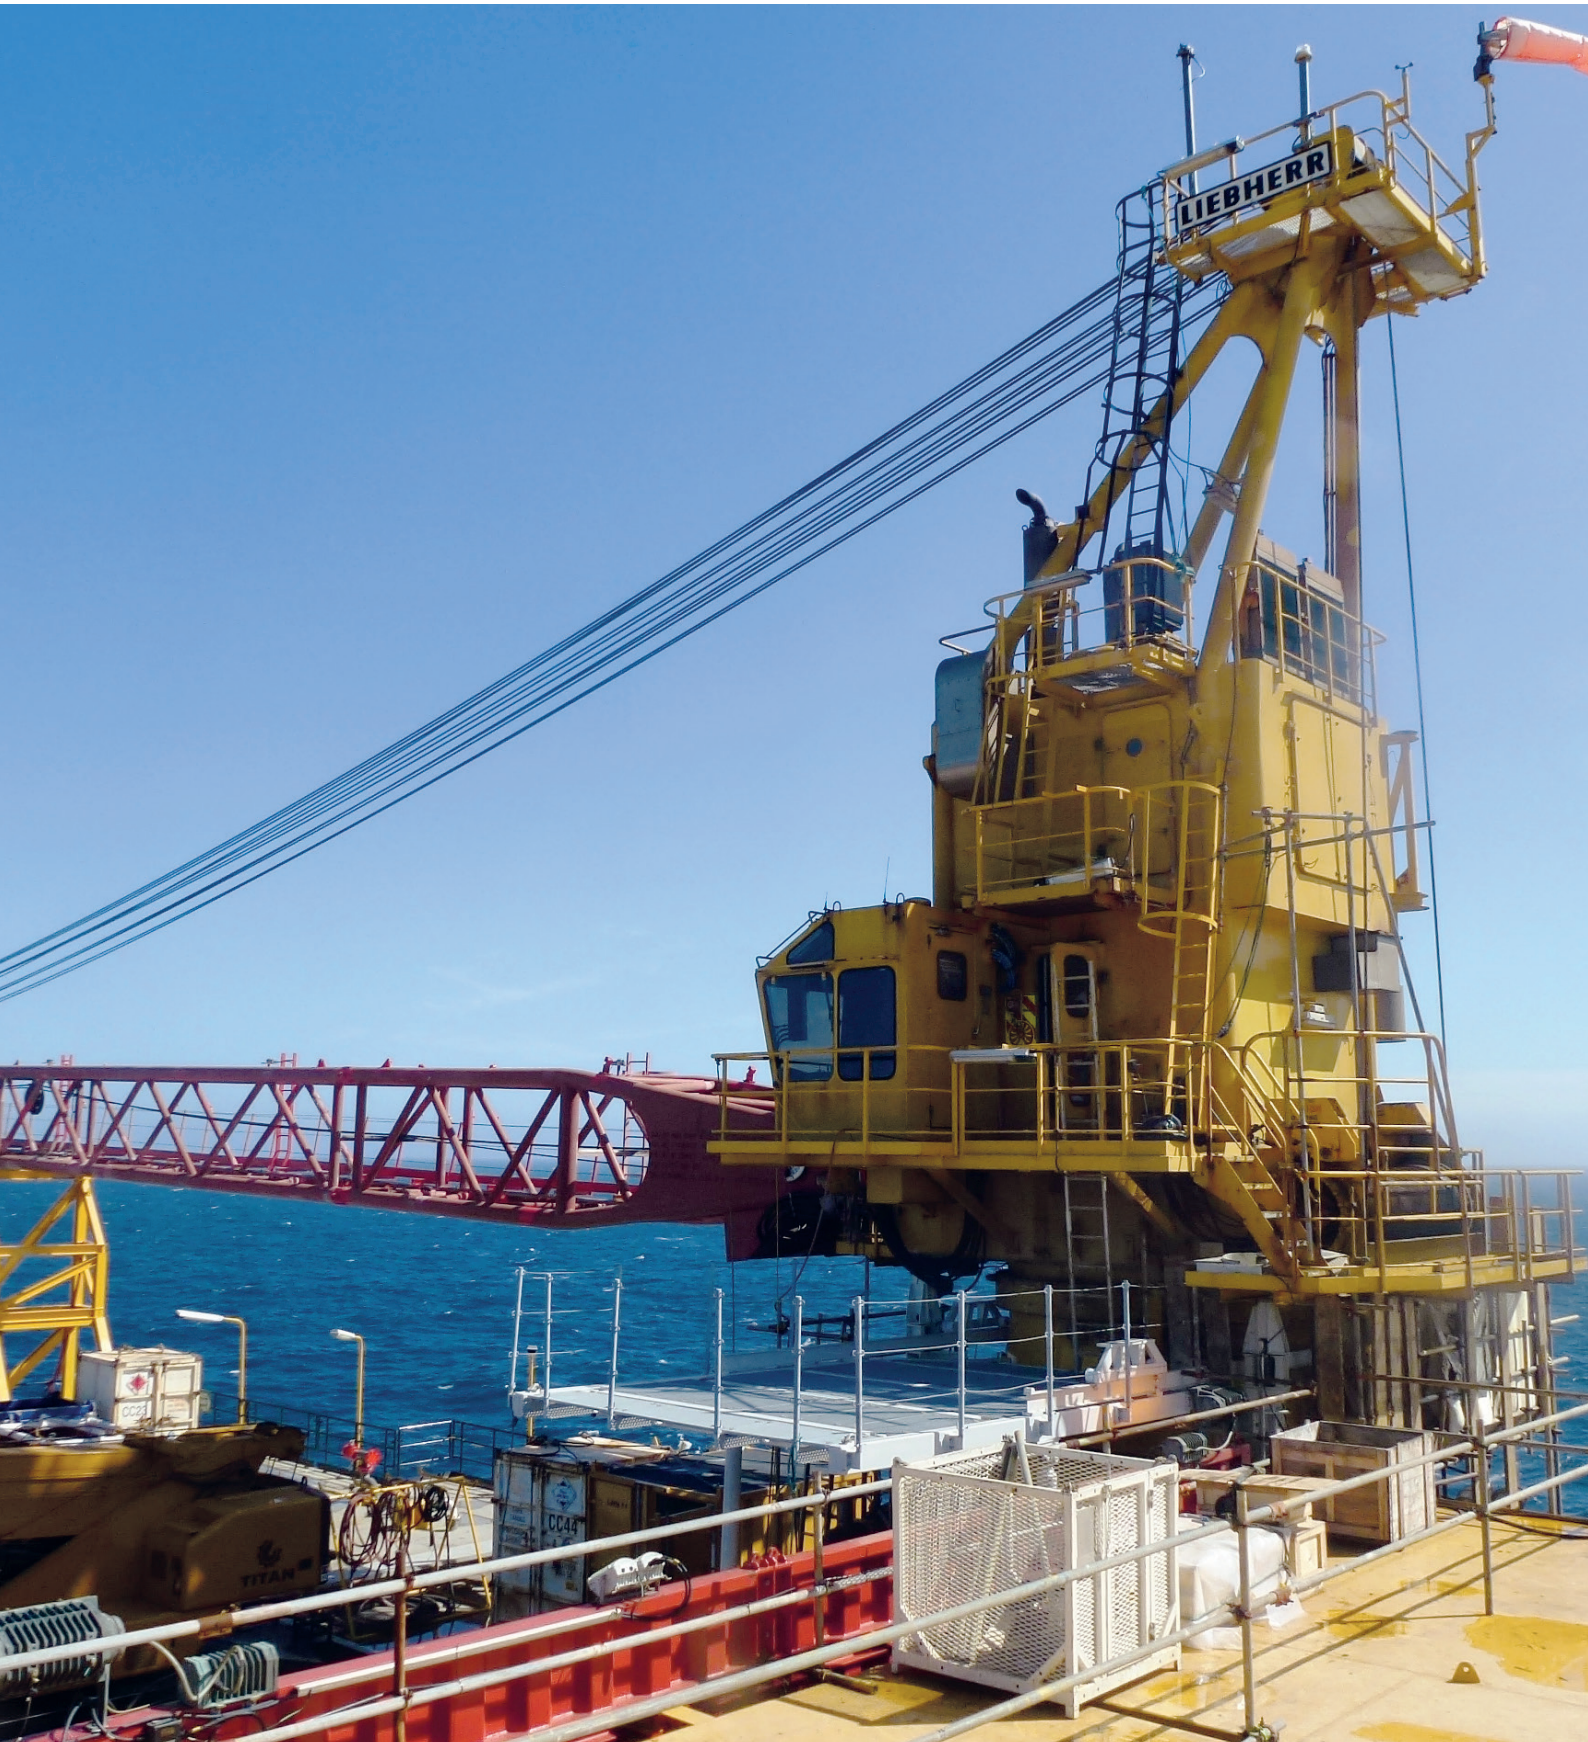
The BOS 80/2500 D EX crane has been operating off the coast of New Zealand in the Tasman Sea for nearly 25 years. Due to extensive use the crane showed abrasion during slewing operation and in the actual slew bearing itself. This caused extra maintenance work for the owner and also required improved work planning. The main challenges for the Liebherr service engineer were the platform's gas environment, which calls for special safety requirements in respect of welding work, as well as the continuously changing weather conditions.

The Liebherr crane was pre-fitted with a specially designed exchange table which was installed on the platform and the crane pedestal. Before the parts were replaced a considerable amount of welding work had to be carried out. The crane was then safely jacked up with hydraulic cylinders so the old slew bearing could be removed and the new one mounted. All project goals were safely achieved with focus on highest quality standards.
