RTW 2021

Airbus

A220

Liebherr Saline

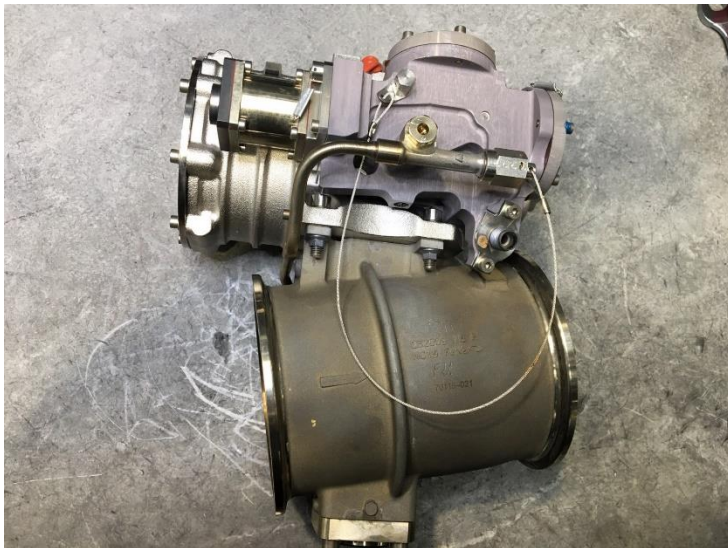
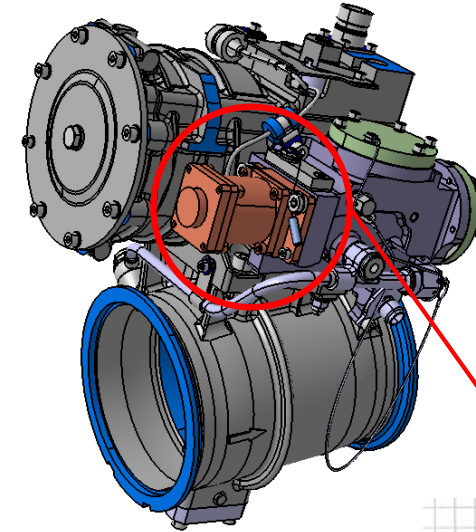
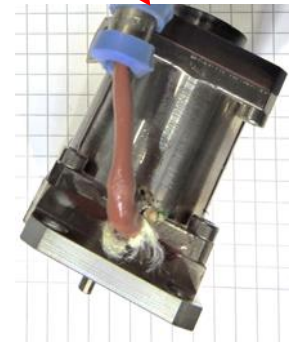
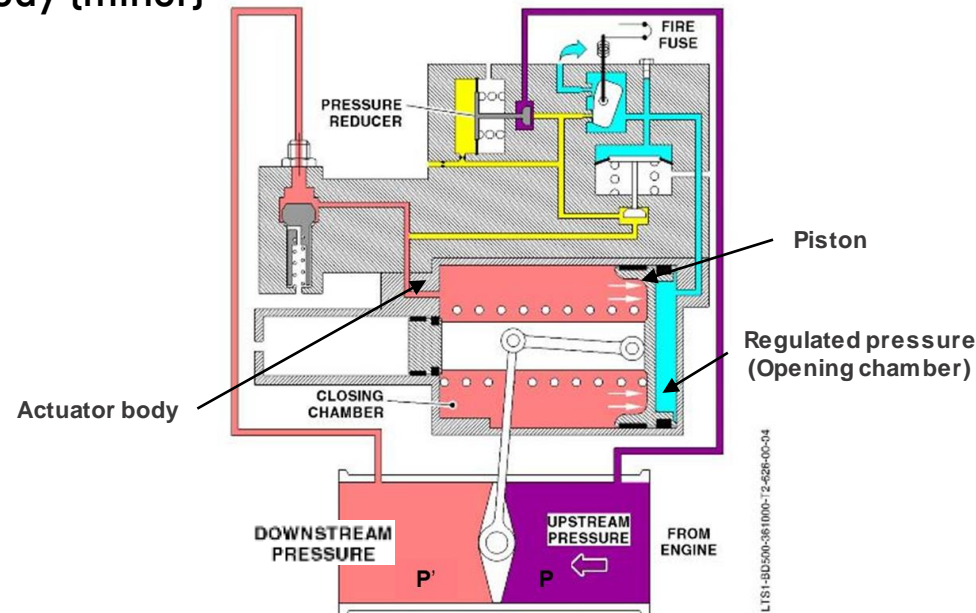
Root Cause Analysis:

1. Vibration environment has been identified as main root cause for premature torque motor and seals wear
2. PRSOV failed open during APU switching due to insufficient upstream/downstream pressure
3. Friction between piston and actuator body (minor)

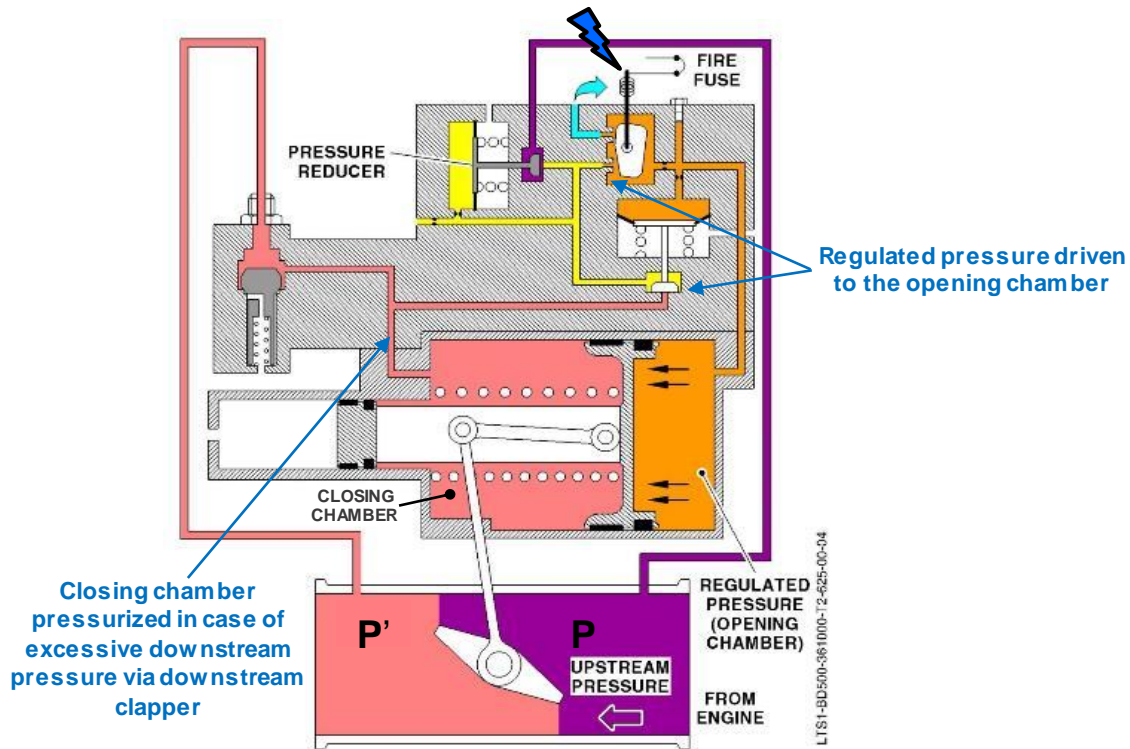
PRSOV regulating

Conditions :
 $I > 150 \text{ mA}$
 $P(\text{upstream}) > 15 \text{ psig}$

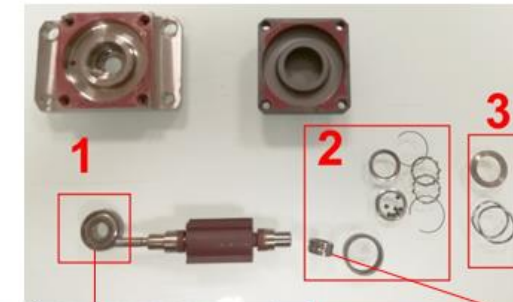
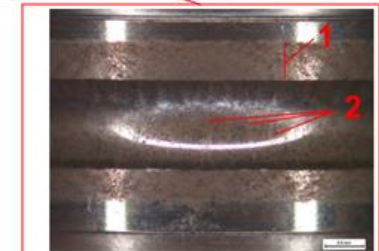
Vibration environment as main root cause for premature torque motor and seals wear

- Severe vibration environment leads to
 - Torque motor bearing damage :
 - Cage degradation : Particles due to cage wear prevent ball bearings motion.
 - Vibrations levels high enough to counter torque motor bearing pre-load (reversible phenomenon which is acceptable during a limited time of exposure).
 - Impact : Residual pressure in opening chamber
 - pressure regulation drift and/or failed open events

- Mitigation actions
 - Systematic replacement of torque motor and seals at each valve's return (since 2018)
 - Health monitoring : PRSOV failed open algorithm (since January 2021)
 - PRSOV Amendment A :
 - Since July 2020, VSB 70115-36-01 is recommended and is implemented on attrition systematically

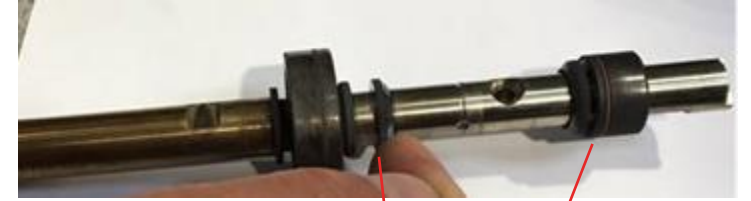
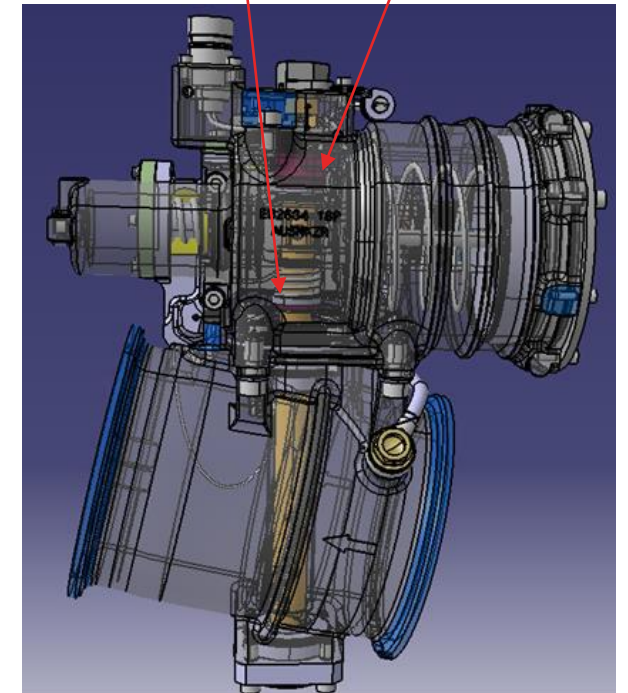
Vibration environment as main root cause for premature torque motor and seals wear

- Seals wear : excessive external leakage
 - Wear is observed on graphite seals located along butterfly axis leading to leakage from closing chamber and from valve body.
- Impact : Pressure decrease inside closing chamber
 - pressure regulation drift and/or failed open events

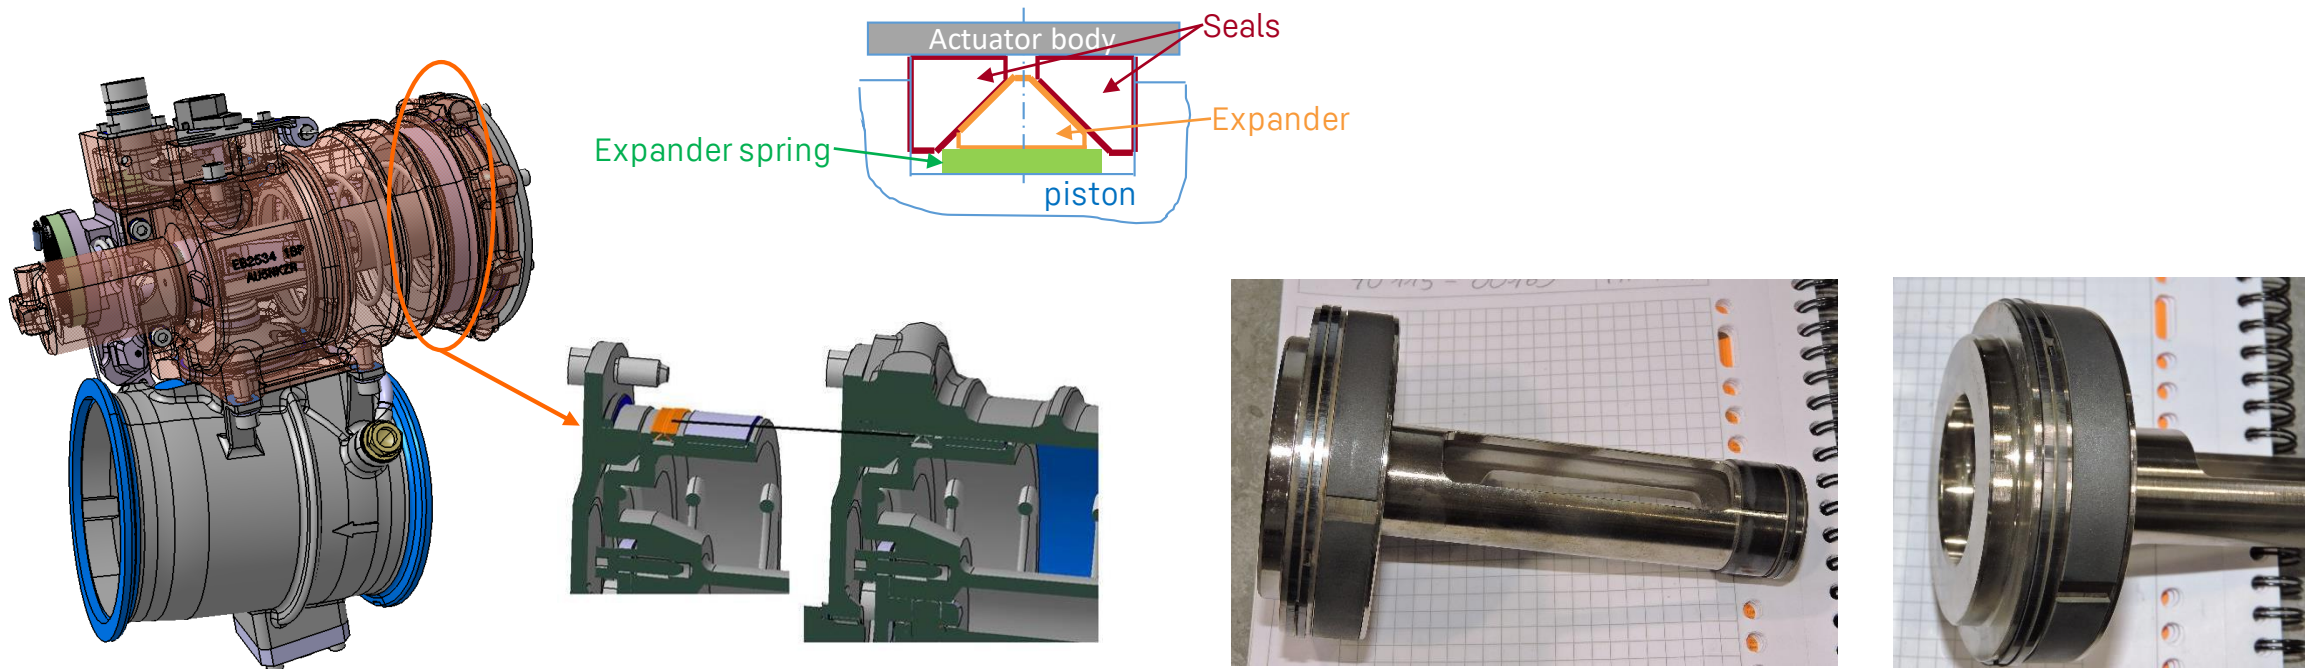
Mitigation : PRSOV Amendement A / Excessive friction between piston and actuator body

- Expander spring apply load on segmentation to minimize leakage between actuator chambers
 - Combined with thermal dilatation effect, this load could increase
 - Not sufficient to block the valve but leads to additional load against valve closing

- Amendment A objective
 - Decrease piston friction to minimize contact load
- Modification
 - Piston groove diameter reduction
 - Expander outer diameter reduction

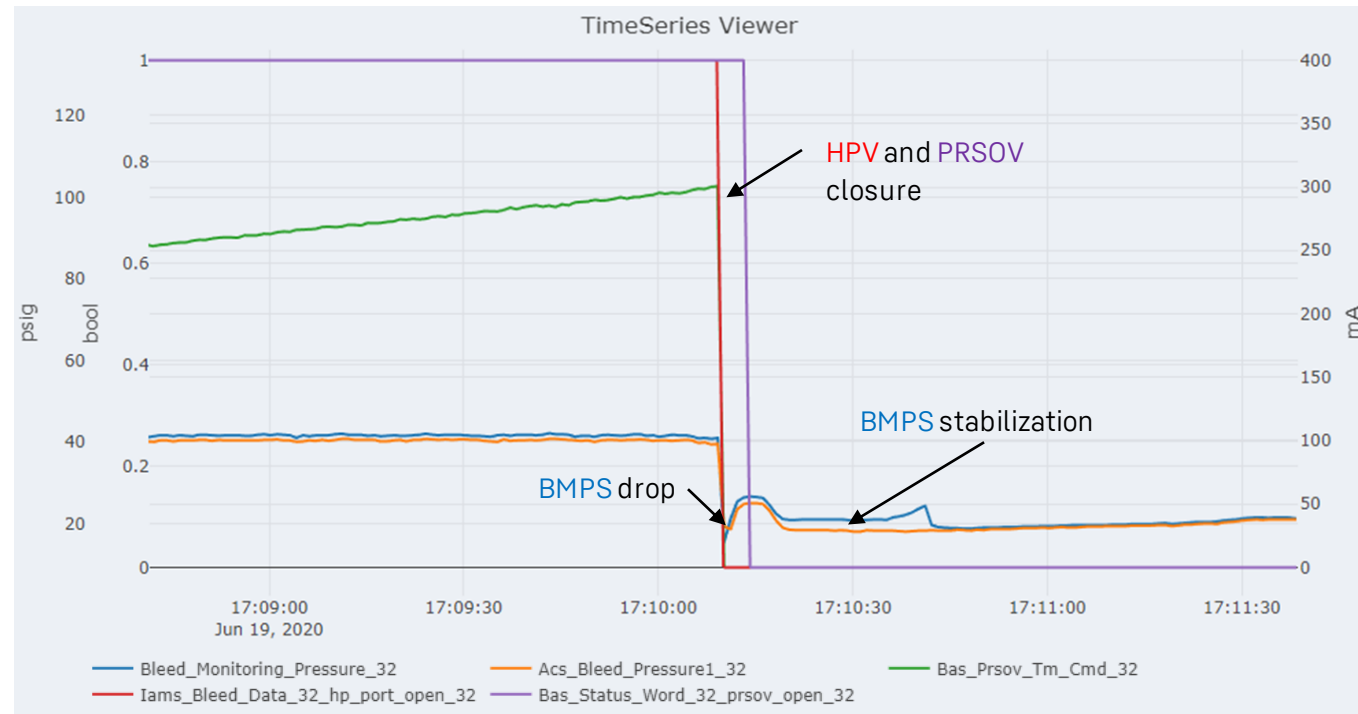
PRSOV failed open during APU switching due to insufficient upstream/downstream pressure:

- However, PRSOV upstream pressure (BMPS) drops during this switching, before stabilization at APU pressure
- In addition to unexpected leakage or Torque Motor hysteresis increase, PRSOV could stop just before contacting FC switch (potential insufficient load)

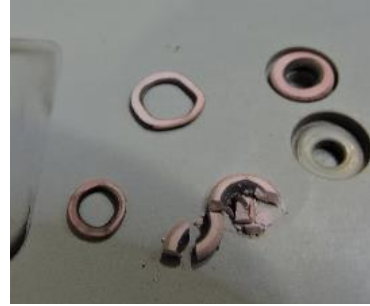
- Failed closed event

Overheated

- Systematic replacement of solenoid plunger and regulator seals (70114B010001)
- HPV redesign 70114B020001
 - VSB released in October 2021

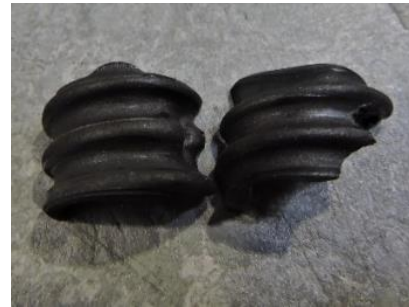
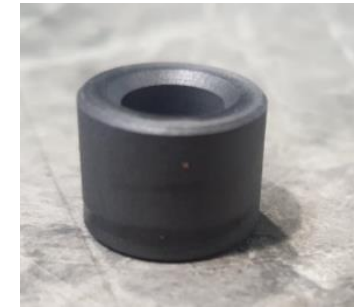
Regulator seals

Good condition

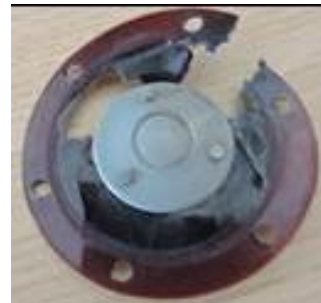
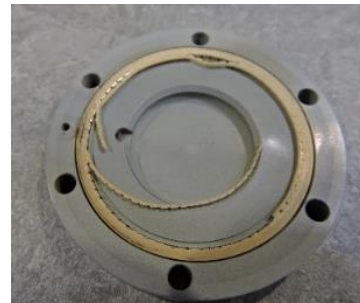
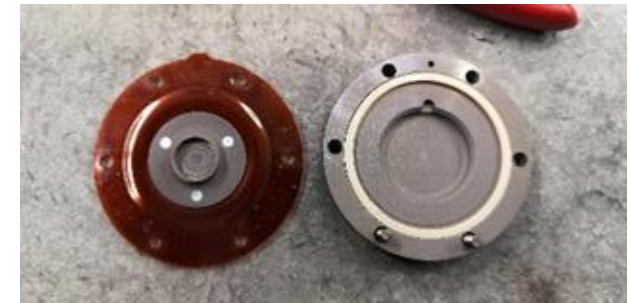
Diaphragm and cover seal

Spring guide

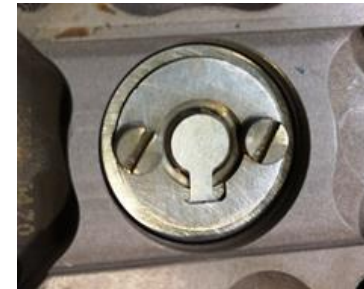
Blade clapper failure

- Failed closed

Broken blade
clapper

- VSB 70114-36-01 is desirable and will be implemented on attrition systematically

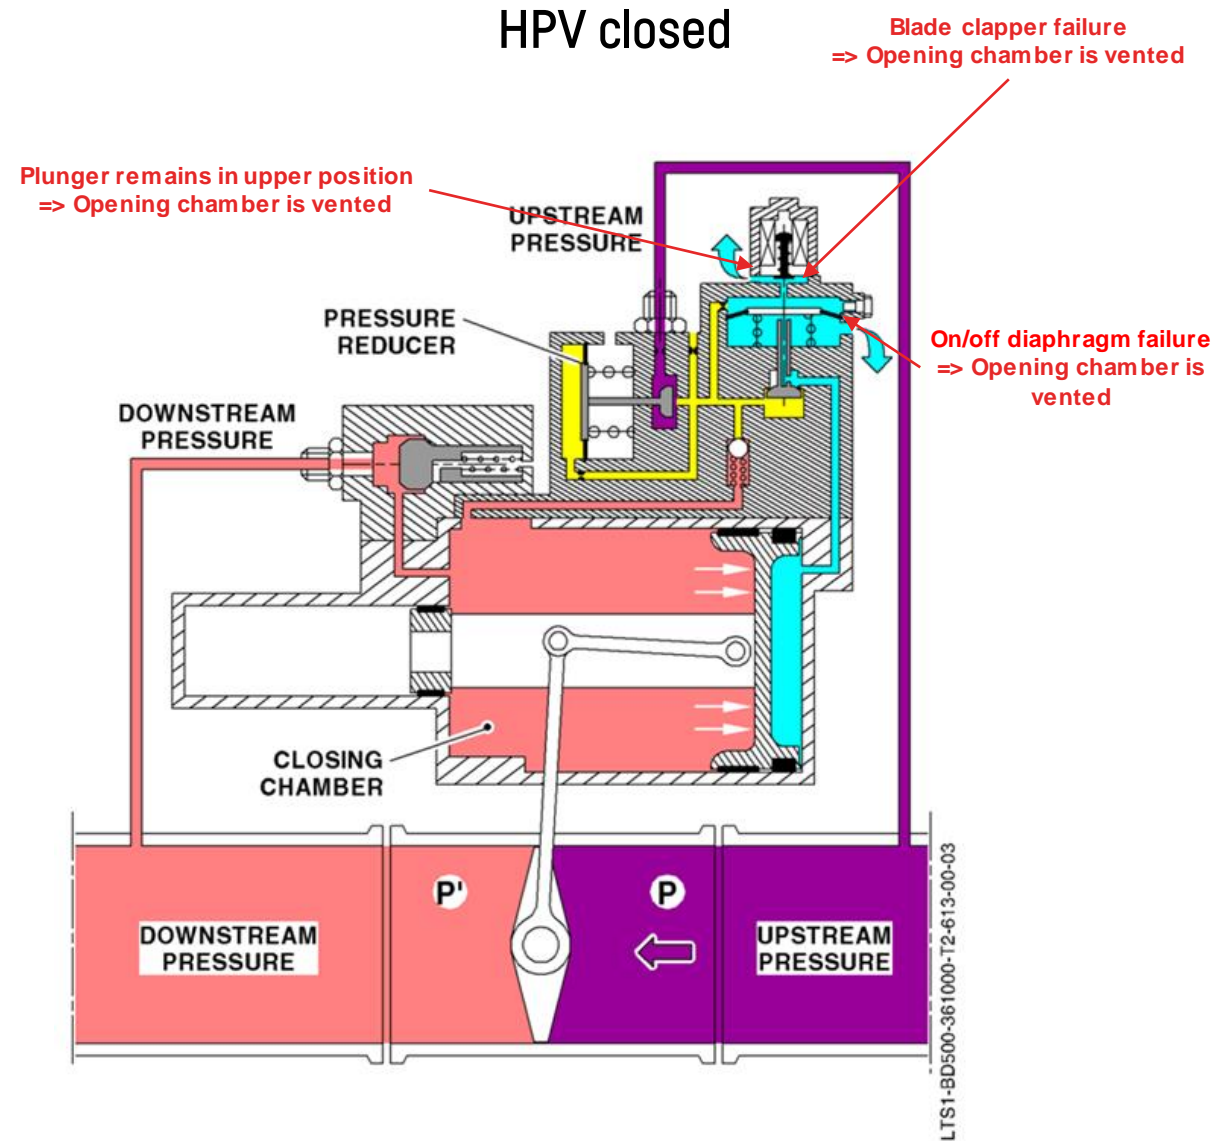
Blade clapper failure

- Opening chamber is vented

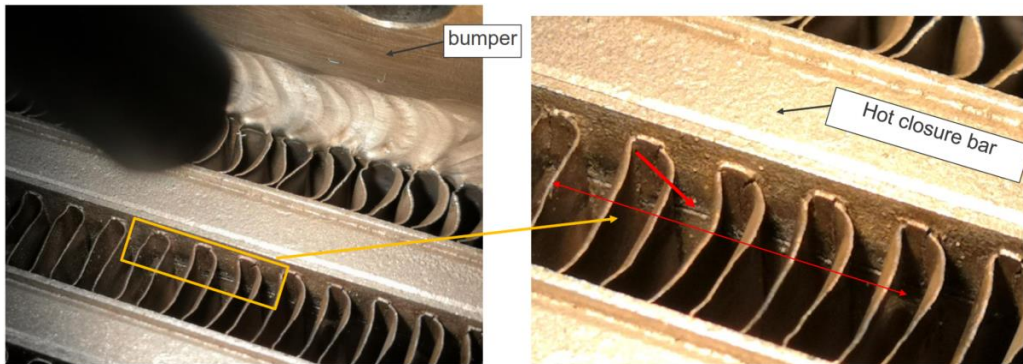
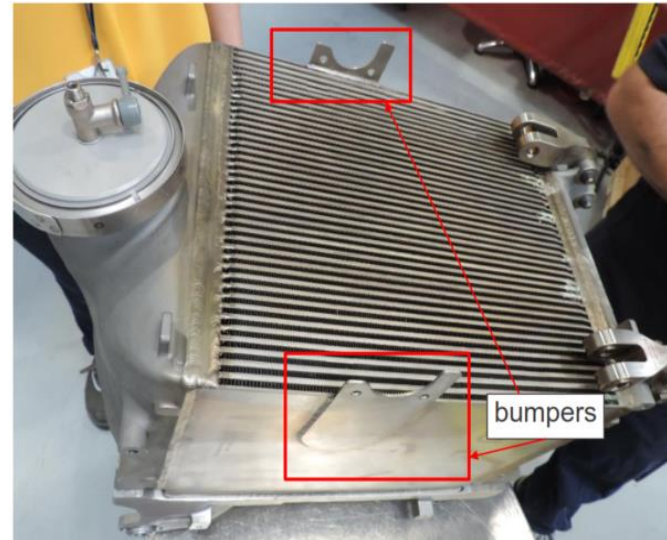
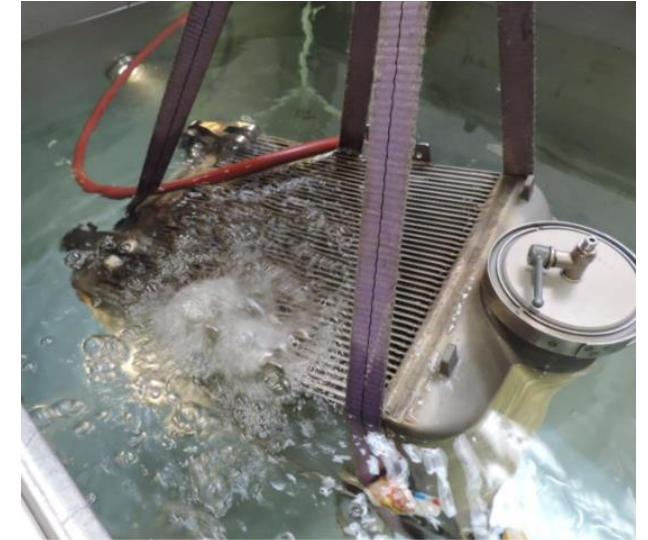
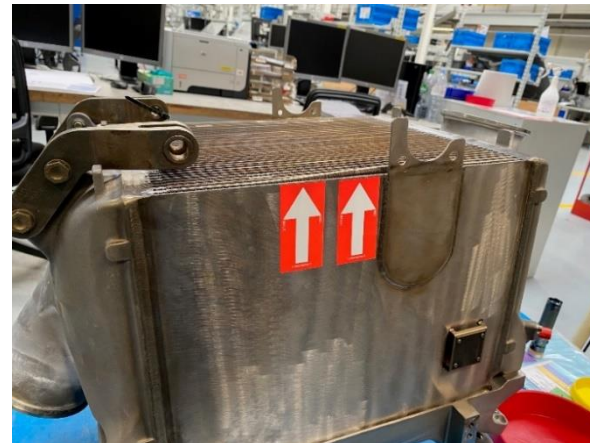
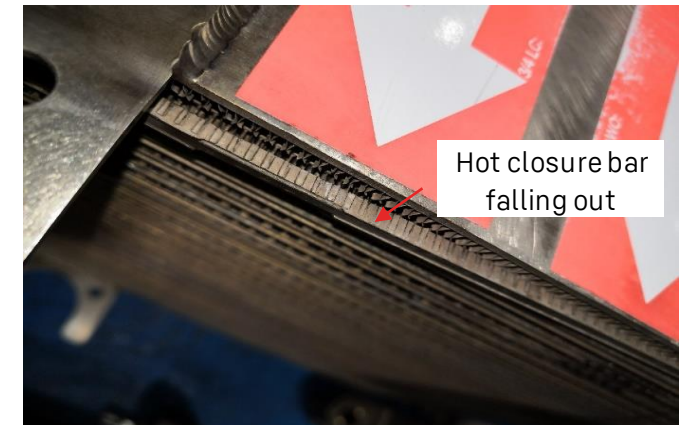
Leakage test performed at Liebherr shop during incoming inspection

Shop findings:

- Main leakage is located under the bumpers (ID plate side), on the cold outlet side.
- The two first parting sheets are cracked on several centimeters and in one case the first hot closure bar was starting to detach and slide outside.
- No brazing defect (manufacturing parameter) was observed on the different removals analyzed by our material laboratory.

- Thermal constraints was identified as major contributor leading to local overstress on cold outlet end sides hot parting sheets. Damage reproduced by calculation on another PCE P/N that has similar failure findings in service.
- Excessive vibrations (second order) FT data used for analysis (PRSOV) : conclusion shows solicitations (around 357 Hz on Y and Z) above what was tested during the qualification test.
- Still open branch : A220 duty cycle with in service data to be analyzed and check if abnormal values (out of development specifications) could cause a premature failure of the PCE not seen during qualification/endurance tests.

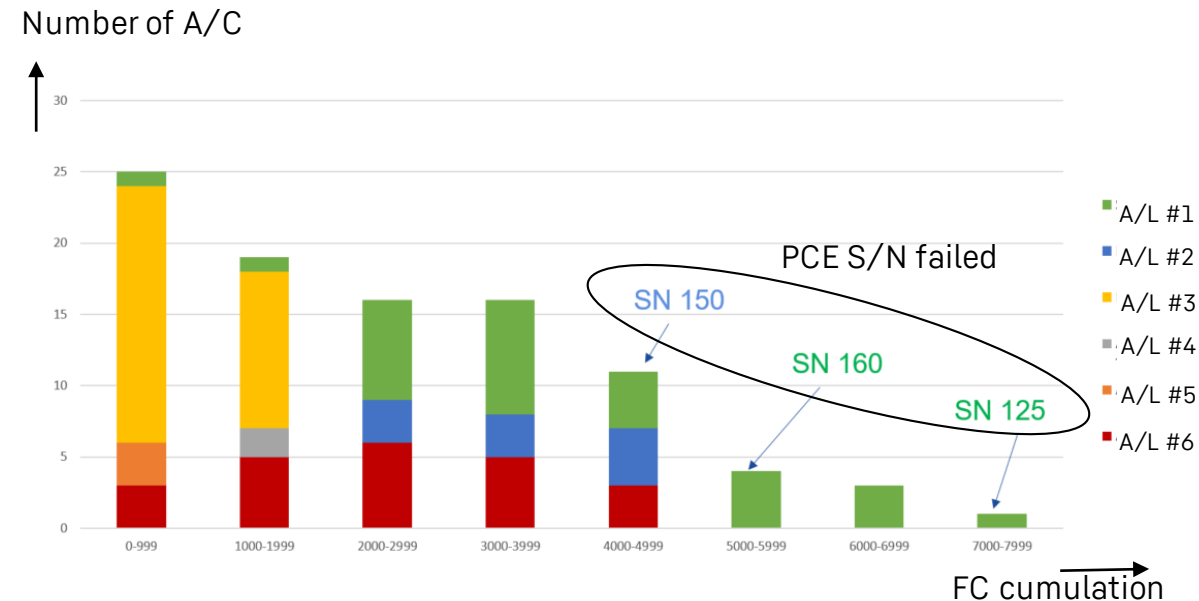
FC are more impacting the PCE than FH cumulation as it creates a thermal stress at each bleed start up or bleed source switching (temperature difference)

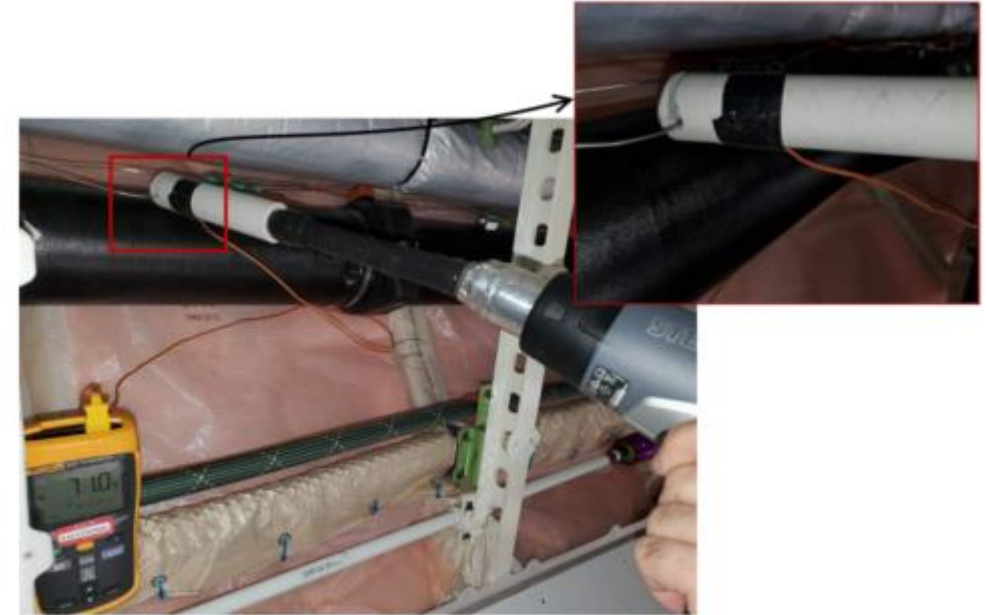
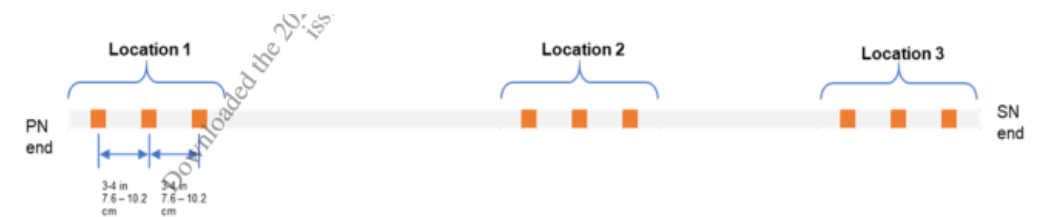
Incompletely filled eutectic salt in sensing elements due to manufacturing equipment issues, combined with deficiencies in their manufacturing process (immersion testing processes) and ATP procedures which were intended to detect the non-conformance.

- Quantity of sensing elements including Loop A & B :
 - 56 sensing elements on A220-100
 - 58 sensing elements on A220-300
- Each sensing element needs to be tested at 3 different locations.
- Required tool : Regulated heat gun equipped with a shielded nozzle
- **Compliance** : Airbus recommends that SB 1 needs to be done at no more than **2450** flight hours, and SB 2 at no more than **8500** FH from the release date.

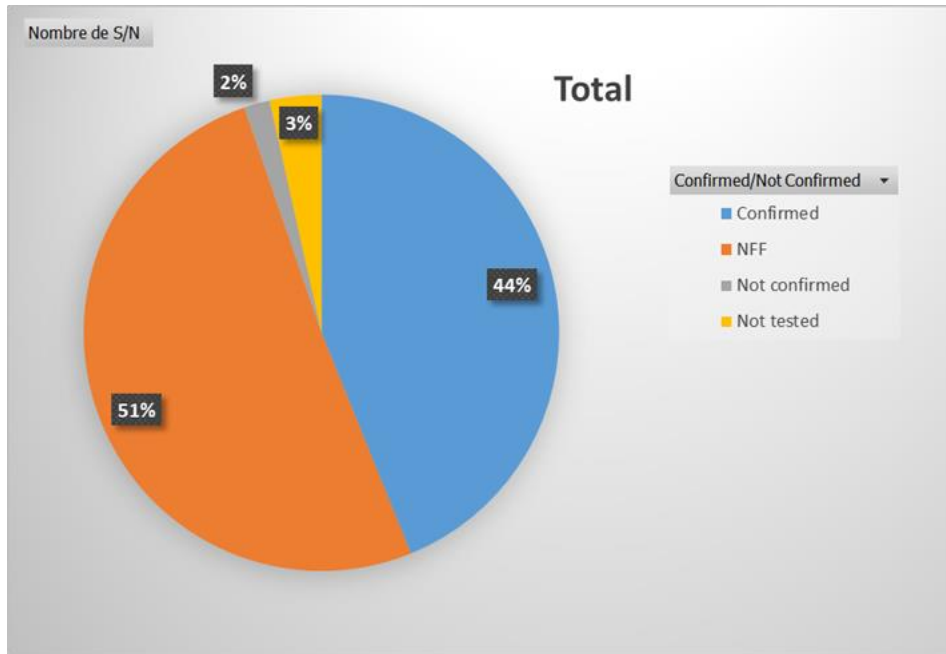
More than half of the removals are NFF or not confirmed

For the confirmed removals, main findings are pollution [14%] and solenoid failure [9%]

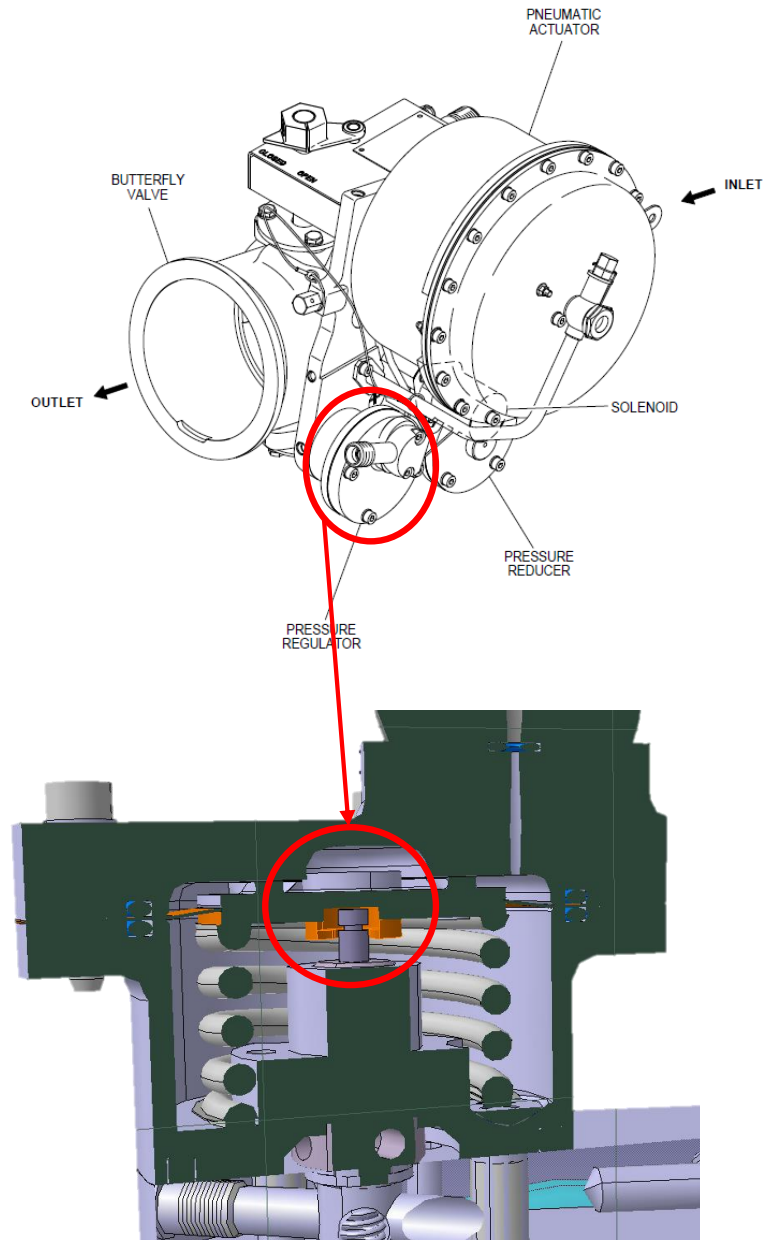
1. Regulator diaphragm issue

- Few cases of unexpected contact between regulator diaphragm and regulator clapper were reported
- This phenomenon can only be detected during hot temperature tests and lead to pressure regulation drift
- Previously not performed on repaired valves
- Associated failure messages
 - 30 L WING A/ICE FAIL - L WING PRESS FAIL or 30 R WING A/ICE FAIL - R WING PRESS FAIL (Info) associated to L/R WING A/ICE FAIL(Warning)

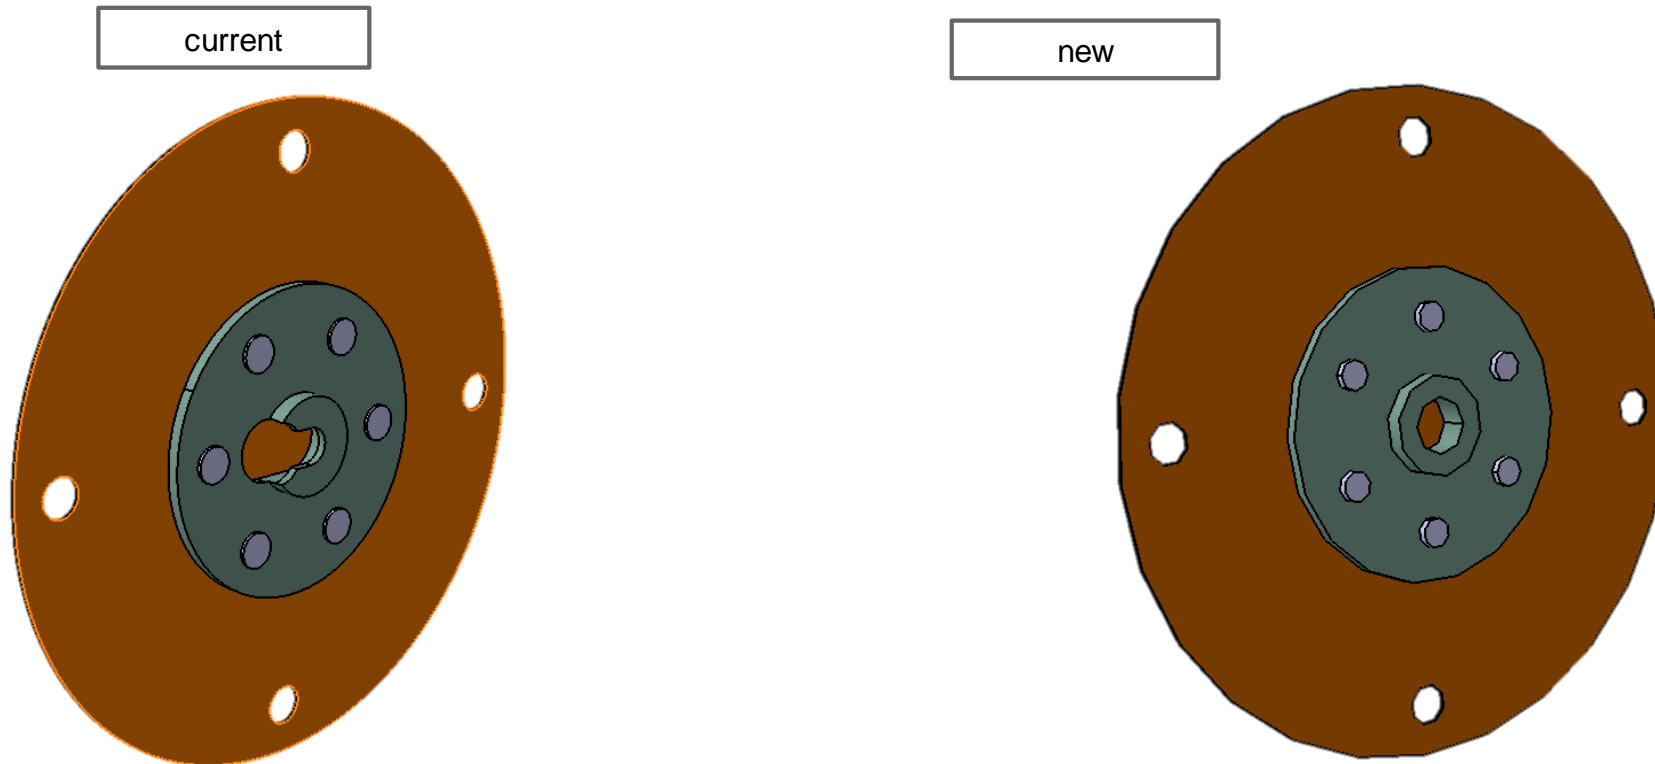
Diaphragm issue :

Mitigation : Hot temperature tests systematically done since April 2021

Solution : diaphragm design improvement to avoid contact with clapper

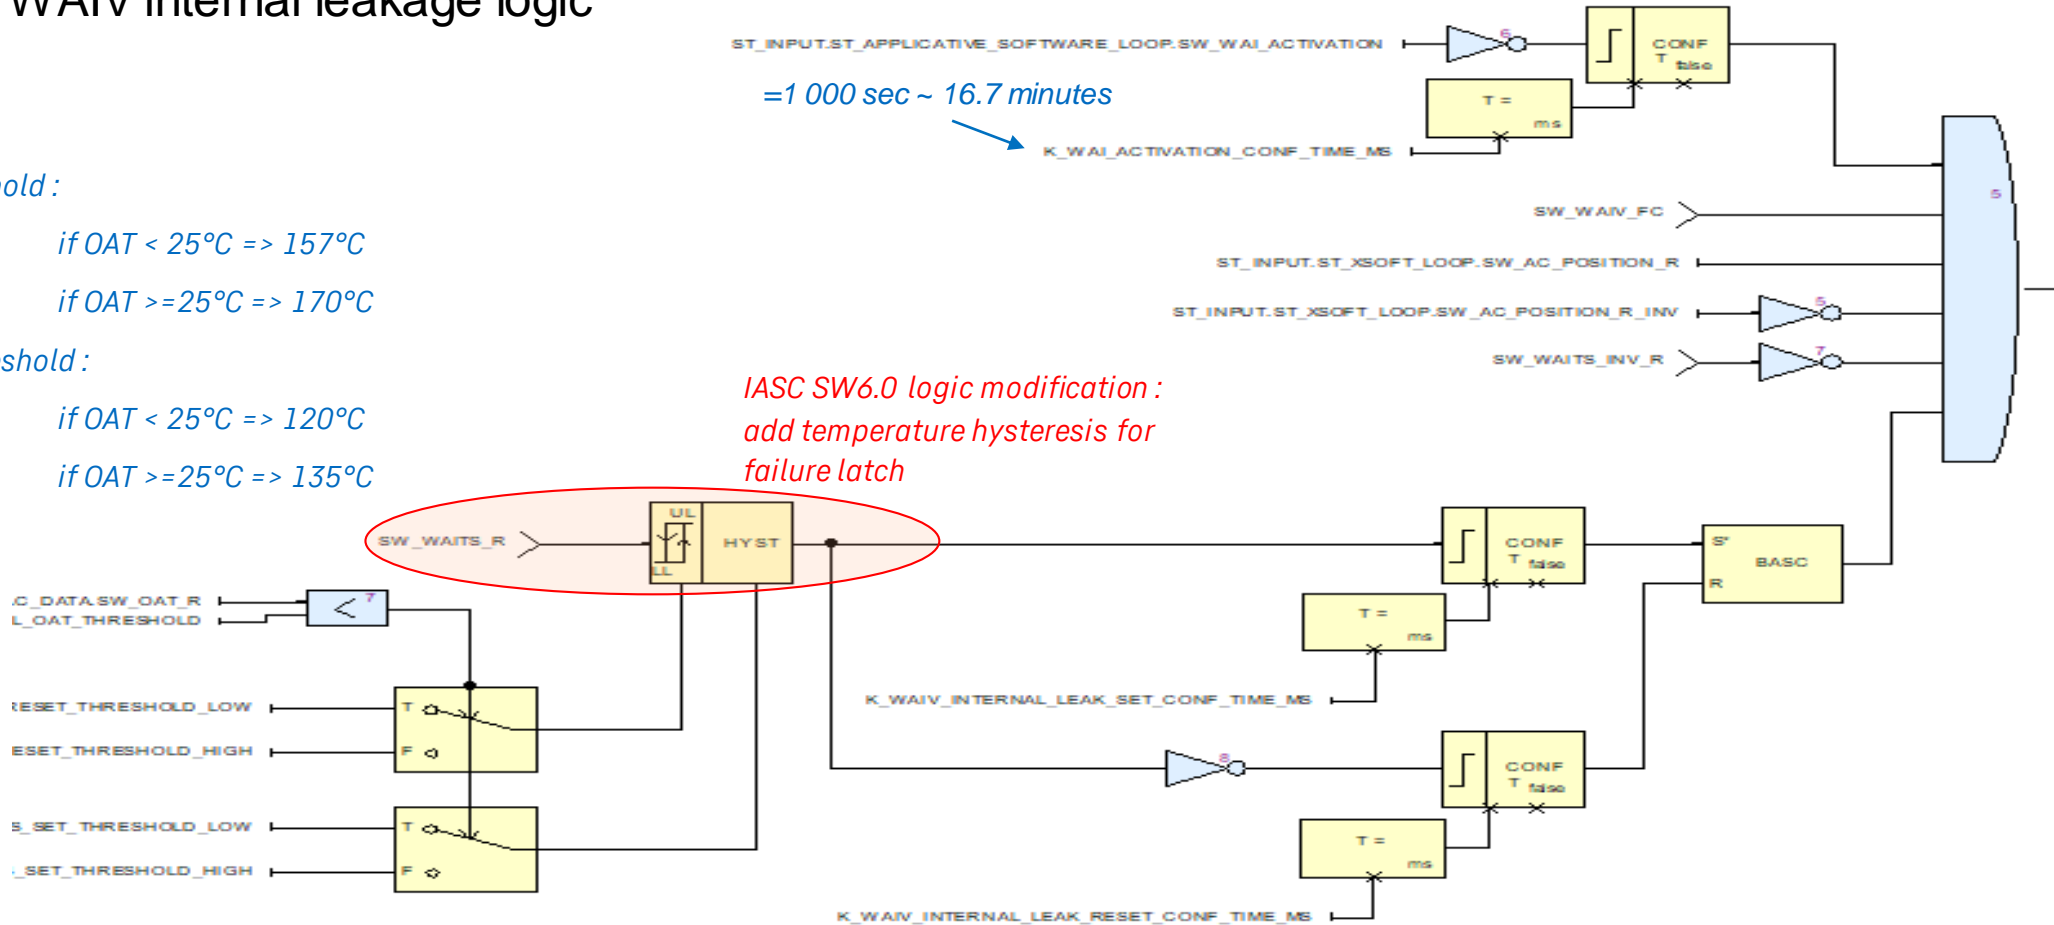
=1 000 sec ~ 16.7 minutes

*IASC SW6.0 logic modification :
add temperature hysteresis for
failure latch*

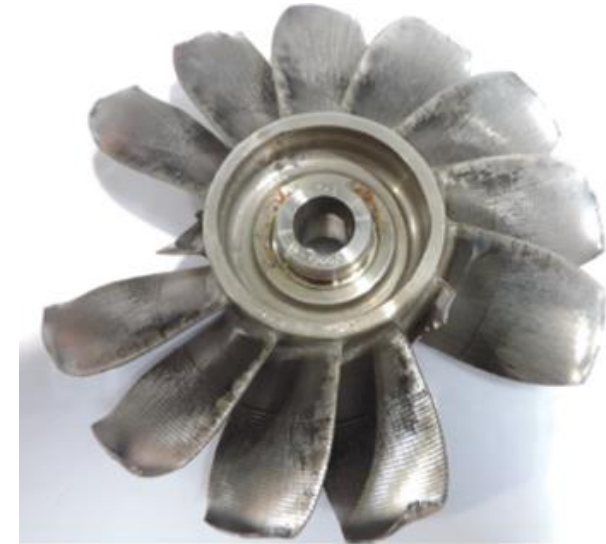
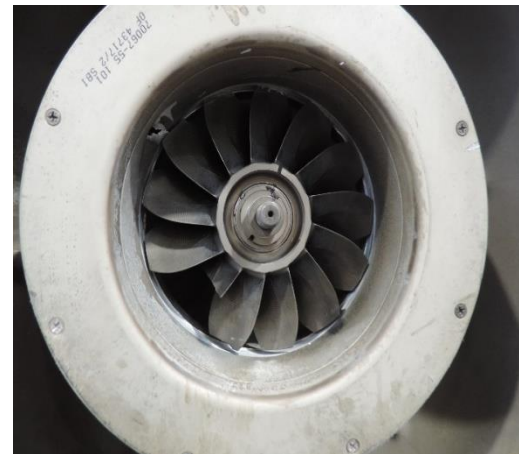
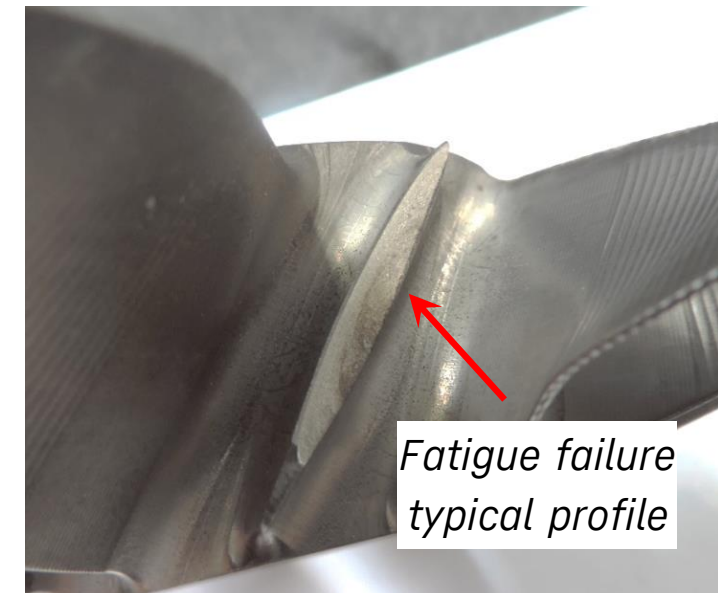
All the failed ACM were found with one or several blades broken.

All observed failures have a typical fatigue fracture cross section with a crack initiation from blade surface

After extensive investigations, the combination of the following causes originates the failure :

- The residual stresses after machining
- The frequency mistuning phenomenon of blades
- The bending stresses induced by the variable aerodynamic flow

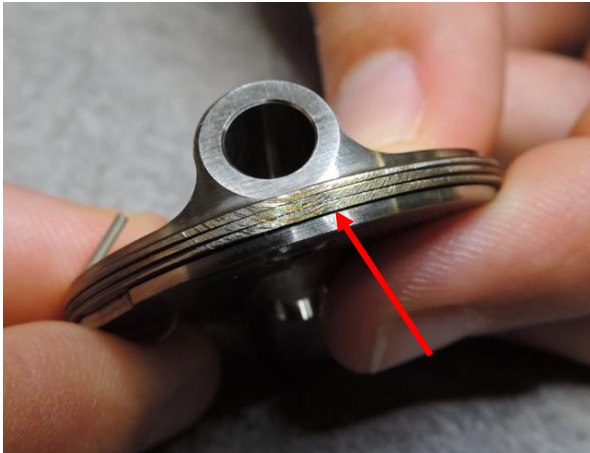
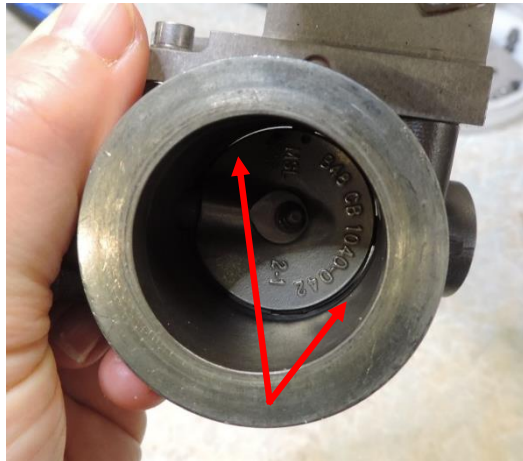
- Internal leakages above the CMM tolerances and/or valve hard to open
- Internal leakage is a consequence of butterfly segmentation wear, which leads to clearance increase with valve body.
- Worn butterfly segmentation on the bottom and top sides.

Friction marks (seals wear) + excessive clearance

- In order to reduce the valve sensitivity to excessive friction a change proposal has been identified at butterfly, butterfly segmentation and shaft.
- P/N change is proposed, P/N will be **70121A030001**.

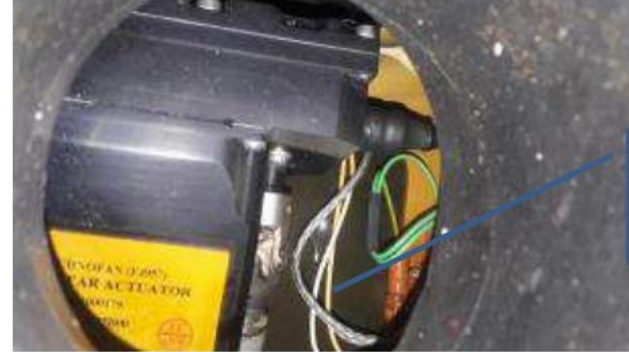
Picture 1

- Water ingress confirmed on returned valves
- Valve fails due to short circuit generated by water presence
- Corrosion of the push button retaining pin preventing deactivation of the valve

water: 86 grams

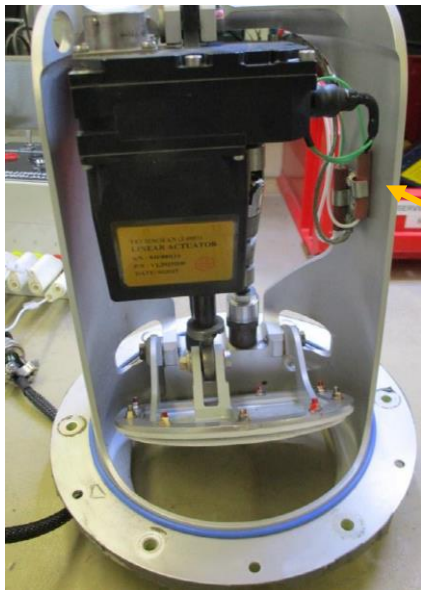
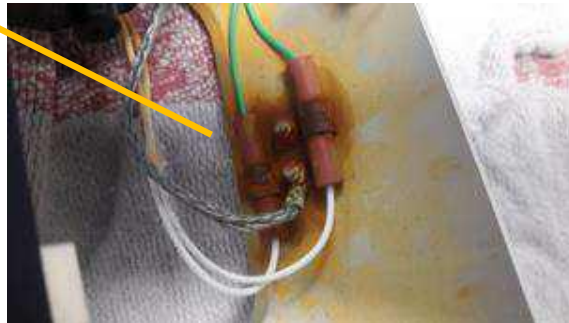
Picture 2

Water found inside the valve

Corrosion on connector adaptor

- Pin corrosion : waterproofness product application on A/C by operator
- Electrical connector corrosion : varnish application by operator (to be discussed if possible on A/C or in repair shop)
- MMEL 21 ITEM 24-24 Valve Inoperative:
Initiate Category change from “Category C”, 10 days time-interval to “Category D”, 120 days time-interval (in work @ Airbus Canada + ECD Q2 22).

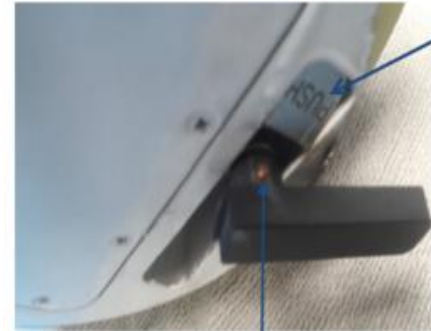
traces of corrosion on the pin of the manual handle

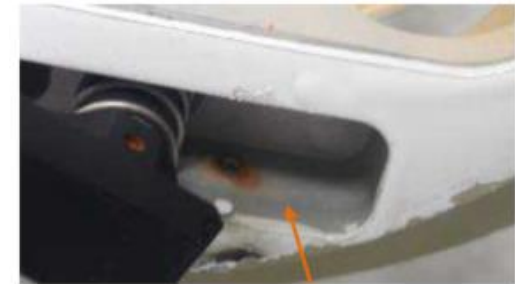
push button : corrosion marks on both sides

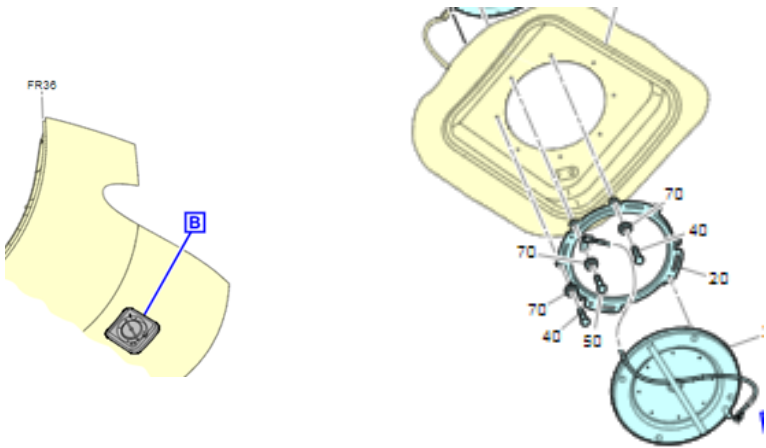
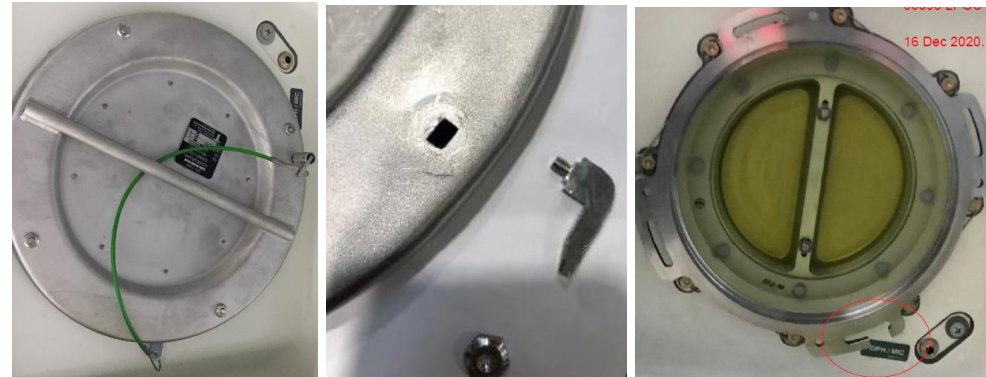
- On several aircraft the cover of the Low Pressure Ground Connector is very hard to close/open.
- In certain cases, maintenance has found the tangs (close and lock tabs) missing or broken.
- The cover is usually operated by ground handling staff. When the cover is found to be hard to close/open, in some cases it is not properly closed which may lead to damage and delays

- CS-SL-12-10-0001: install/remove & lubrication of tangs.
- CS-RIL-21-20-0007: Install tang/nut
- SNIEO (limited trial) for operational placard
- LTS tool to help cover manipulation
- REO 500-21-21-001: continue a/c operation with one tang missing and/or cover installation adapter fitting loop damaged
- MMEL relief is under consideration to allow operation of the a/c with one tang and one adapter loop damaged

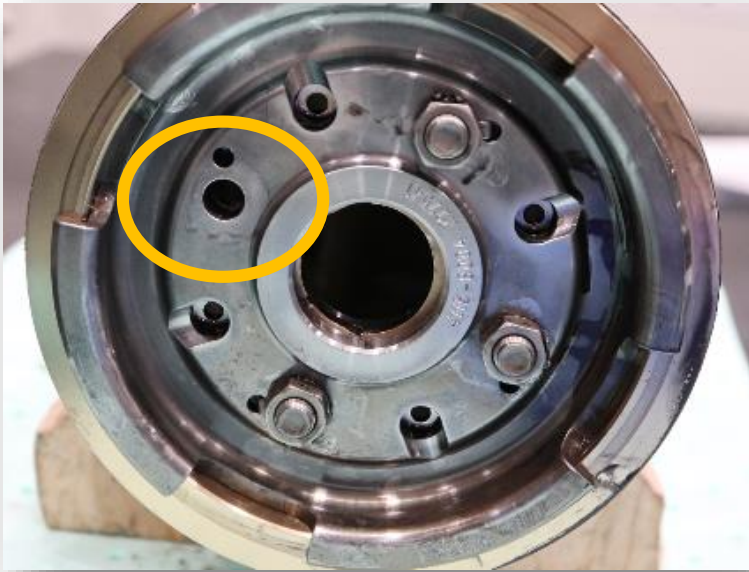
Throttle Mount with lost screw

Lost screws create damage on inner surfaces and parts

- torque increased from 5 Nm to 27 Nm
- use of self-locking helicoils doubly secured with locking washers
- improved tightening procedure

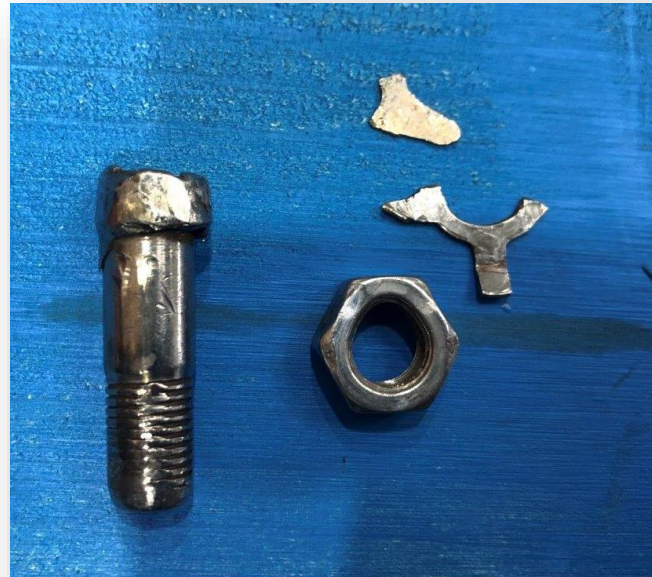
Parts found in Shock Strut

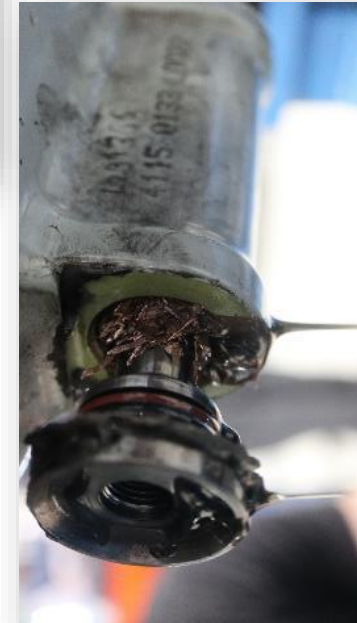
Metal Chips in COV

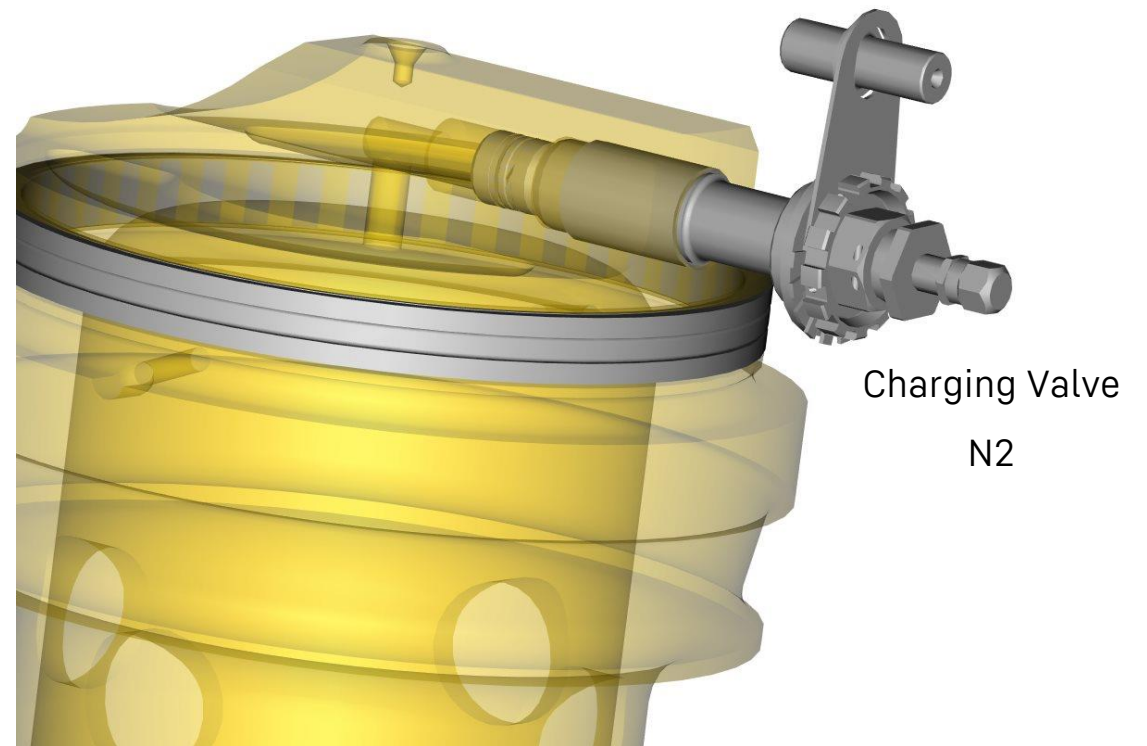
At disassembly of the cylinder tube in the main fitting there is a risk of cross bore surface damage!
