RTW 2021

Airbus

A220

Liebherr Saline

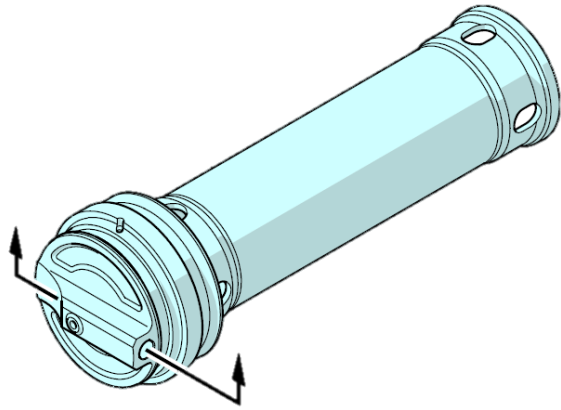
INSPECTION ZONE 1
POTENTIAL DAMAGE AT THE INNER
SHOULDER OF THE BORE

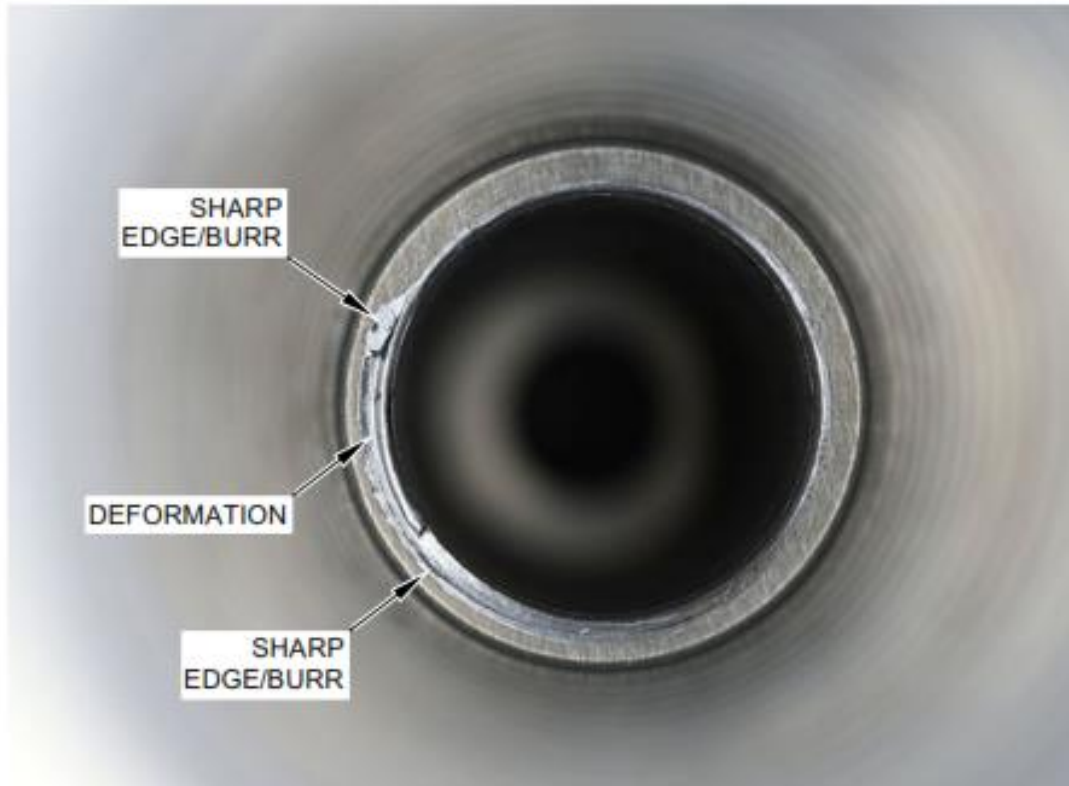
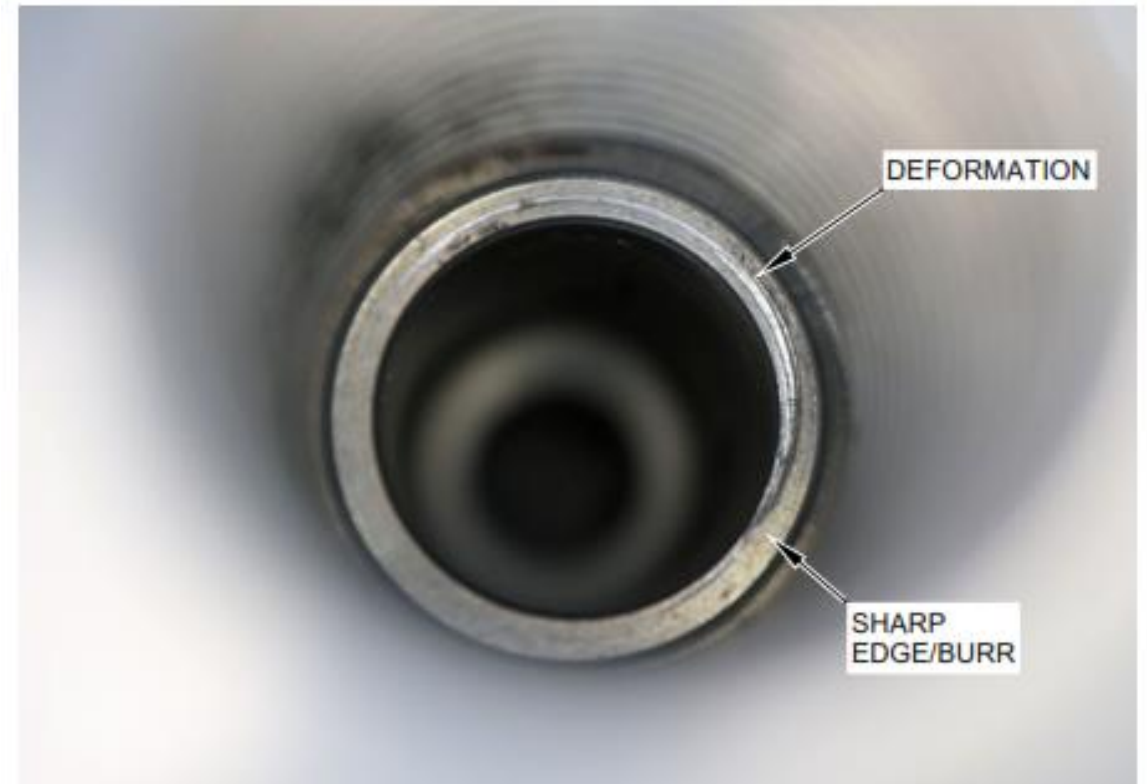
Inspection Zone 1 - Potential damage at the Inner Shoulder of the Bore

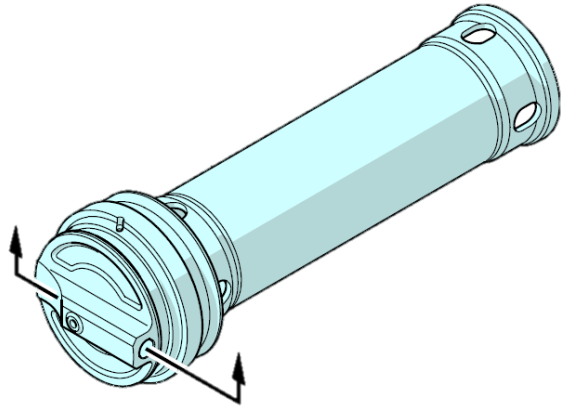
INSPECTION ZONE 2
POTENTIAL DAMAGE AT THE INNER
DIAMETER OF THE BORE
(O-RING GLIDE SURFACE)

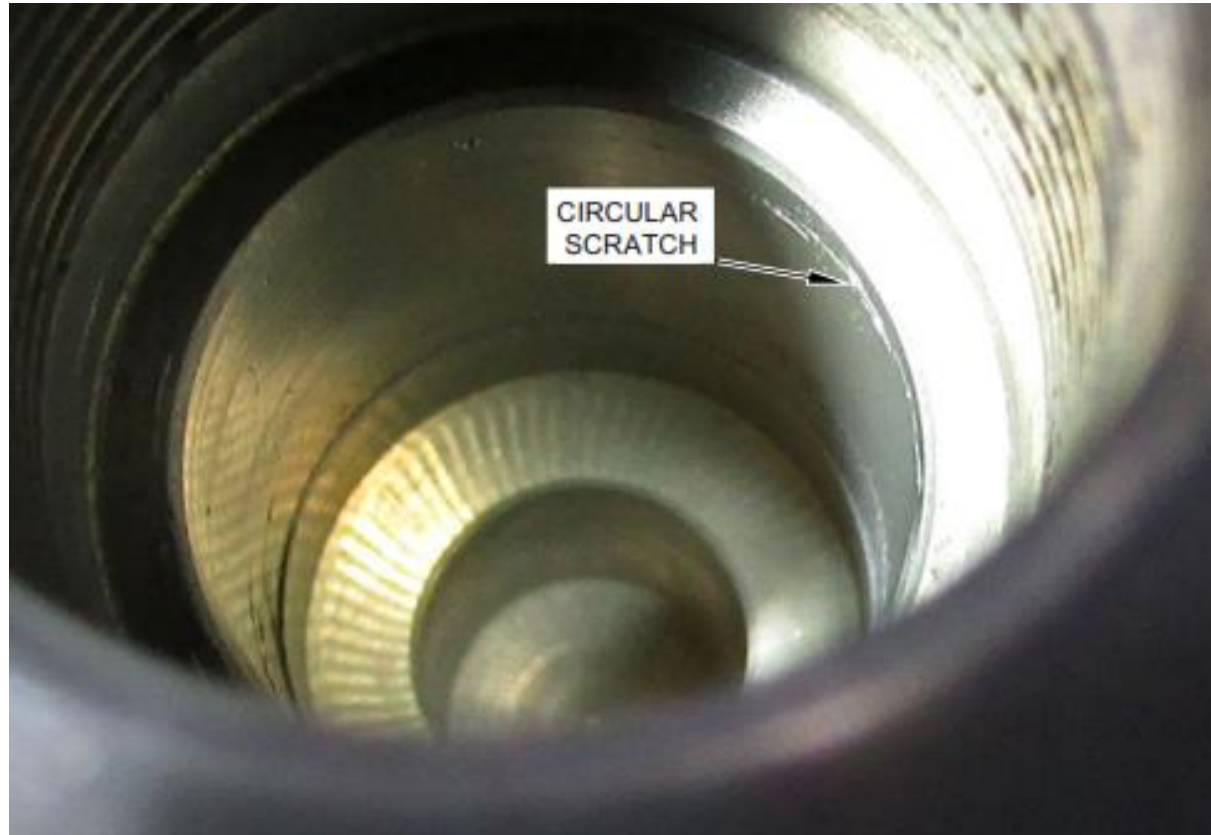
Inspection Zone 2 - Potential damage at the Inner Diameter of the Bore

Repair with Honing Brush Assembly PN 4115A0700-02W04

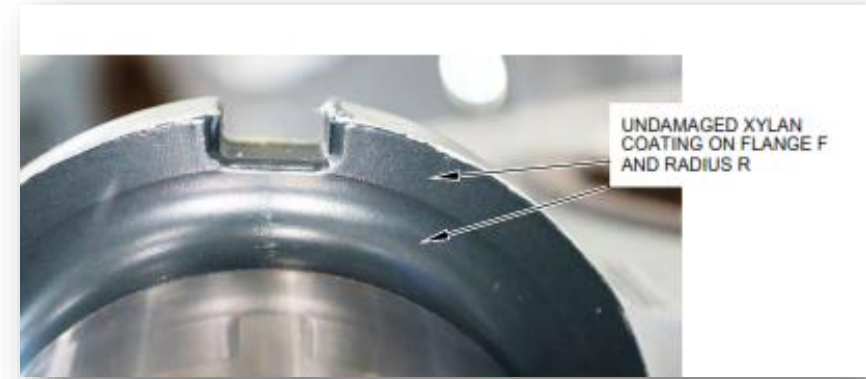
Corrosion on Lower Spindle was detected.

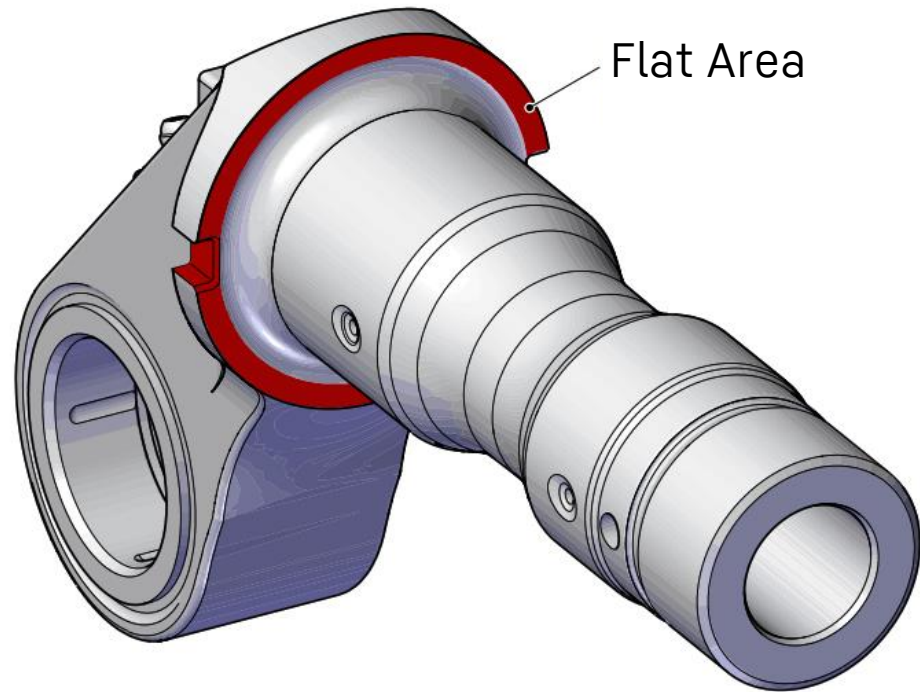
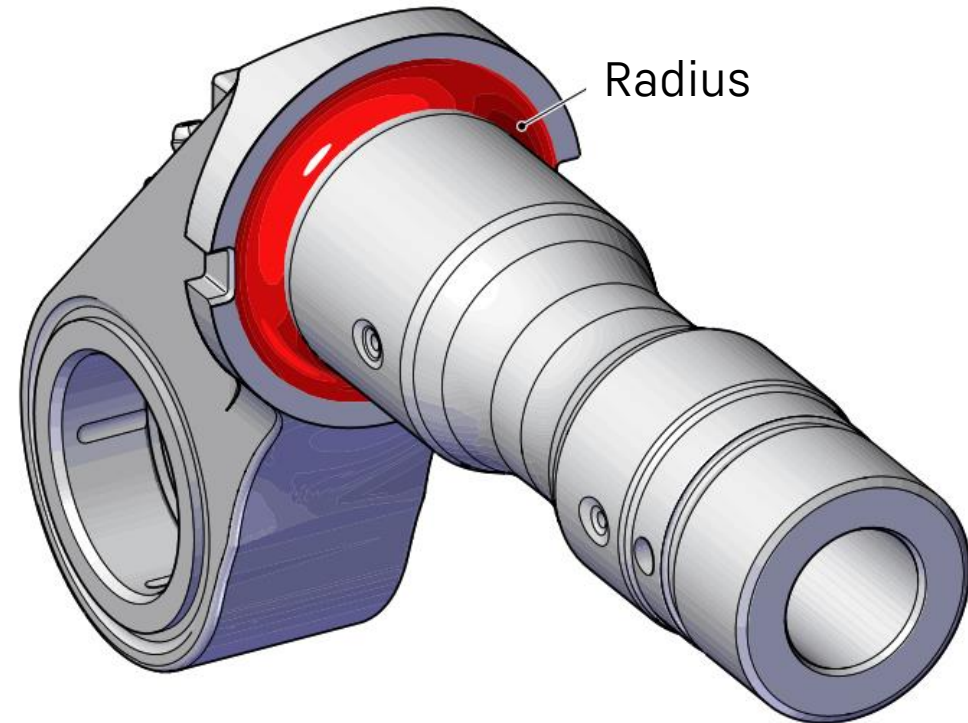
Definition of Inspection Areas – Spindle removed
