RTW 2021

Airbus

SA Family

Liebherr Saline

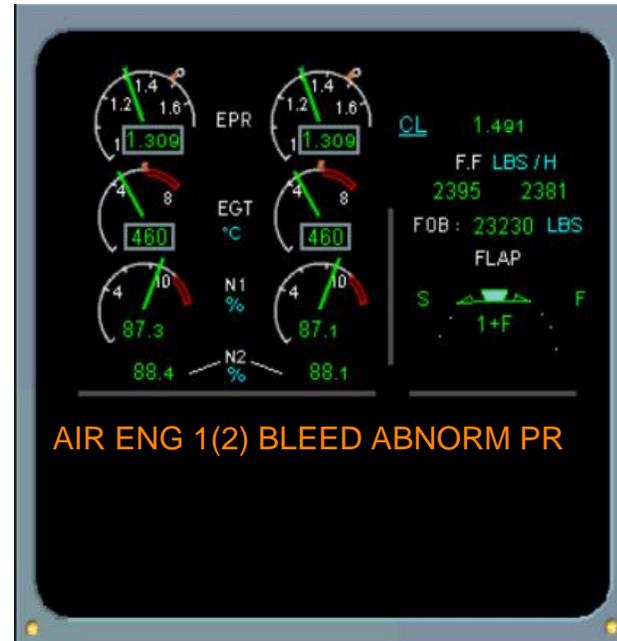
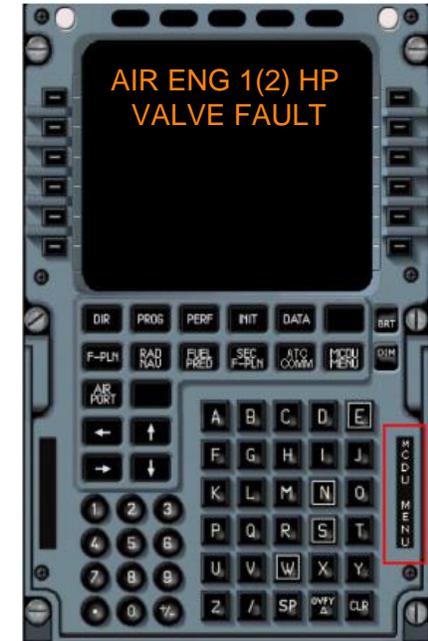
Cruise, bleed on Intermediate Pressure port
Top of descent leads to engine thrust reduction

Pack Inlet Pressure is detected below 18 psig
HPV is detected closed while commanded to open

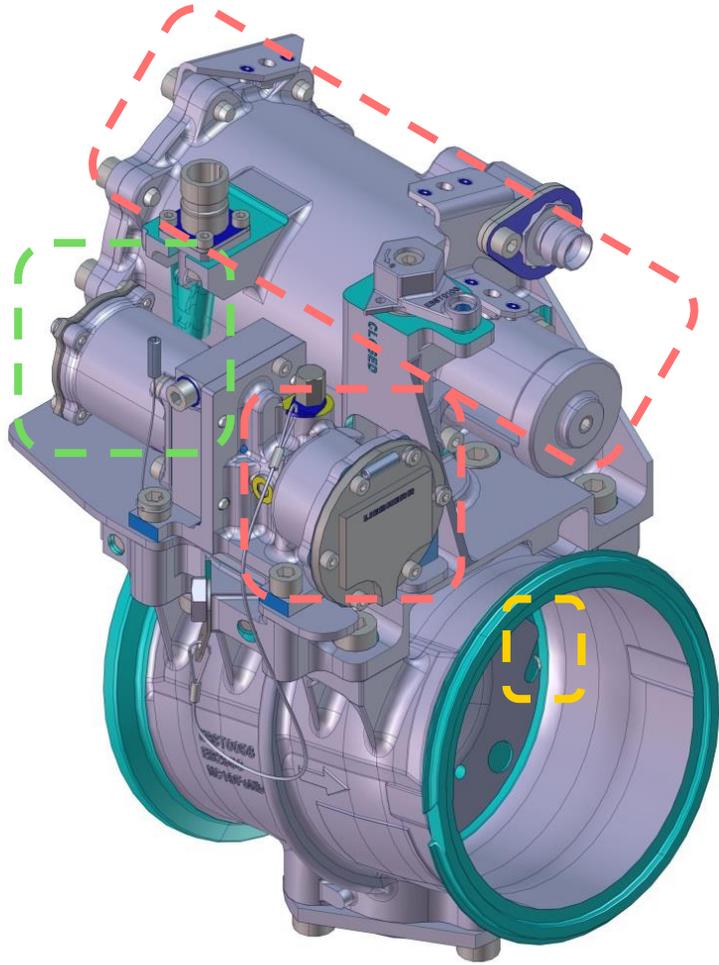
- ✓ *Aluminium phosphate exudation from JPXX32 graphite on actuator seals and regulation clapper*

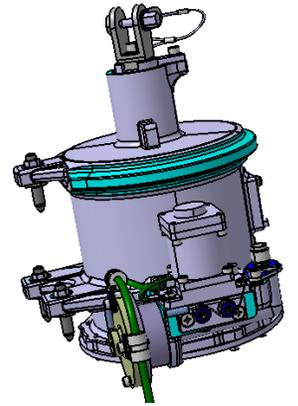
Multiple cases of FAV actuators removed and found in Liebherr shops with high level of water contamination and traces of corrosion

ECAM warning: “ENG 1(2) BLEED FAULT” with maintenance message FAN AIR-V (9HA1(2))) / SENSE LINE / PRECOOLER (7150HM1(2))

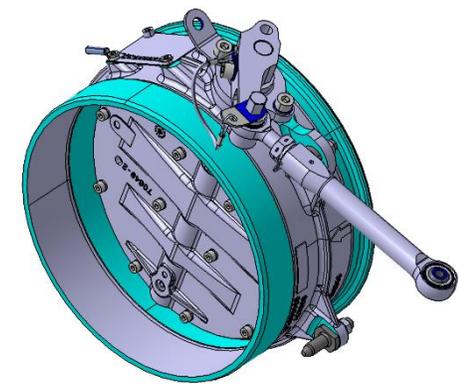
For CFM & PW engine installation, a combination of aeroacoustics resonances in the fan inlet scoop & Installation variability lead to excessive vibrations and break the inlet scoop brackets. Load are then transmitted to FAV sub assemblies.

Original bracket installation were first affected.

Post bracket MOD aircraft (2018) are also affected by FAV Body heavy damages.

During aircraft inspection, if any of these damages are observed, the complete FAV Body + ROD needs to be replaced.

Important reminder: AMM does not provide instructions to replace only the FAV rod on the wing. Airbus and Liebherr absolutely do not recommend replacing only the rod because other parts integrity cannot be ensured.

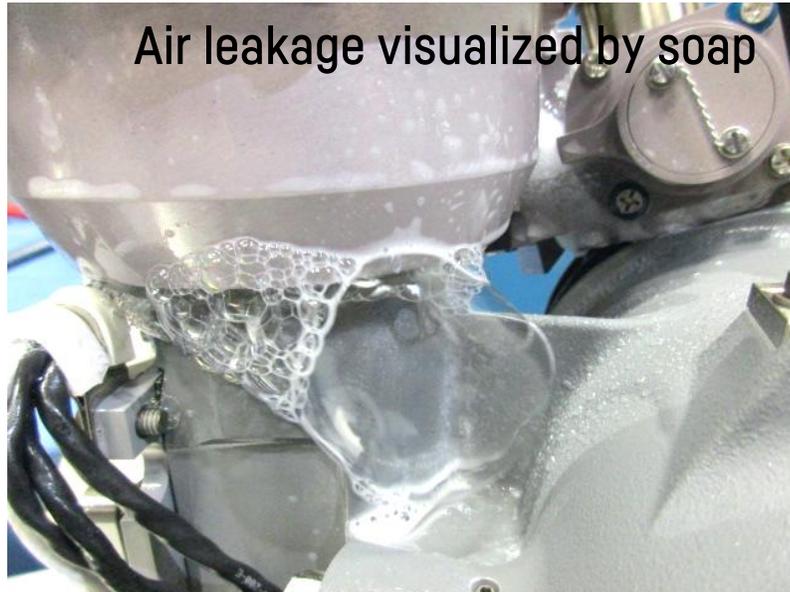
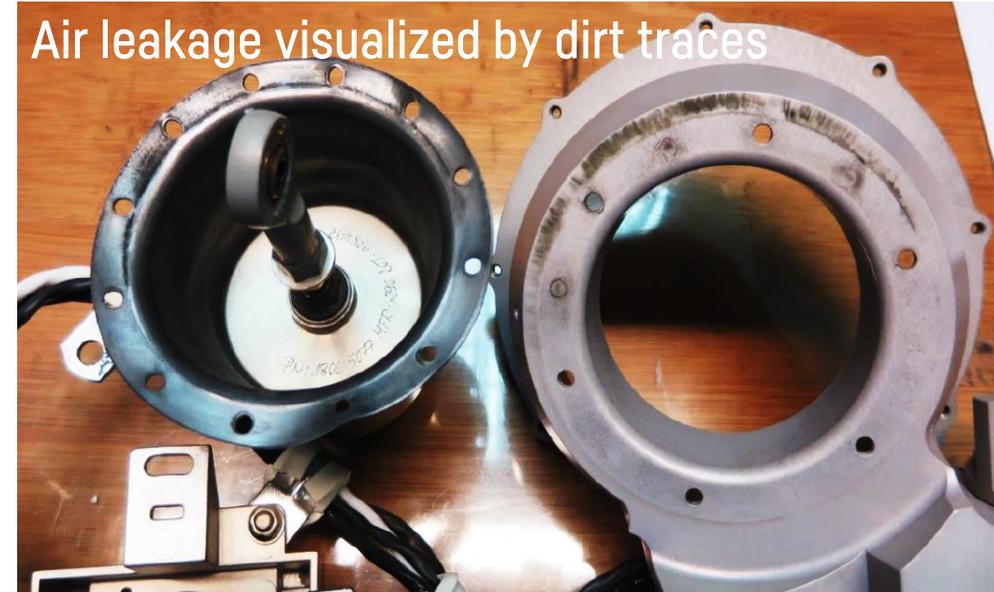
Liebherr noticed since Q4 2020 an increase of Flow Control Valves P/N 1806D0000-02 removals within the standard warranty period.

- A/C level: “AIR PACK X REGUL FAULT” associated to “P1/2 PACK FLOW CTL VALVE (23HB/24HB)” CFDS message (depending on the level of the leakage)
- FCV level: external leakage high, torque motor drift

Manufacturing process & repair shop in Jan 2021 : addition of a second torqueing task of the actuator screws to secure the tightening on a longer period than with a single torqueing.

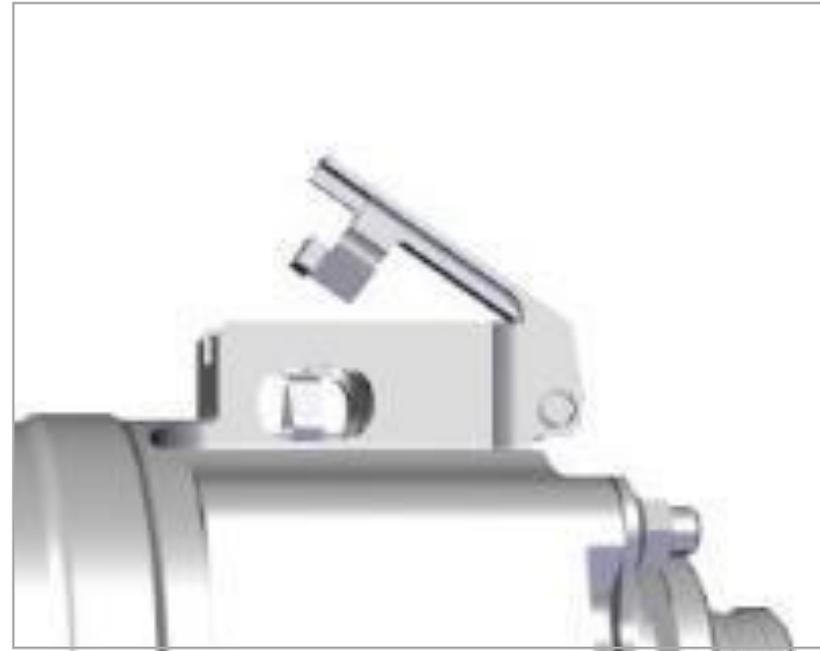
LOCKOUT INDICATOR ACTIVATED
MOSTLY ON A321 TRACKS 9, 10, 11:

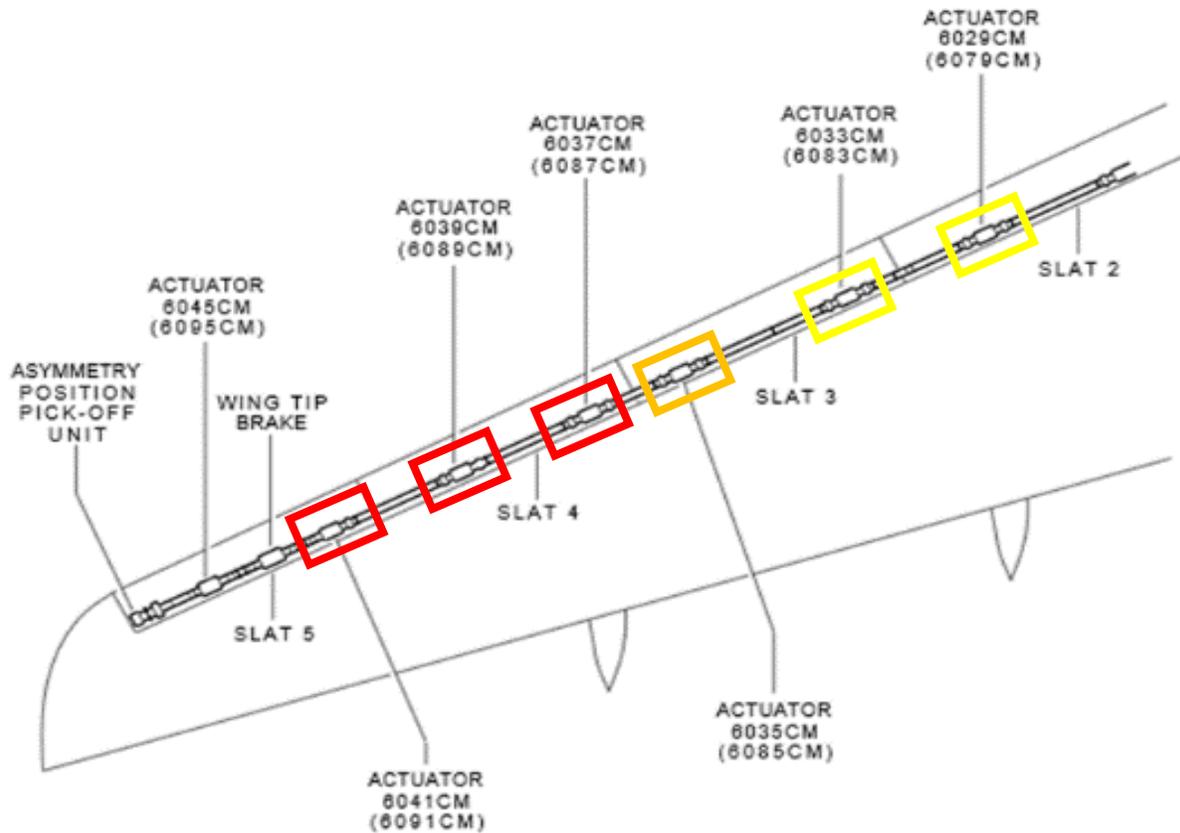
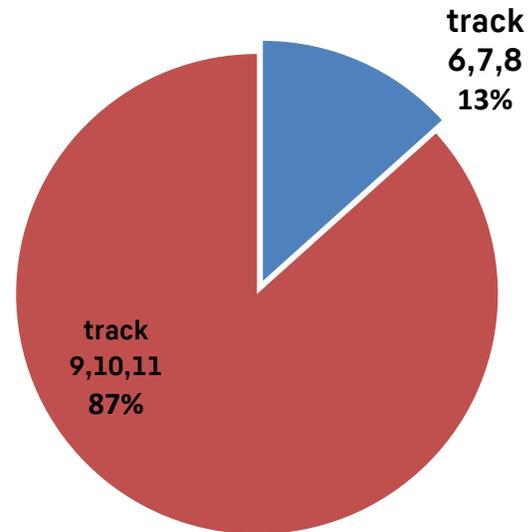
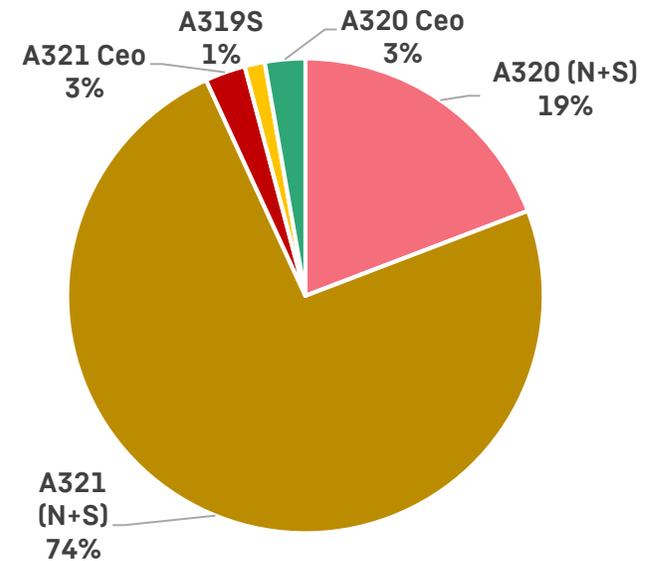
- Mainly slat track 9/10/11
- 76 reported slat Jam cases since 2013

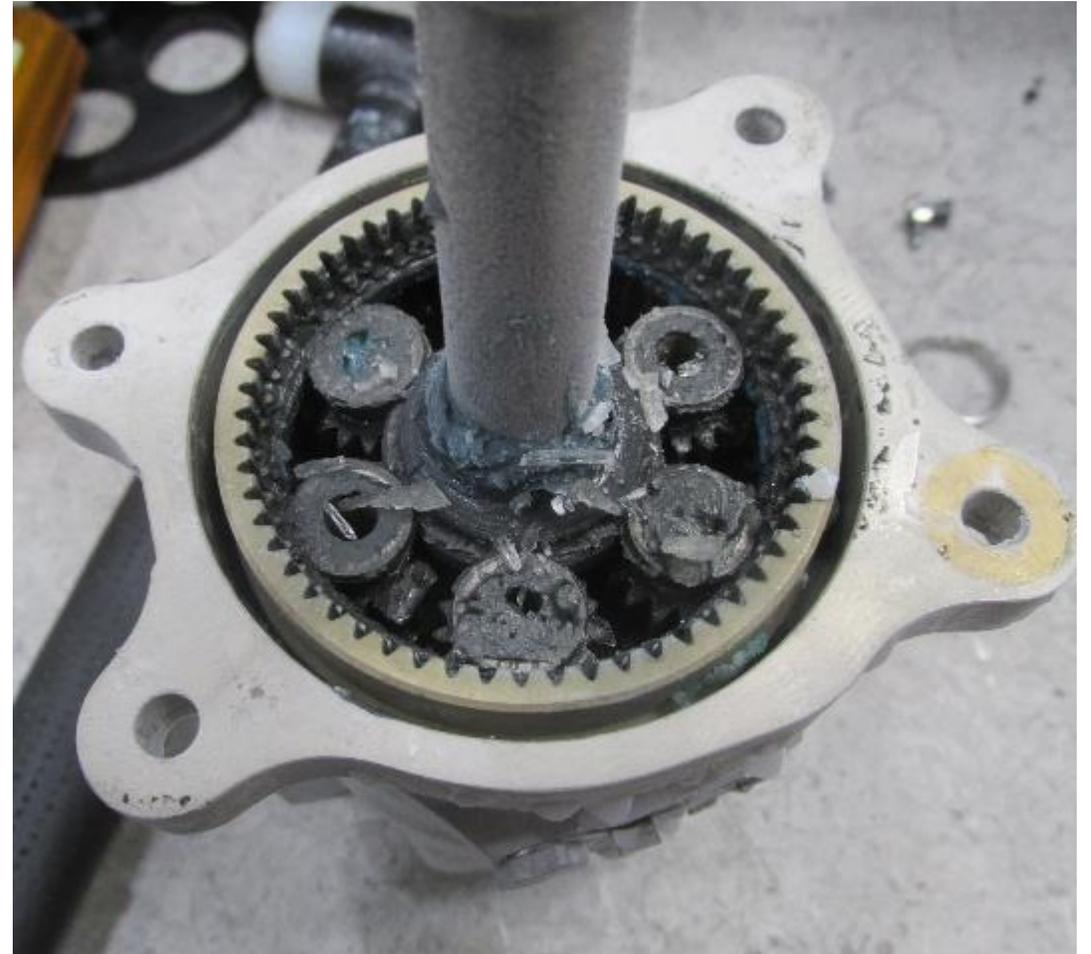
- 43% of returned GRAs jammed @ -40°C test *
- Moisture found on 45% GRAs during disassembly.*

INVESTIGATIONS & ROOT CAUSE

- Root cause on GRA level: Frozen water
- Root Cause contributor on A/C level: Increased wing bending (sharklets)

Solution:

- Change the grease from AeroShell 33 back to Nyco GN22
- Sealing the gap between the Housing and the Cover.

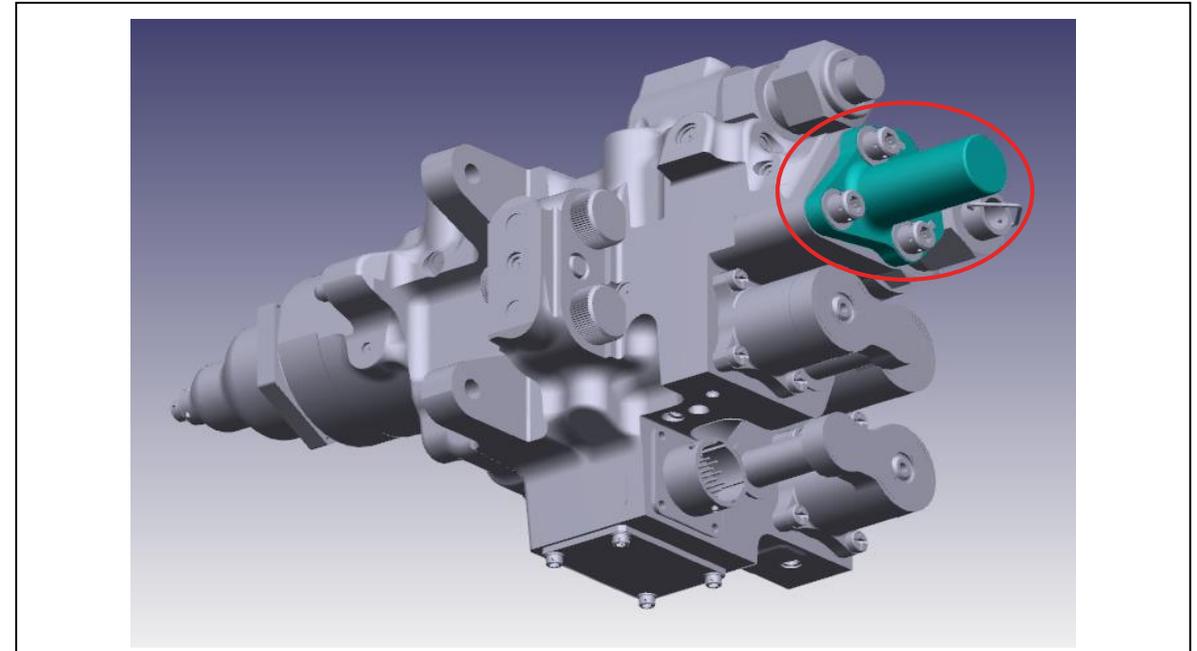
FLAP (SLAT) SYS 1 (2)
Fault with failure
message VALVE
BLOCK - VALVE SENSOR

- New LVDT shows good reliability.
- No more removals of new LVDT 9070A0008-03
