RTW 2022

Airbus

Liebherr-Aerospace Toulouse

Airbus SAceo

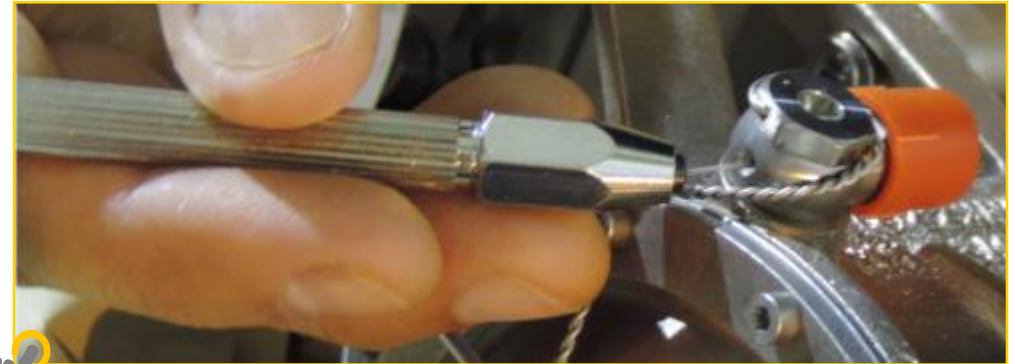
A periodic cleaning of the FAV banjo hole can efficiently prevent the majority of low temp events

Refer to Airbus AMM TASK 36-11-00-720-012-A

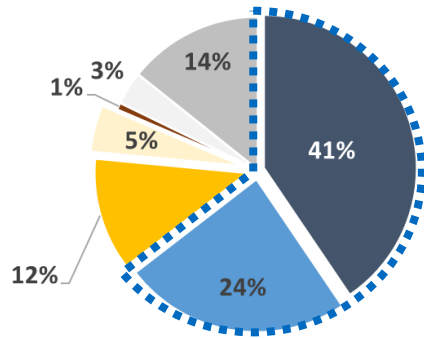
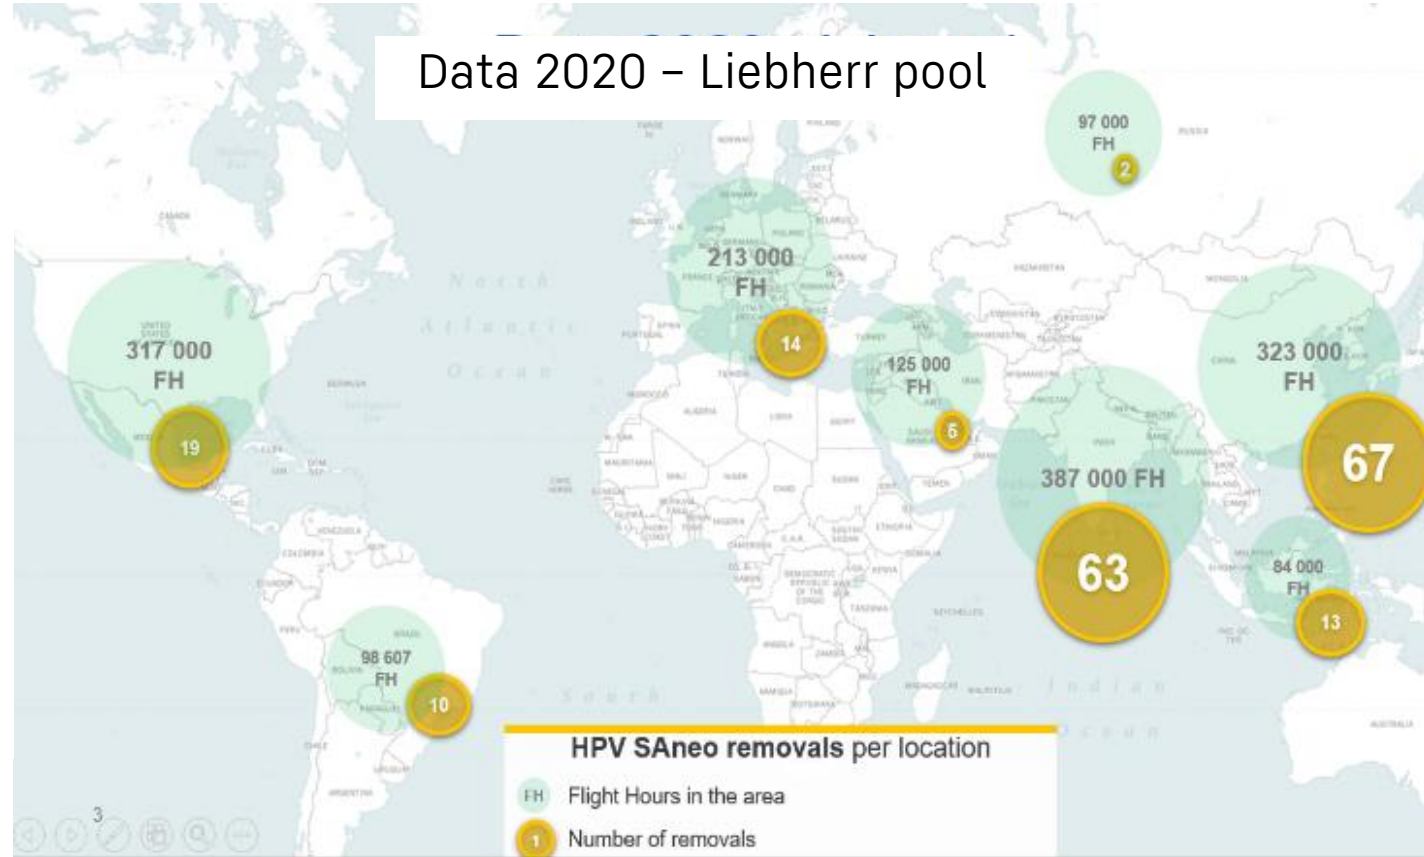
Major finding HPV 70645
Study period [Jan 2018-Oct 2021]

- ACTUATOR S/A ALUMINUM PHOSPHATE CONTAMINATION
- REGULATOR S/A ALUMINUM PHOSPHATE CONTAMINATION
- SOLENOID S/A failed
- CLIP RUPTURE
- BEARINGS WORN
- INDUCED
- NFF

*NFF rate drastically reduced starting from CMM update

Asia more affected than the rest of the world

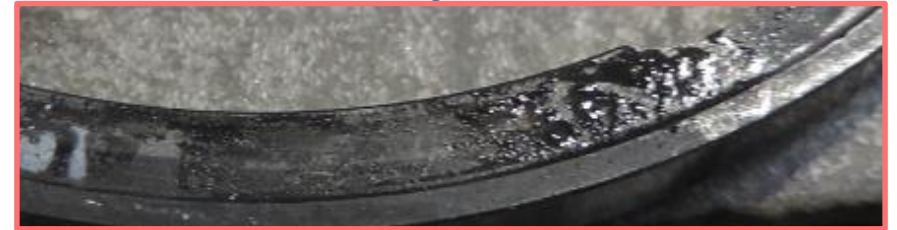
- ✓ *Aluminium phosphate exudation from JPXX32 graphite on actuator seals and regulation clapper*

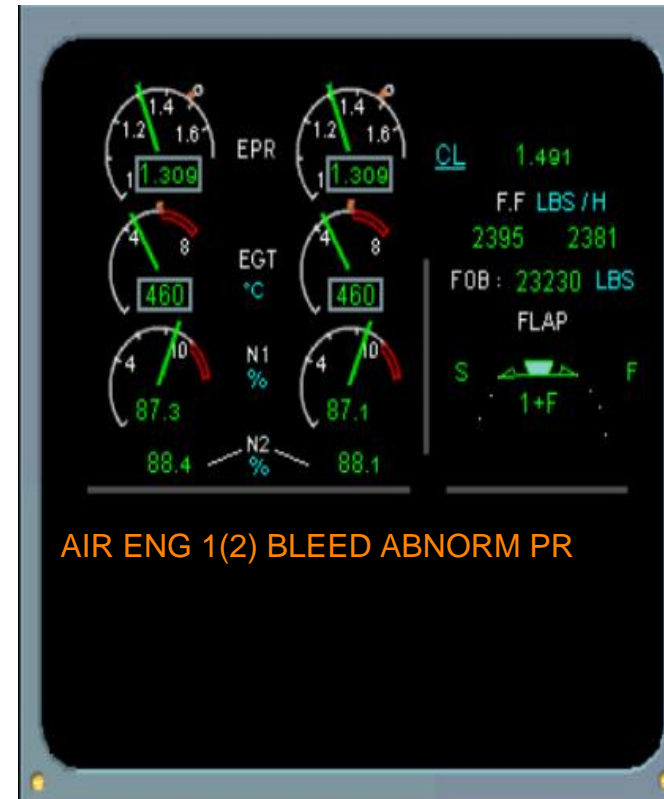
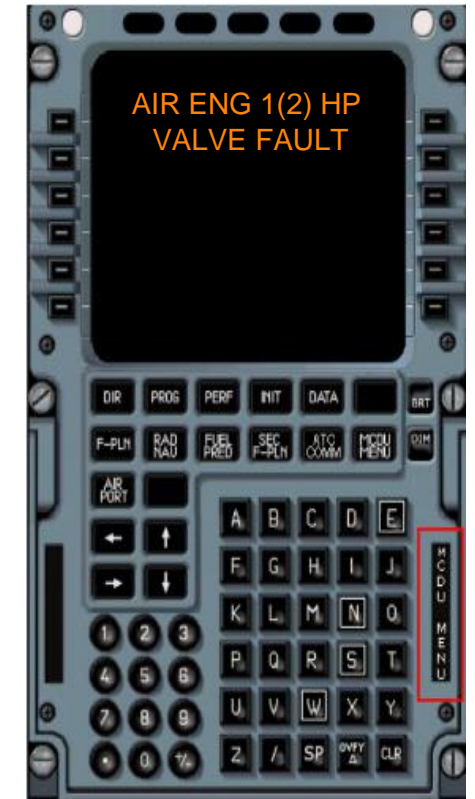
- After investigation of the different events, Airbus and Liebherr confirm the troubleshooting is very efficient to detect the HPV faults on wing. In the majority of cases, a HPV faults is linked to a **hard failure of the valve**.
- Pending HPV 70645A030001 introduction, Airbus and Liebherr recommend to strictly follow Airbus TSM and remove HPV when an HPV Maintenance Message (CMS) is triggered.

Recommendation: per TSM, replace the HPV when a HPV Maintenance Message is posted

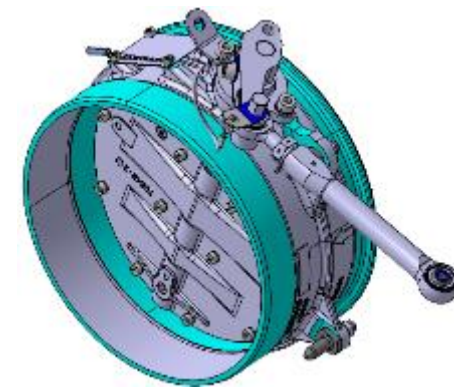
FAV valve body overview

Root cause for FAV valve body observed damages

From 2018, reports of FAV (body & rod) damage on AC with reinforced brackets i.e:

- Airbus POST SB 54-1045 or POST MOD 164147 for PW engines
 - Airbus POST SB 54-1044 or POST MOD 163328 for CFM engines
- Typical finding described here:

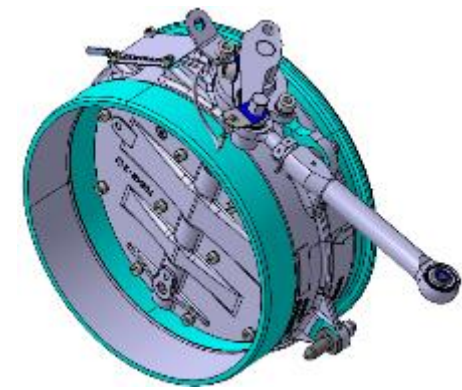
FAV valve body overview

AMM does not provide instructions to replace only the FAV rod on the wing. Airbus and Liebherr absolutely do not recommend replacing only the rod because other parts integrity cannot be ensured.

During aircraft inspection, if any of these damages are observed, the complete FAV Body + ROD needs to be replaced

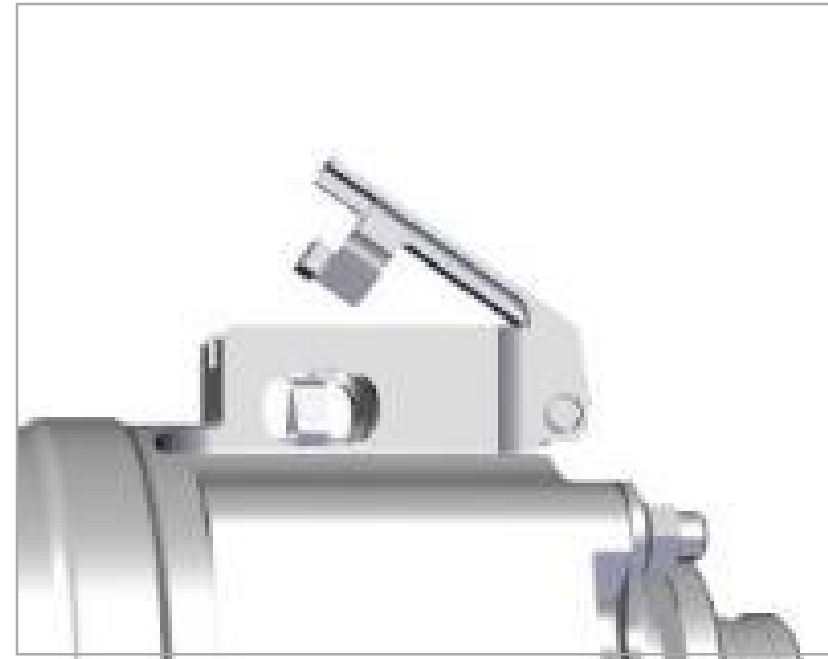
SLAT JAM

LOCKOUT INDICATOR ACTIVATED
MOSTLY ON A321 TRACKS 9, 10, 11:

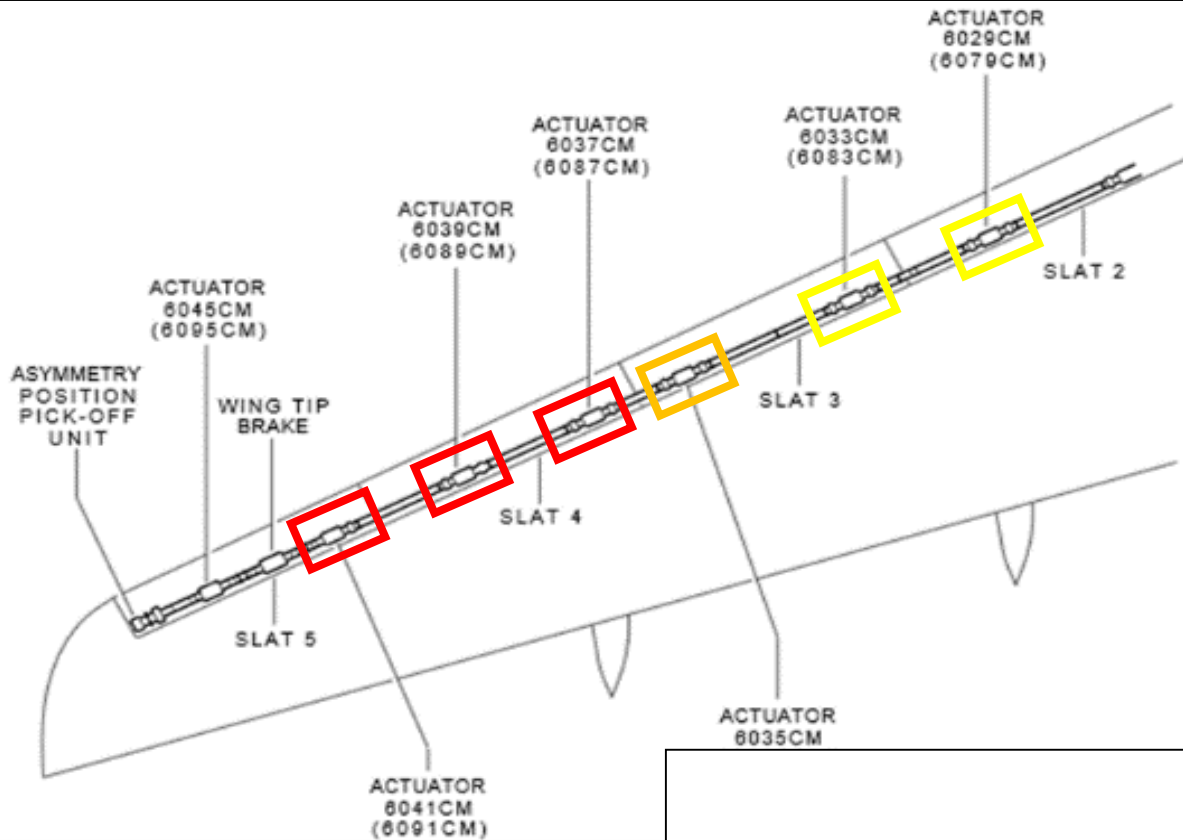
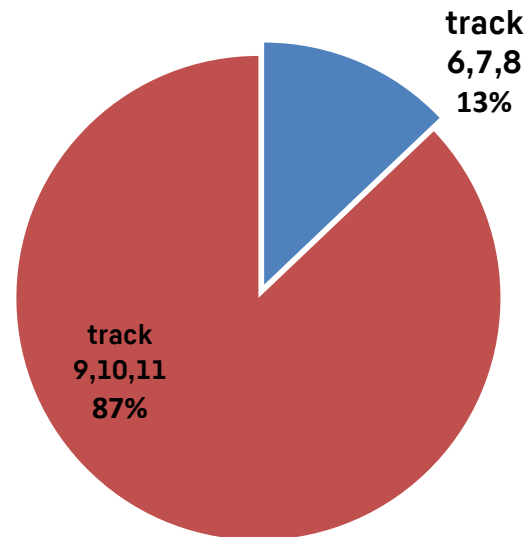
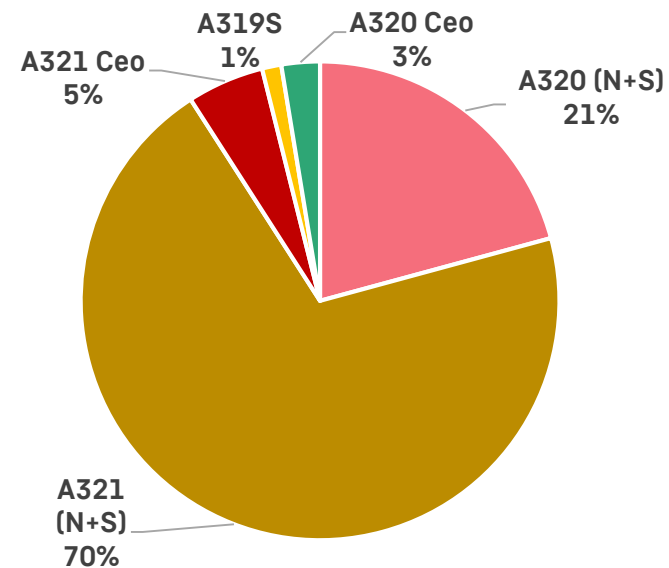
OVERVIEW

- Mainly slat track 9/10/11
- 77 reported slat Jam cases from 2014 to 2021

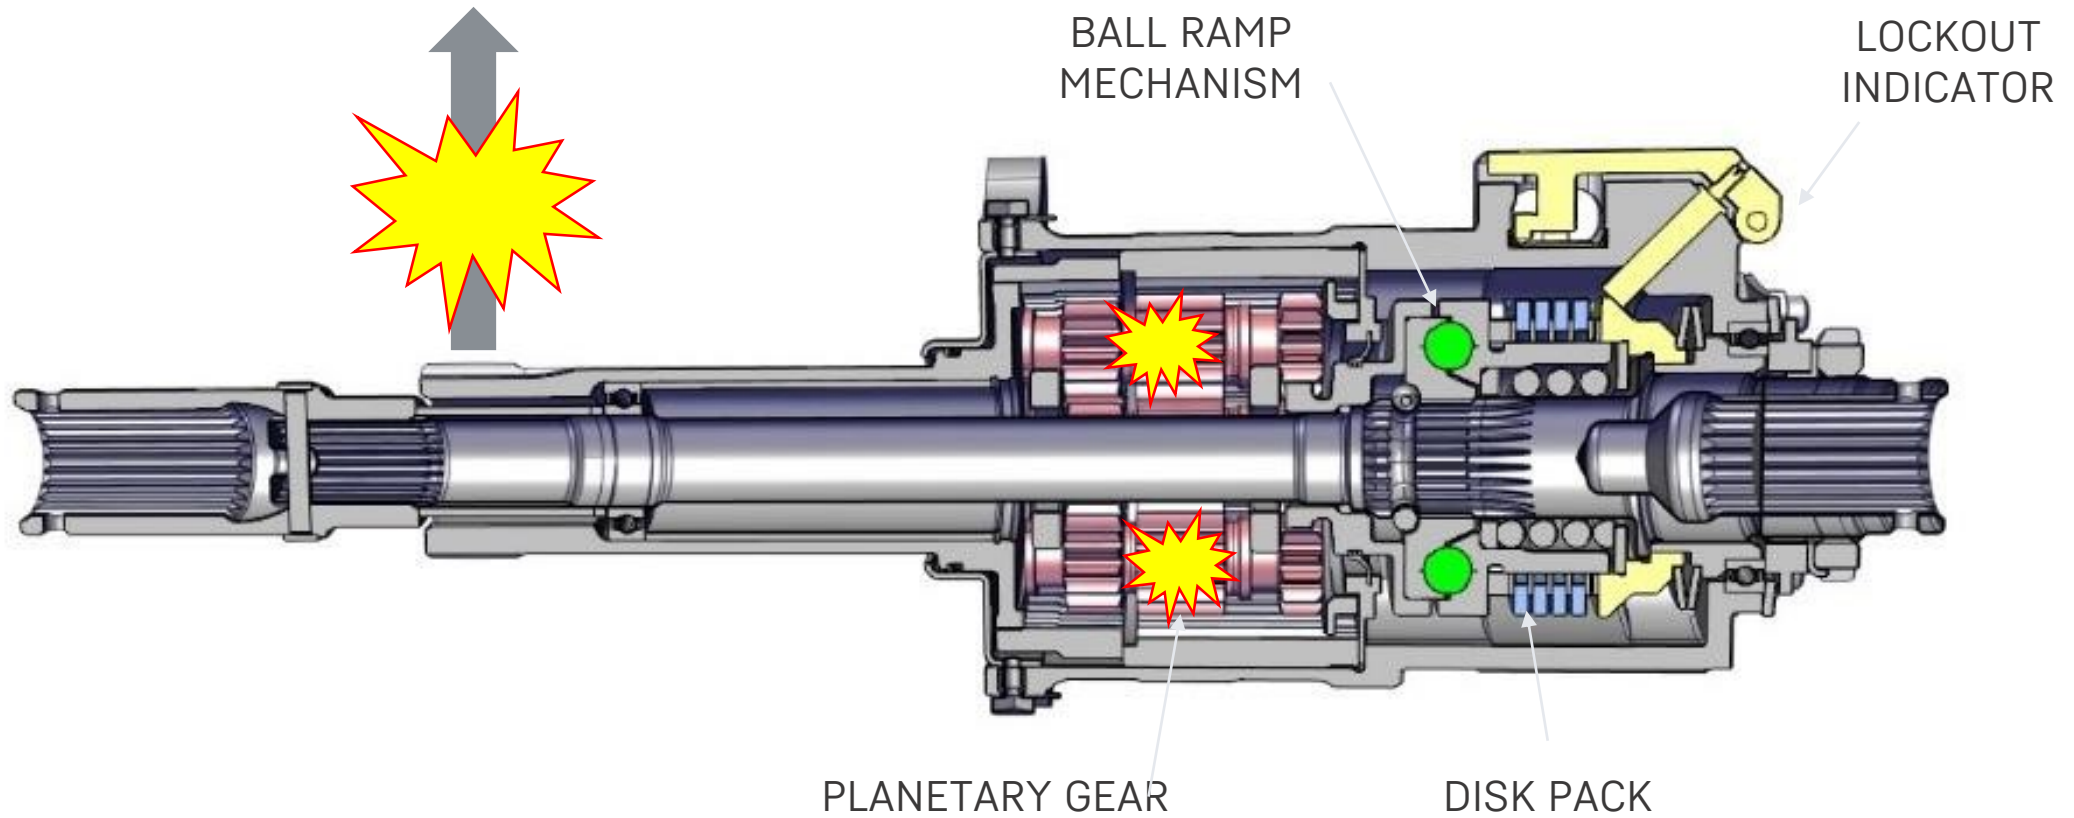
INVESTIGATIONS & ROOT CAUSE

- 43% of returned GRAs jammed @ -40°C test *
- Moisture found on 45% GRAs during disassembly.*

- Recommendation: ship affected units in sealed plastic bags to avoid water evaporation
- Reminder: Report every slat jam event to Airbus

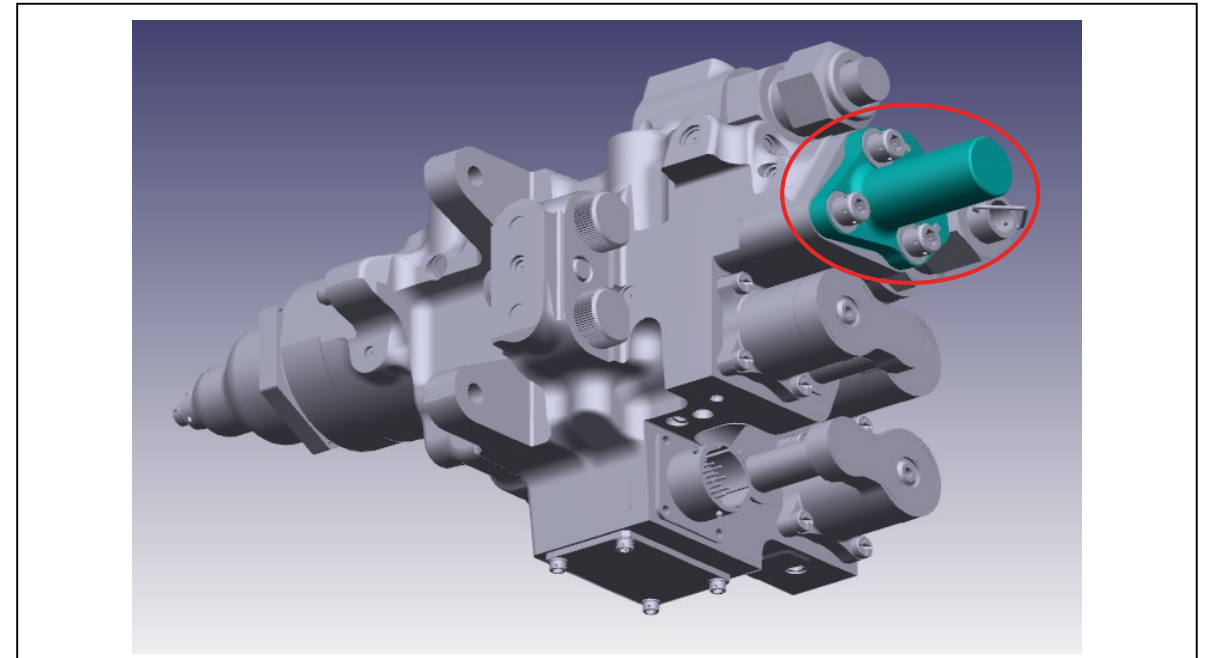
FLAP (SLAT) SYS 1 (2)
Fault with failure
message VALVE
BLOCK - VALVE SENSOR

- New LVDT shows good reliability.
- No more removals of new LVDT 9070A0008-03

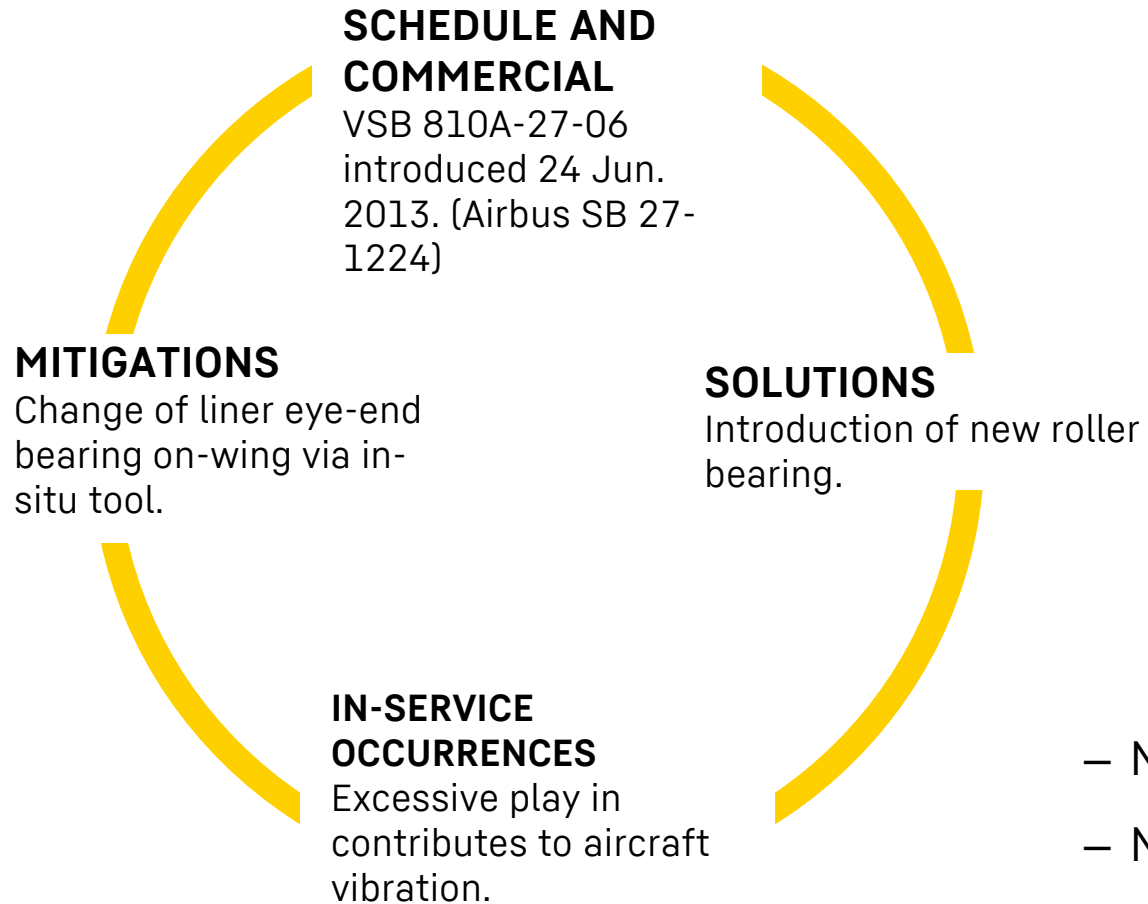
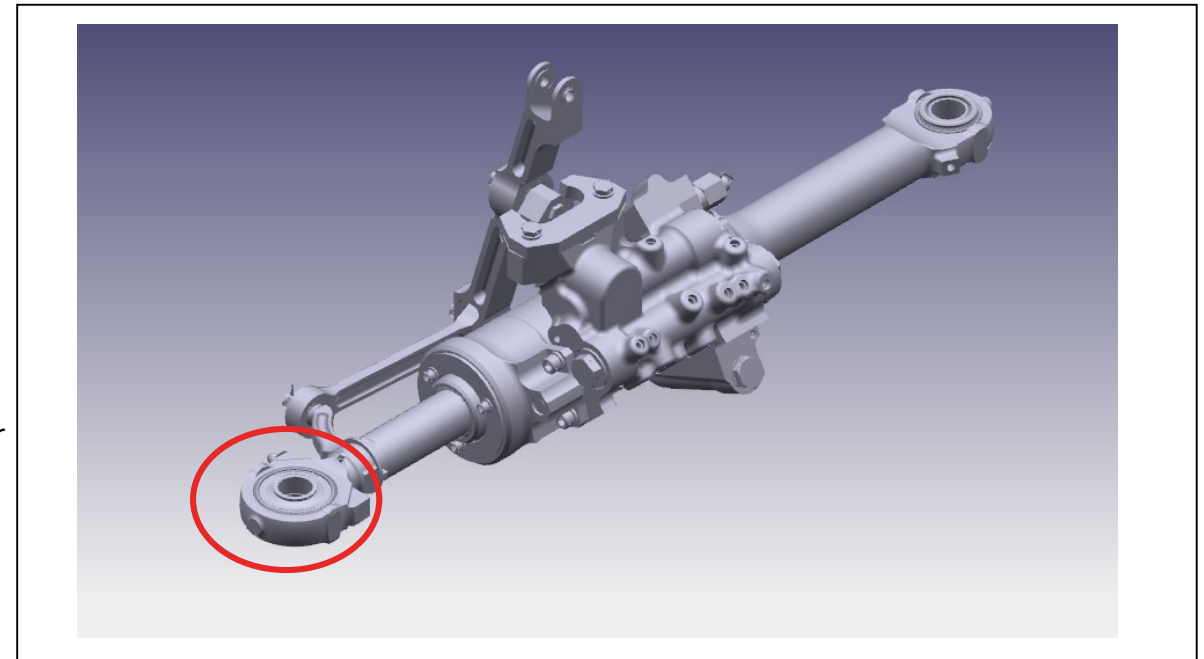
Rudder Servo Actuator Eye-end

- New Eye-end shows good reliability
 - No new complaints
 - About 5,200 A/Cs flying with roller bearing as of end of 2021*
- *data from Airbus
