# ATA 21 – Air Conditioning System SA

A320 CEO/NEO

# LIEBHERR

October – November 2023

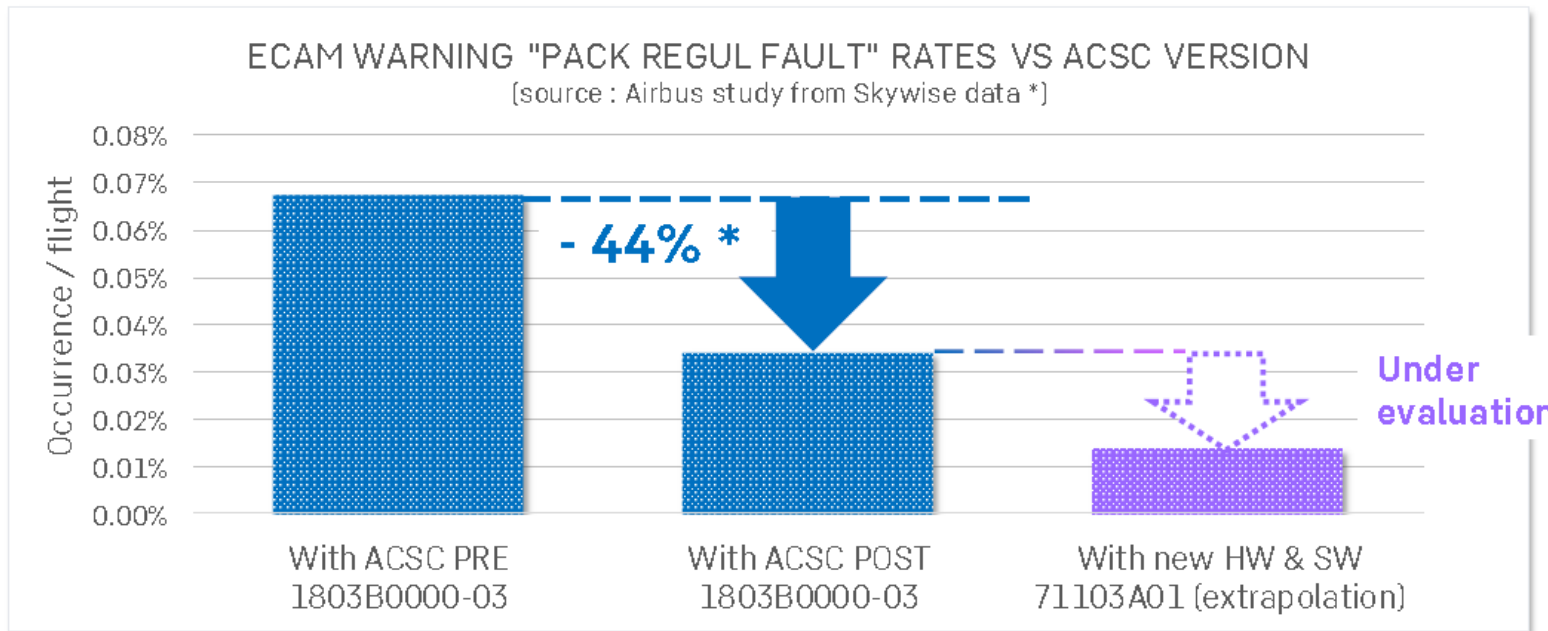
In June 2021, Airbus performed a comparative study in ECAMs "AIR PACK# REGUL FAULT" occurrence rate per flight between pre and post mod 1803B0000-03 software. The result is very positive, with a reduction of :

(\*) : Based on A319-A320-A321 aircraft delivered from 2010 to 2019, on a total of nearly 3,500,000 flights.

– ACSC software modification improvement measure
