Airbus SAceo

ATA 36

Liebherr-Aerospace

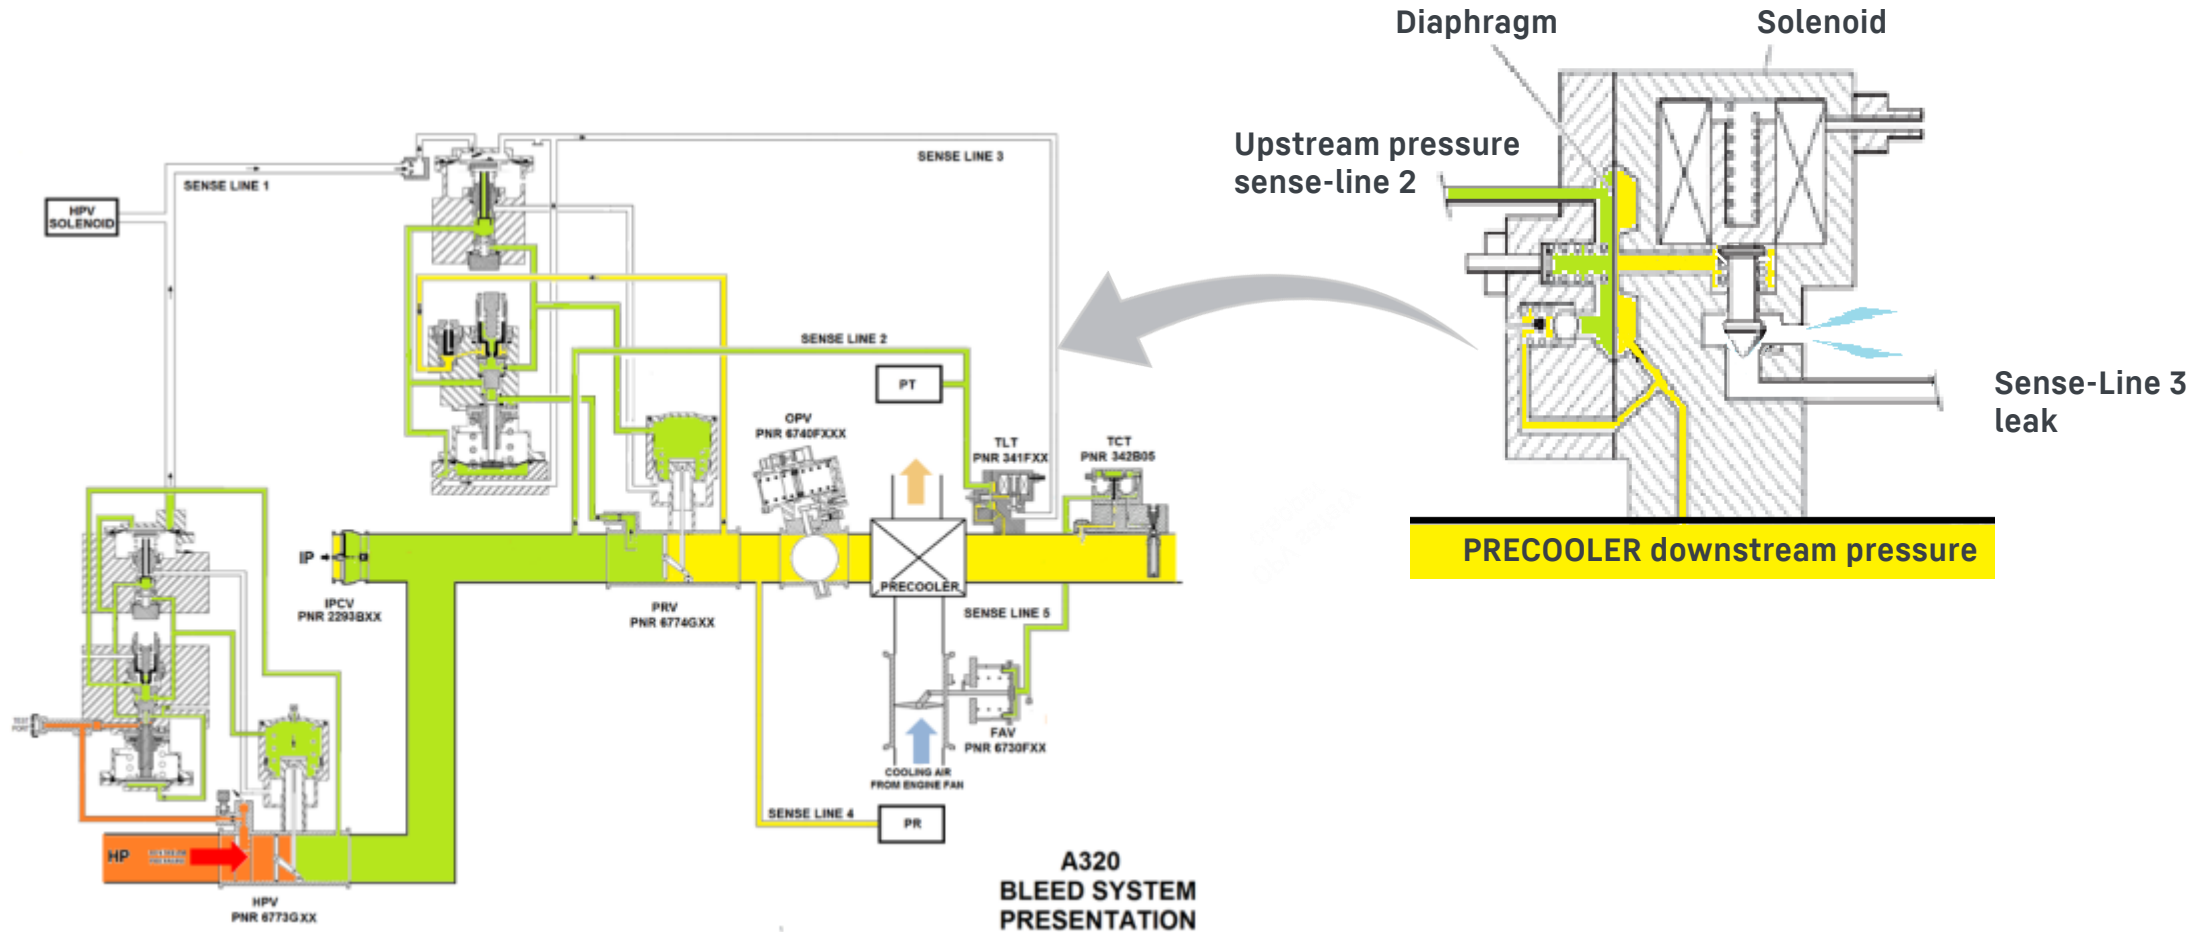
Engine Reverse Flow at start sequence – TLT function

Behaviour of the TLT Non-Return function

- Only during Engine starting sequence using APU Bleed, both Bleeds are still interconnected for a 10s time period
- The TLT Non-Return Function is alone to protect the engine
- In this particular 10s timeframe, the failure of TLT reverse flow protection may lead to engine stall.

Complete failure of TLT reverse flow function just after the engine start sequence with APU Bleed (10s) may lead to engine stall.

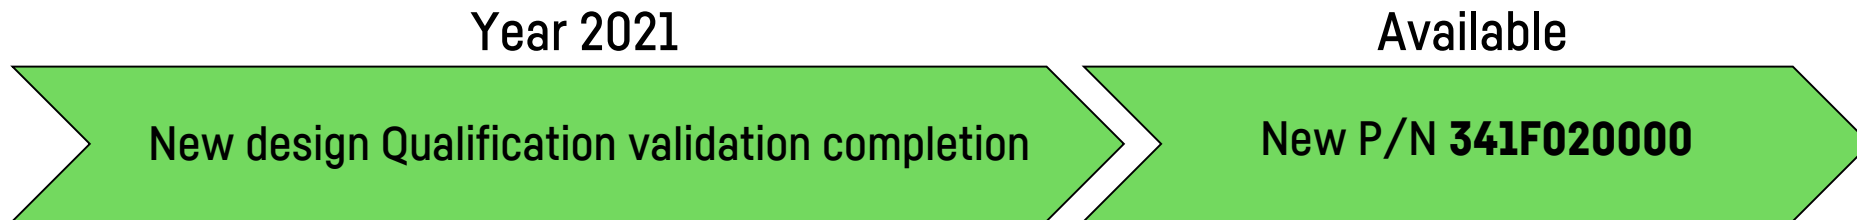
After engine stall events, some TLT (341F010000) were investigated and found with pollution in the Non-return function and the solenoid.

After analysis, some RTV was found as part of the pollution and RTV is used in the manufacturing of TLT diaphragm

The modification will consist in removing RTV during diaphragm manufacturing only.

VSB 341F-36-01 to be applied on attrition basis. At opportunity of a Major repair, systematic embodiment at no additional costs.

VSB 341F-36-01 available since July 2022

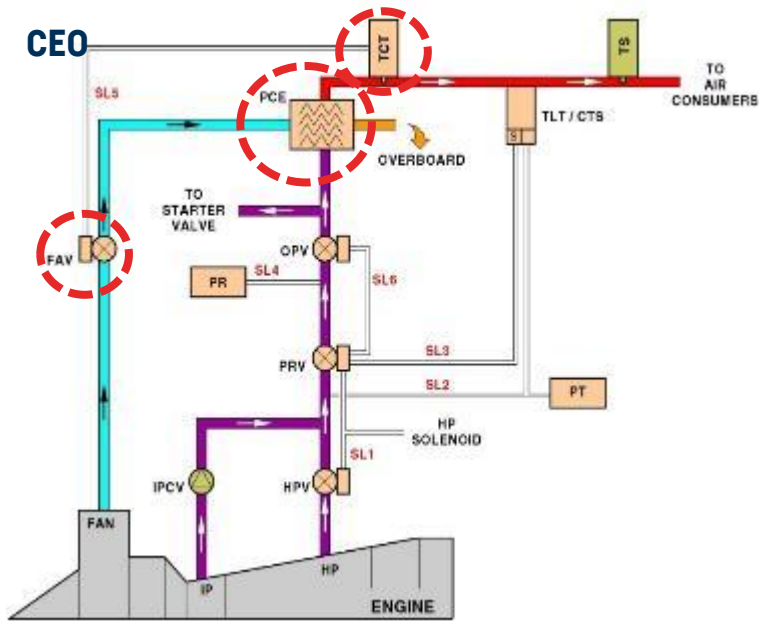
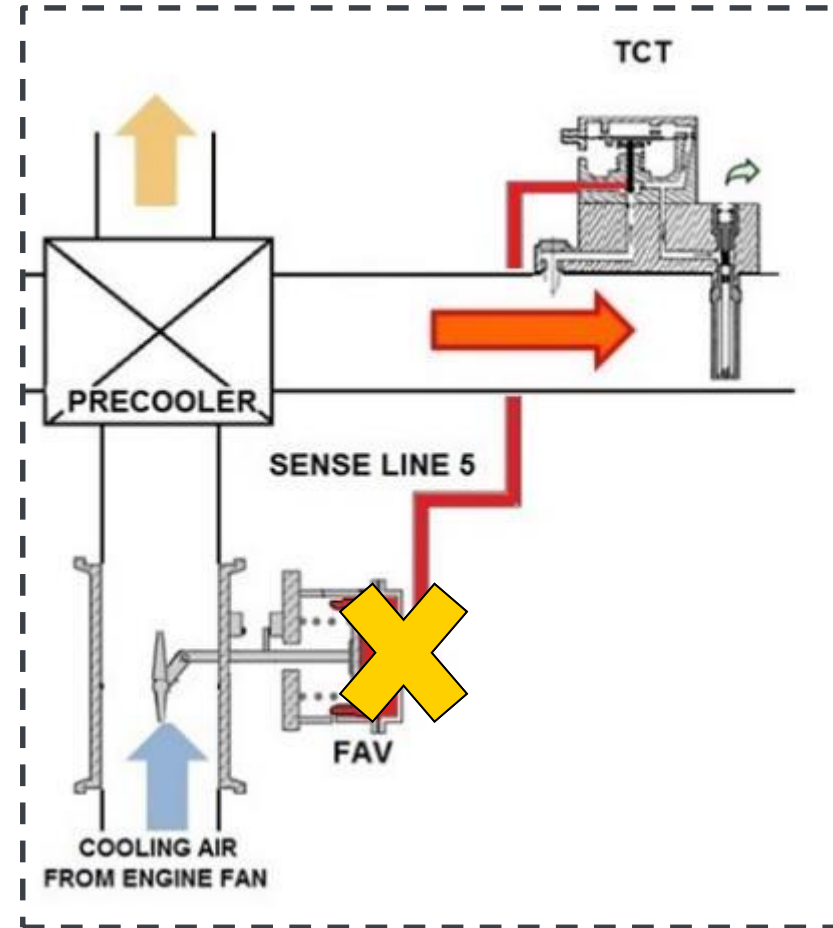
Engine Bleed Low Temp

Bleed Low Temp is detected when Precooler Outlet temperature drops below 150°C for more than 5secs

A periodic cleaning of the FAV banjo hole can efficiently prevent the majority of low temp events

Refer to Airbus AMM TASK 36-11-00-720-012-A
