# Airbus A320NEO

ATA36 System

**LIEBHERR**

Regional Technical Workshop  
2023

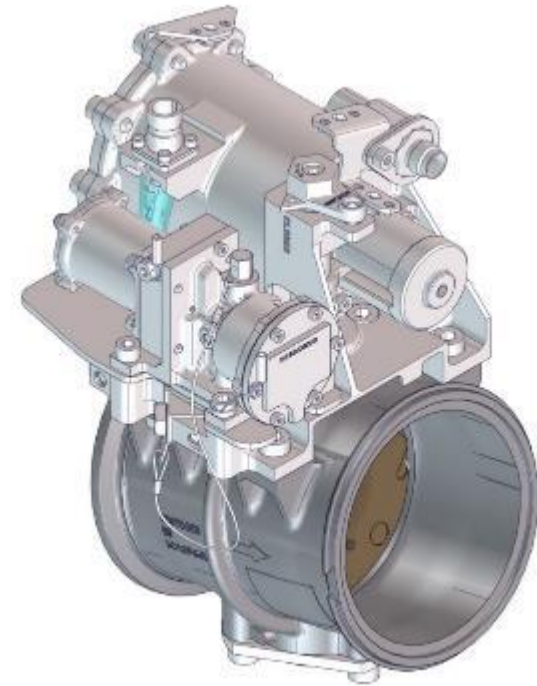
### High Pressure Valve (HPV) 70645A020001

- HPV Failed Closed
  - RCP-Saneo-36-0339
  - TFU 36.11.00115

- HPV Failed Open
  - RCP-Saneo-36-0380
  - TFU 36.11.00106

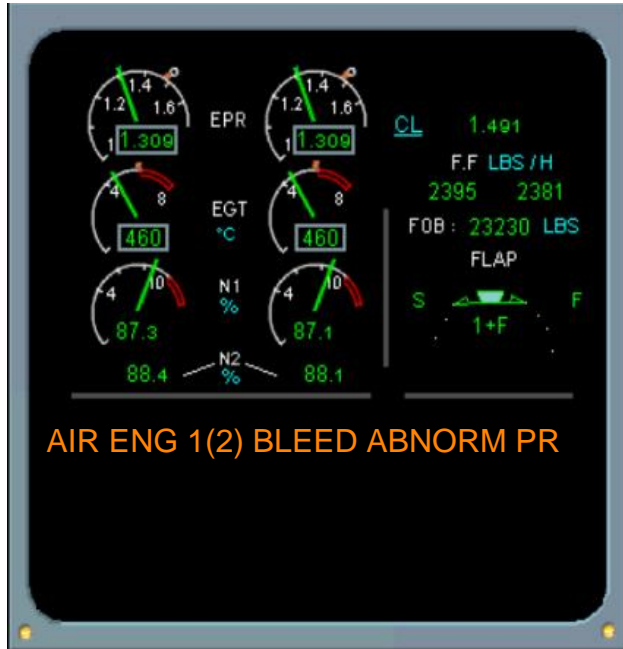
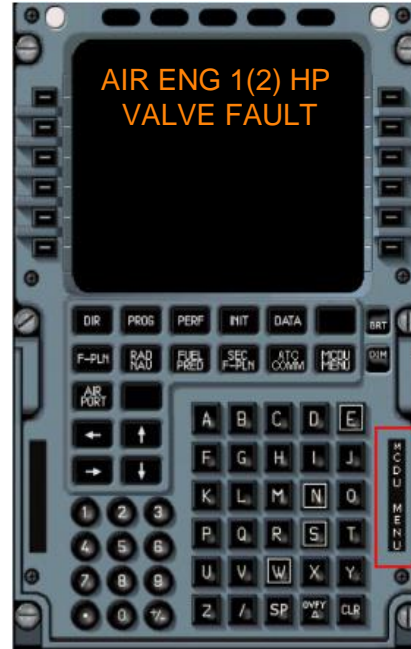
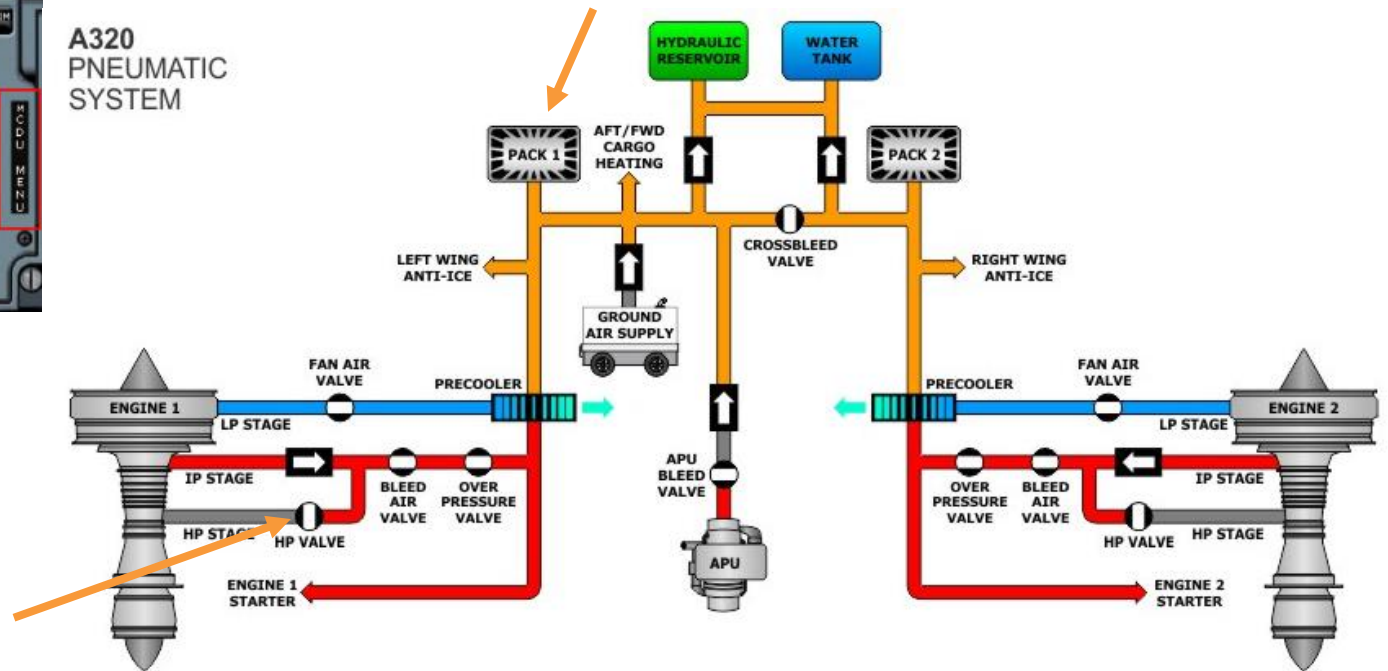
# HPV 70645A02\* Fault - Failed closed (FC) system effect

Cruise, bleed on Intermediate Pressure port

Top of descent leads to engine thrust reduction

Pack Inlet Pressure is detected below 18 psig

HPV is detected closed while commanded to open

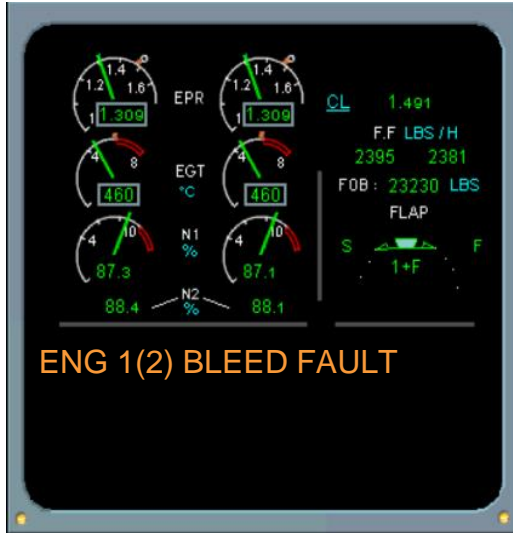
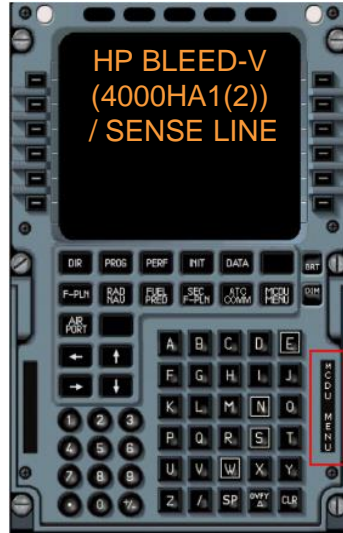
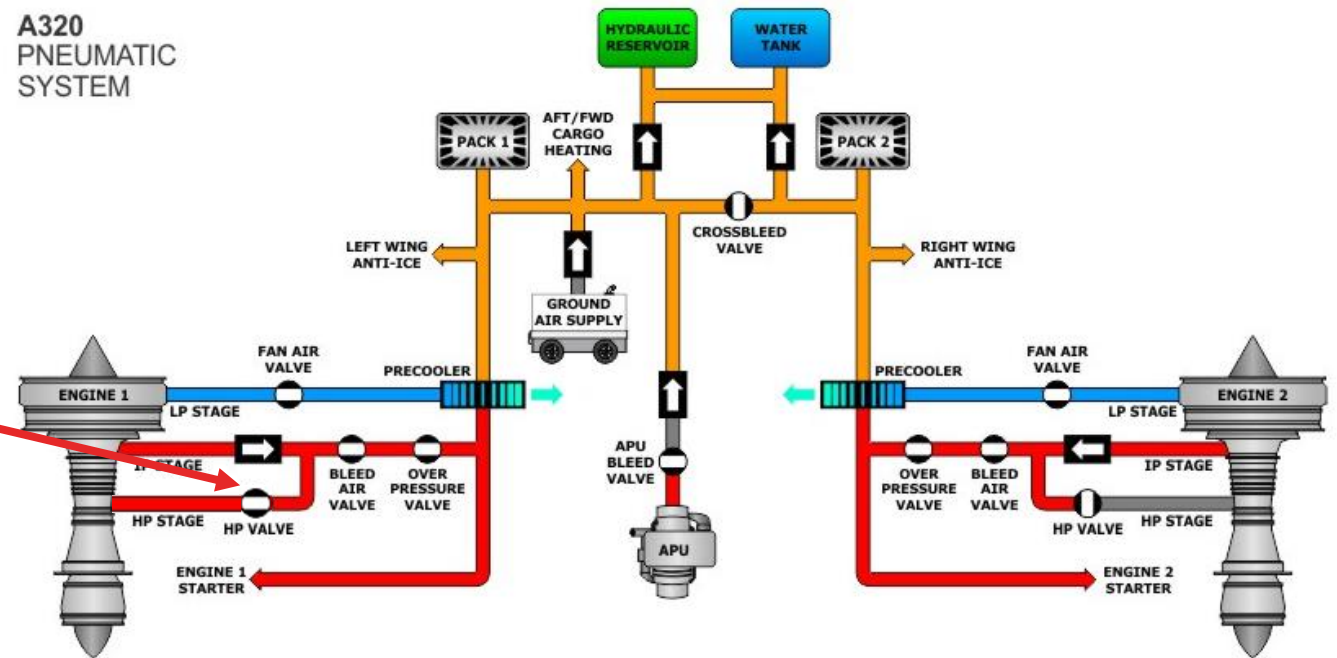
# HPV 70645A02\* Fault - Failed open (FO) system effect

**In-service occurrence**  
Most cases occur on ground at Take-off during engine thrust increase to Take-off level

BMC detects HPV is open also it is commanded to close  
BMC isolates the bleed and closes corresponding PRV

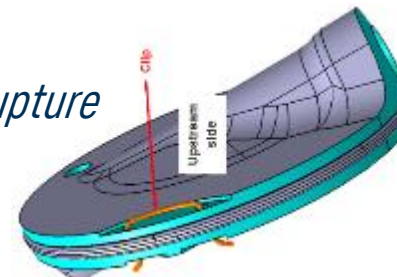
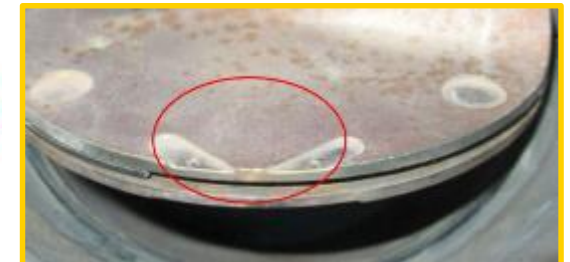
✓ *Butterfly clip rupture*

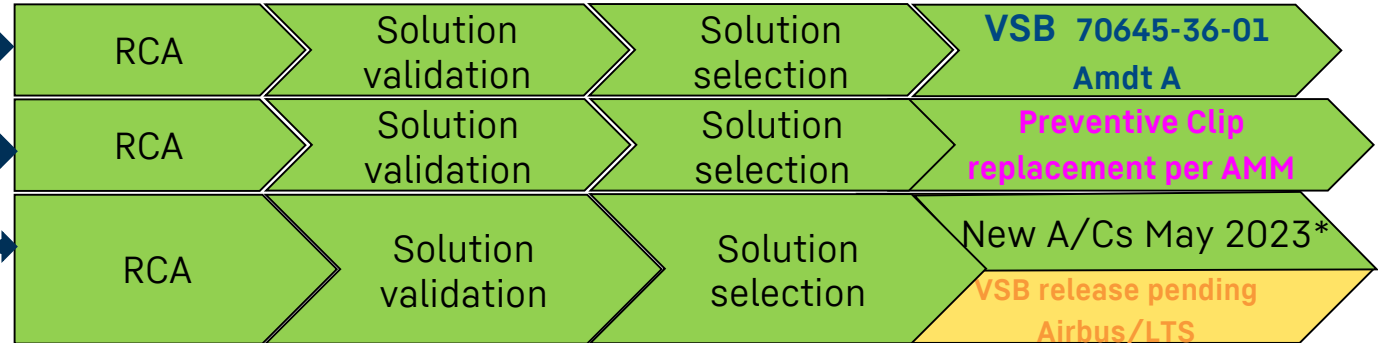
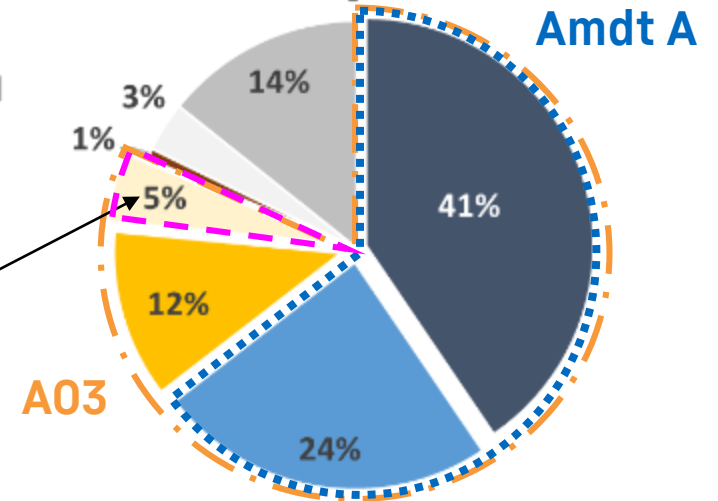
# HPV faults & solution + mitigation generalization timeline

Design solutions	Failure Mode		Amdt A	clip replt	HPV A03
	FC	FO			
Graphite piston seals	X	X	✓		✓
Graphite regul. clapper	X		✓		✓
Butterfly clip		X		✓	✓
Solenoid sleeve	X				✓

Major finding HPV 70645  
Study period [Jan 2018-Oct 2021]

- ACTUATOR SEALING EXUDATION
- REGULATOR S/A EXUDATION
- SOLENOID S/A failed
- CLIP RUPTURE
- BEARINGS WORN
- INDUCED
- NFF

Leap : AMM 36-11-51-000/400-805-A

PW : AMM 36-11-51-000/400-806-A

Or Preventive clip replacement in Shop

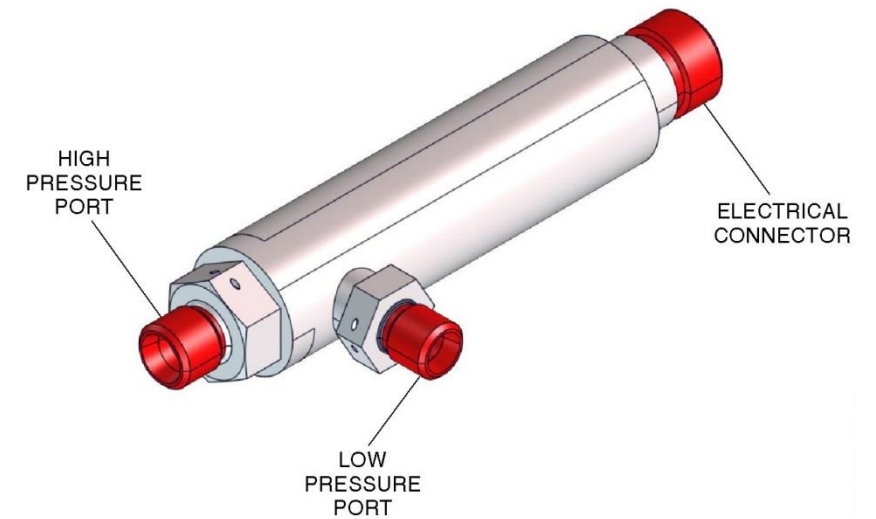
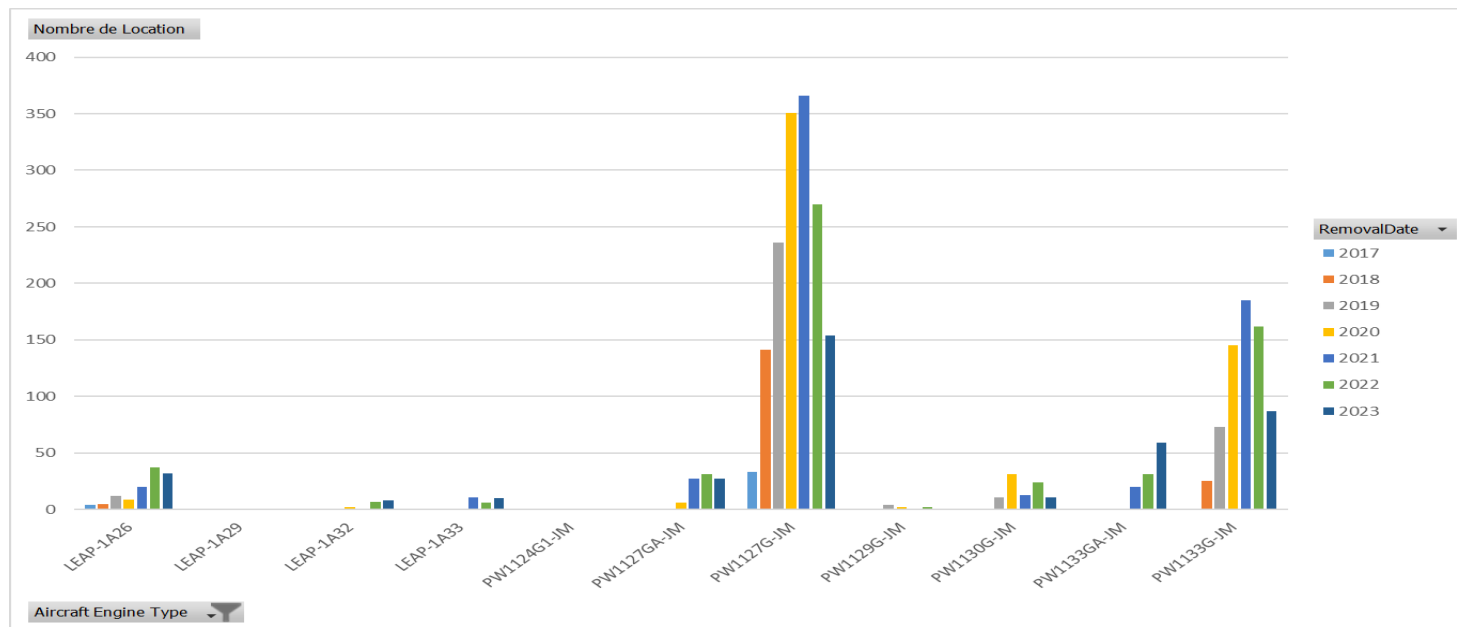
**Delta pressure Switch  
25002A010001**

- Multiple Differential Pressure Sensor (DPS) removals due to "DRIFT DIFF-PRESS XDCR /SENSE LINE" or "DIFF-PRESS XDCR /SENSE LINE"
- PW engine installation is more affected (91% of removals)
- 80% of DPS are No Fault Found during ATP at ambient temperature.
- Sense line modification deployed by Airbus to avoid water migration inside the sensor
  - ➔ Despite Operators report DPS faults after modification, improvement can be observed
  - ➔ The sensor are not damaged by water/ice

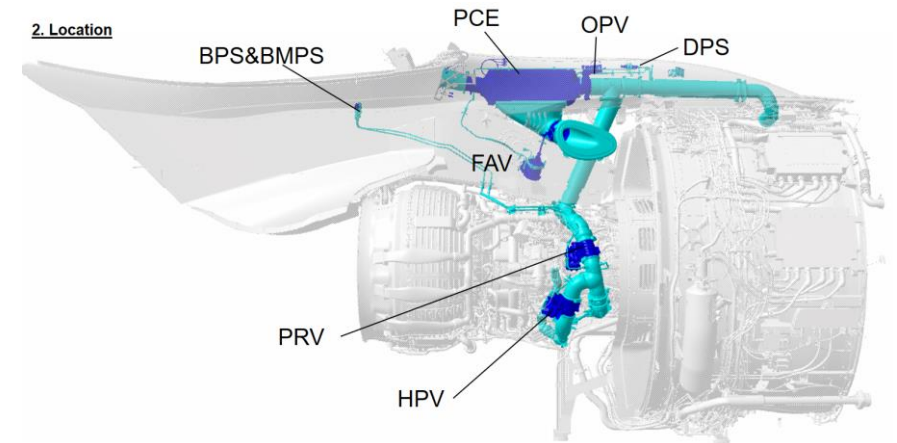
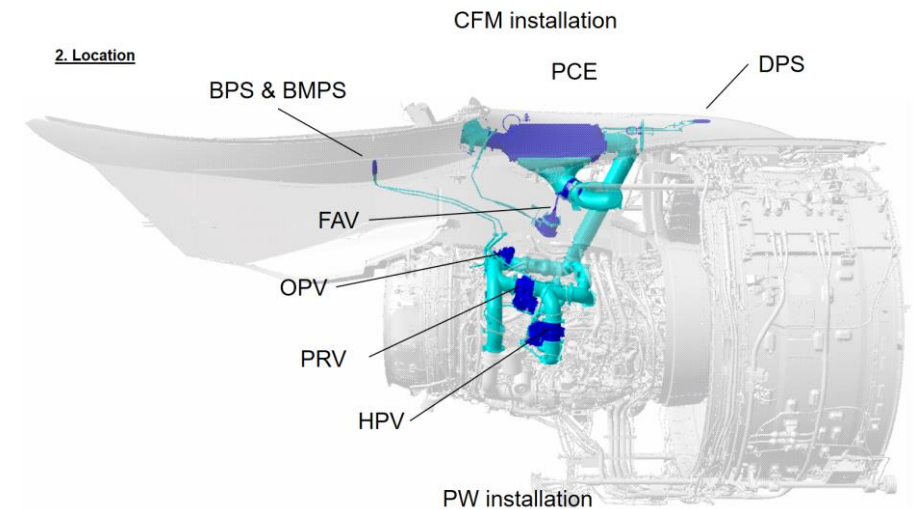
Weibull analysis per manufacturer and per engine

- The Weibull analysis per engine and per manufacturer confirms the sensor is performing well
- The two DPS manufacturer have the same reliability on LEAP and the same reliability on PW

Data	Average MTF	Lower MTF @90%	$\beta$
25002A010001	51 180	38 931	2.19
70653B*	63 450	44 340	1.12
CFM	6 488 779	203 843	0.68
PW	16 122	13 321	1.49
70996A*	30 185	20 724	1.75
CFM	<i>not enough data for a consistent result</i>		
PW	15 352	11 901	2.02

DPS reliability & solution efficiency under monitoring

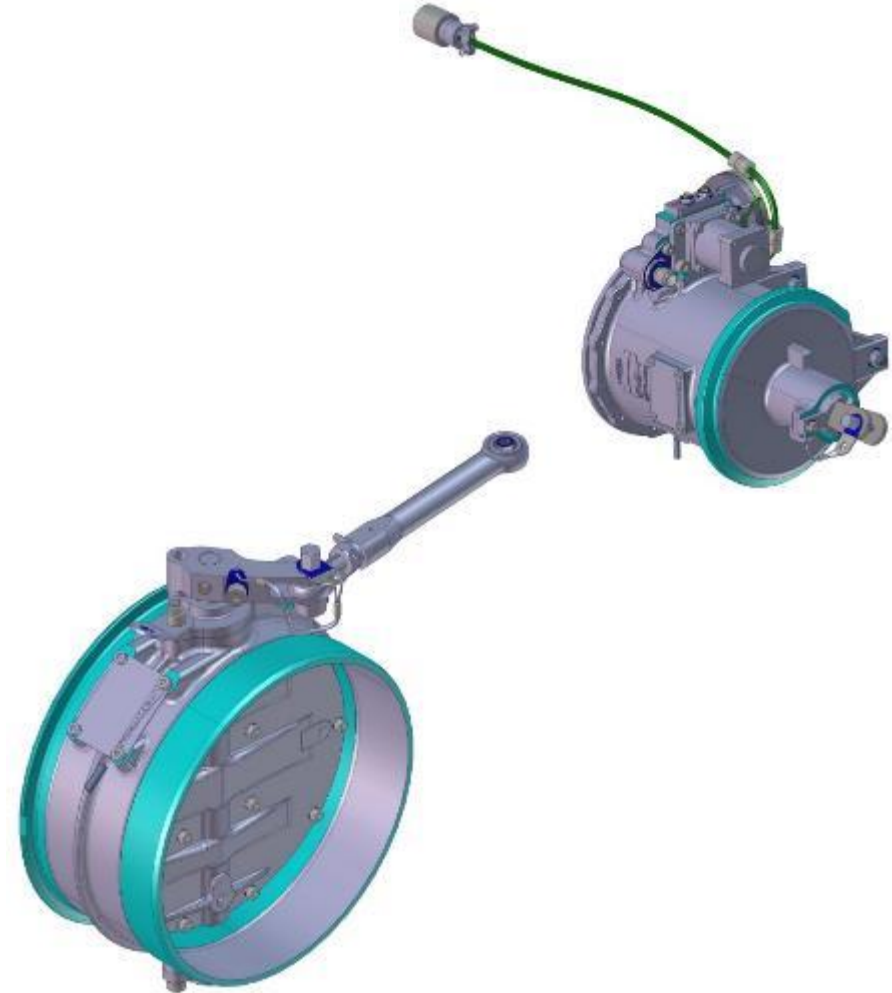
### Fan Air Valve (FAV) 70649A01000x (body)

- FAV Investigation
  - RCP-Saneo-36-0318
  - TFU 36.11.00104
