**RTW 2023**  
**Airbus**  
**A330CEO**  
**ATA 36**

Liebherr-Aerospace Toulouse SAS

# Engine Bleed Not Closed – Airbus / Liebherr ISE Status

# HPV NOT OPEN

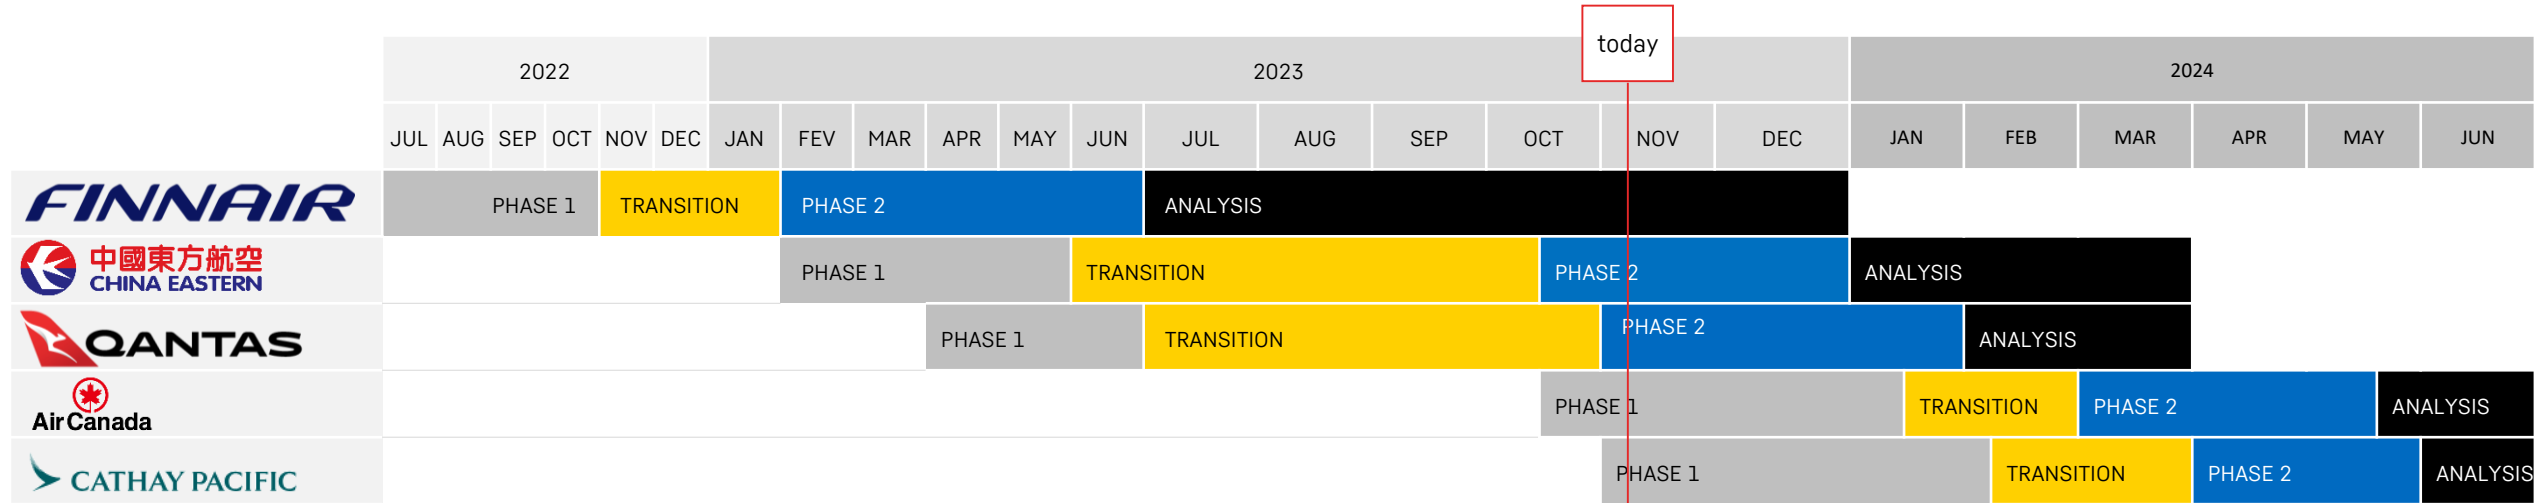
- Shall be reduced as much as possible
- Shall be made “in the flow”

Phase 1 : Data analysis for EBNC characterization & Aircraft candidate selection

Preventive Maintenance EBNC Workscope description :  
 Inspection of several components (ie ring guide, ring sealing, spring, washer...) for Body actuator S/A, butterfly S/A, regulator S/A for sign of wear or heavy pollution.  
 → Clean or replace if necessary

10 PRVs = 4 with EBNC preventive maintenance + 4 with standard repair + 2 new
