# A350 NLG

Steering & Operating Noise

Liebherr-Aerospace

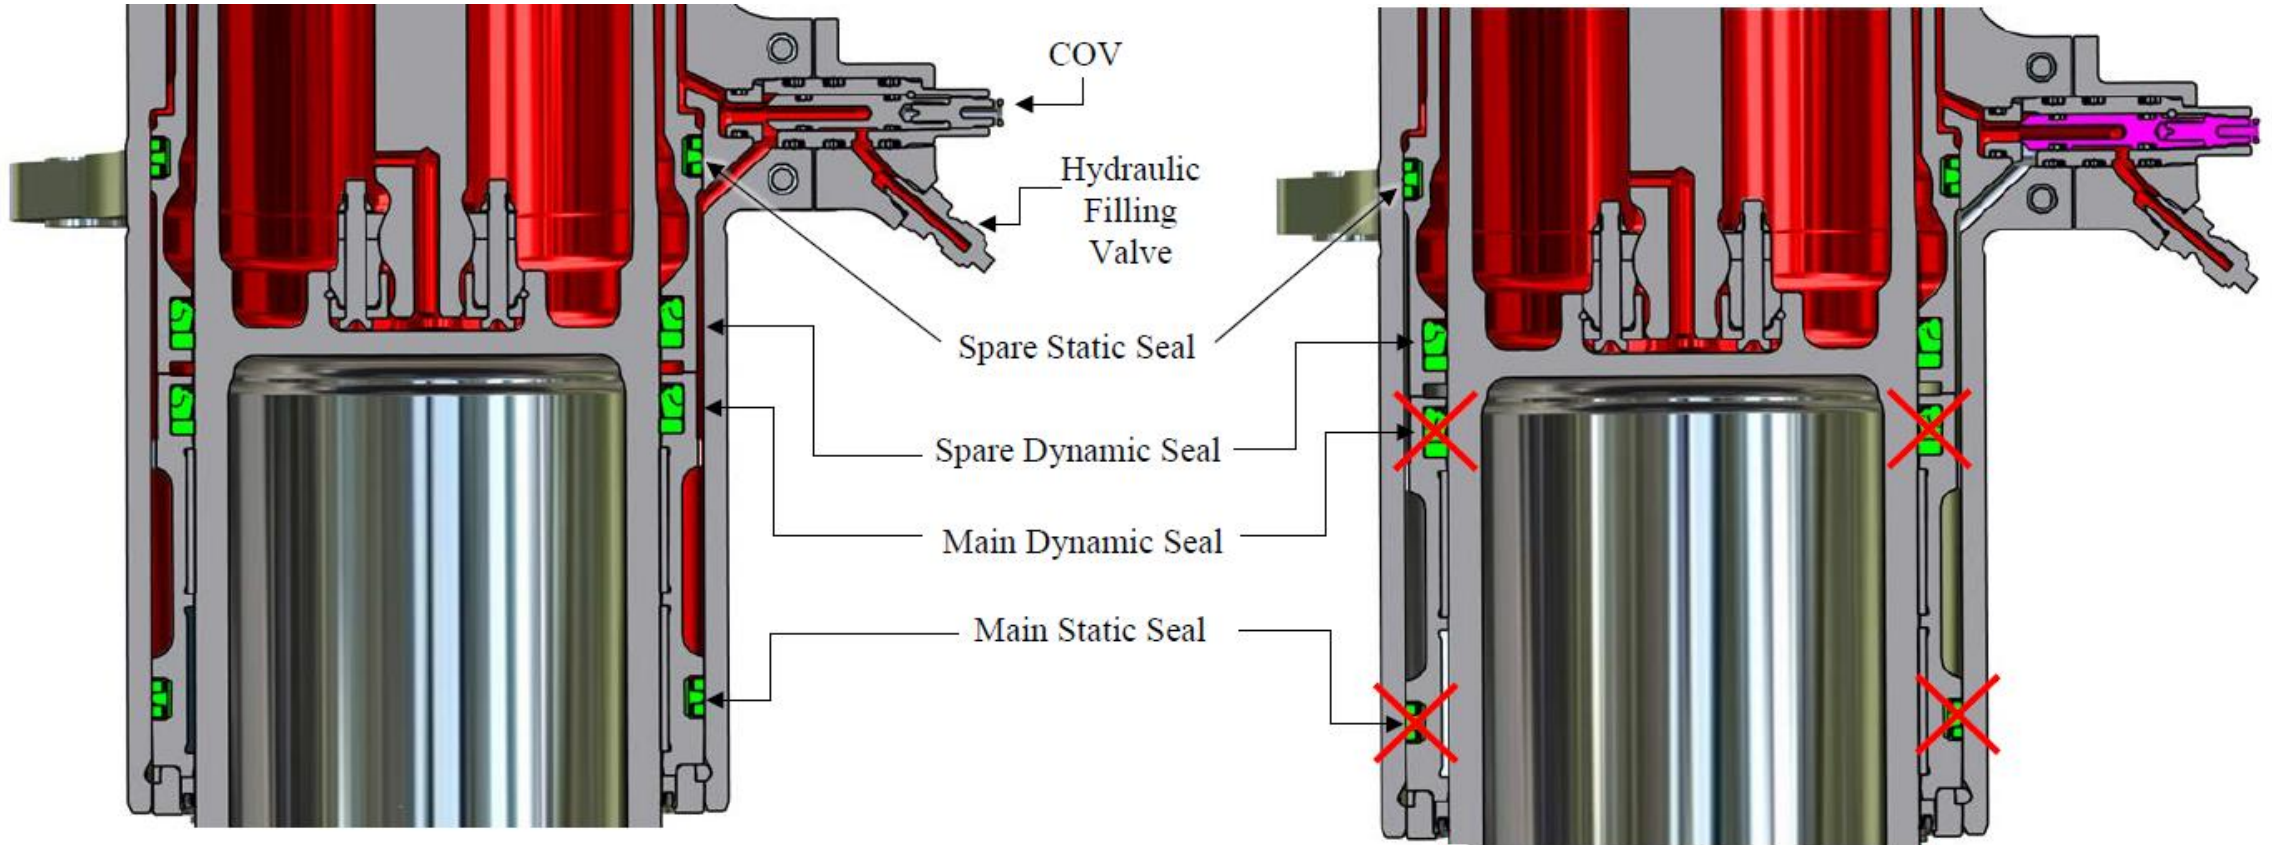
## AFFECTED COMPONENTS

**Upper Carrier  
(Contains Secondary  
Sealing System)**

**Lower Carrier  
(Contains Primary  
Sealing System)**

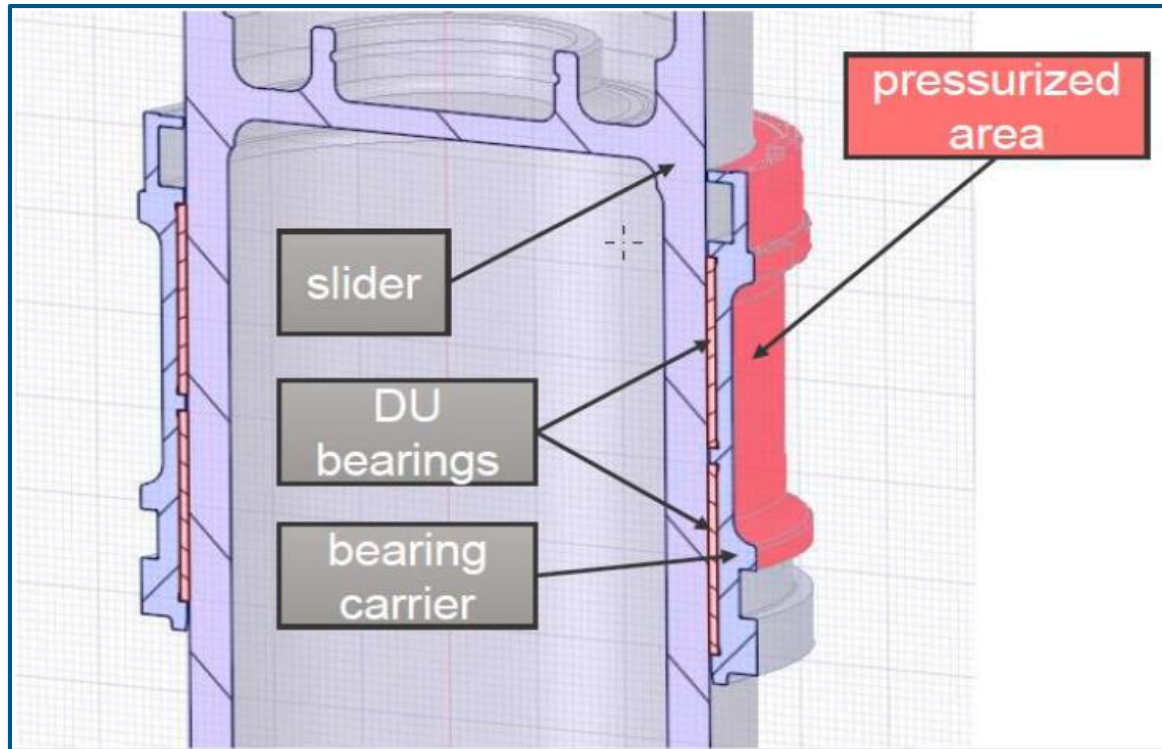
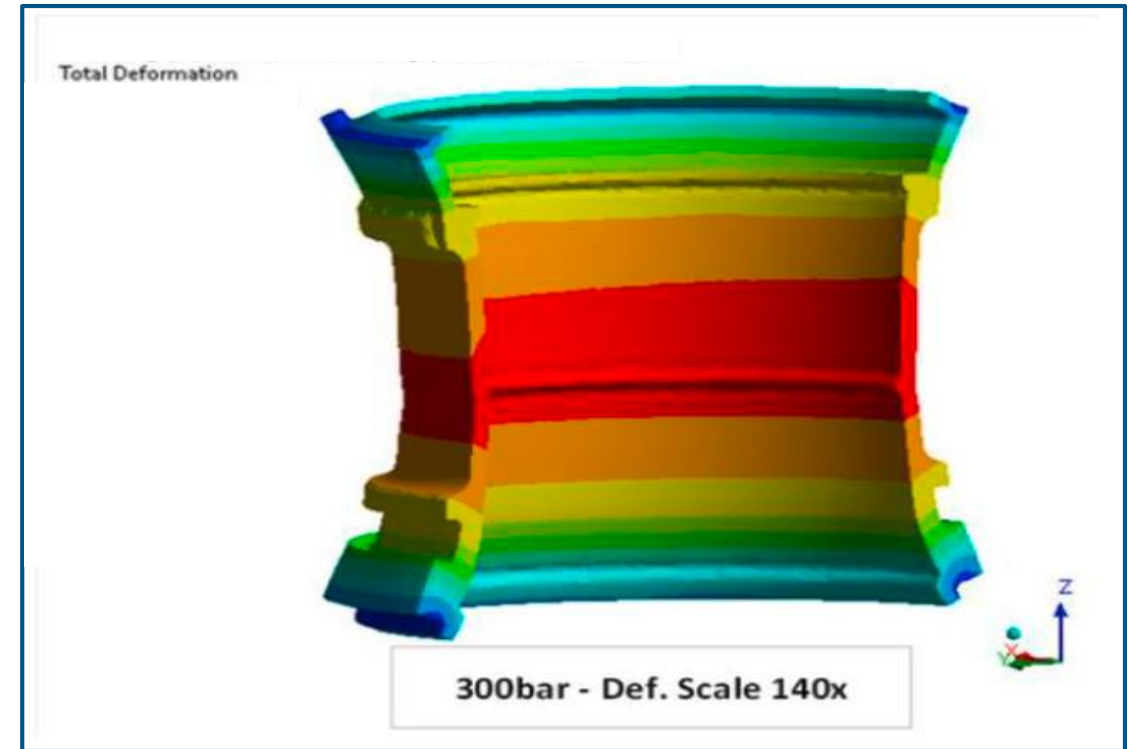
# Investigation

- No noise / no elastic deformation on bearing carrier (A/C unloaded)
- Elastic deformation on bearing carrier with high oil pressure (A/C loaded)
- Noise confirmed for the investigated NLGs @ LLI Test Rig
- Noise confirmed for turning and/or damping movement
